# Technical Journal

**Outer rear view mirror jamming**

| REF NO:<br><b>TJ 36763.2.0</b> | ISSUING DEPARTMENT:<br><b>Technical Service</b> | CAR MARKET:<br><b>United States and Canada</b> | |

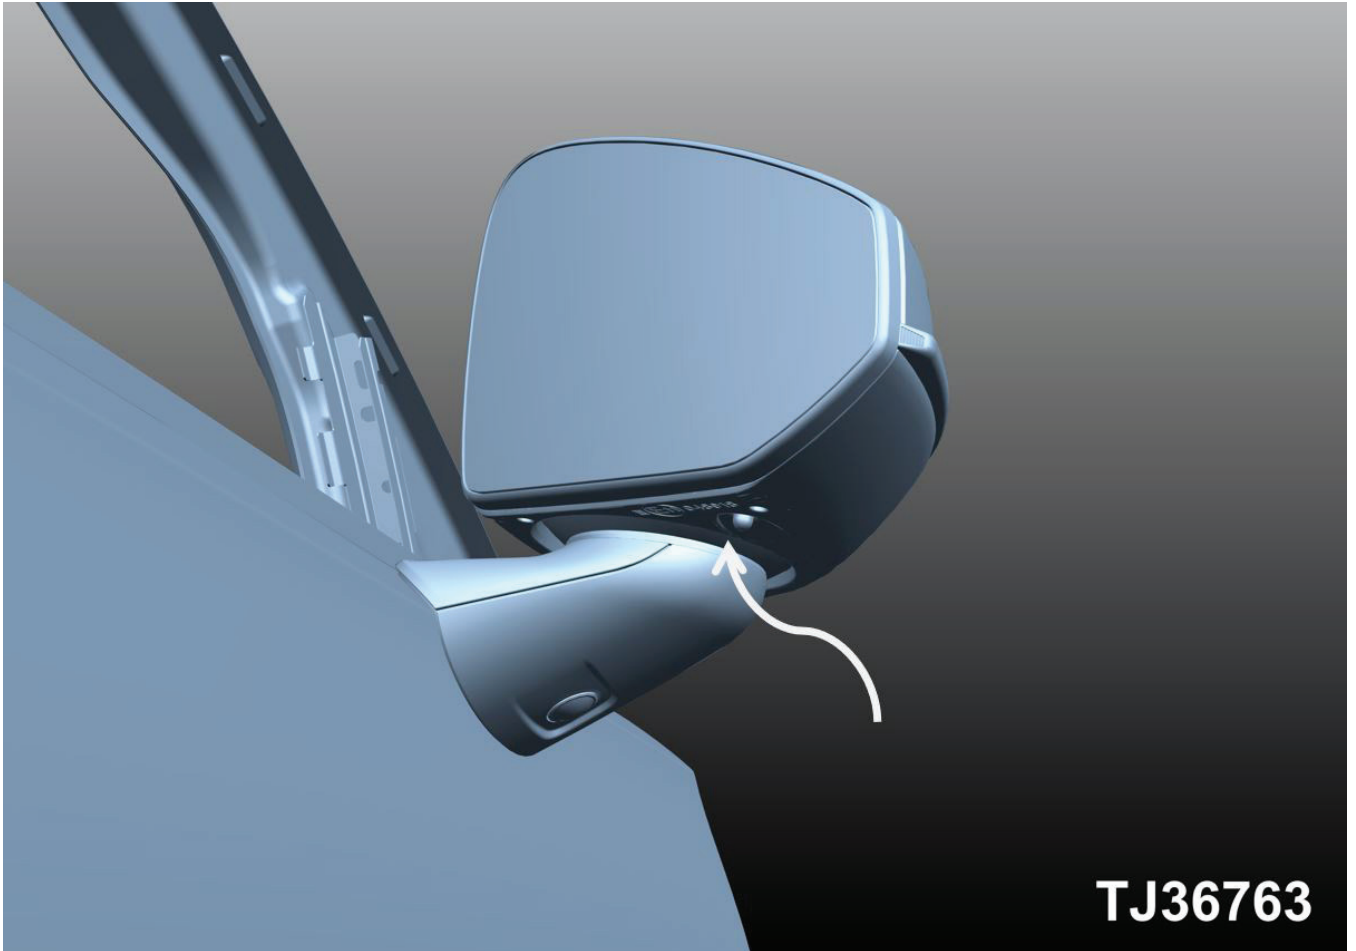
| File Name | File Size |
|---|---|
| TJ 36763_1.JPG | 0.0576 MB |

1. Assemble the cable correctly and then lock/unlock the car. If the symptom remains, see step 2.
2. Use Wurth Dry Lubricant Spray (PTFE) with part number 0893550 and spray underneath the mirror at the base. See attachment.
