04/01/2024
CAL FTL 54-033

Subject: Red LV Battery Telltale Present on Startup

Make: Freightliner

Model: eCascadia and eM2

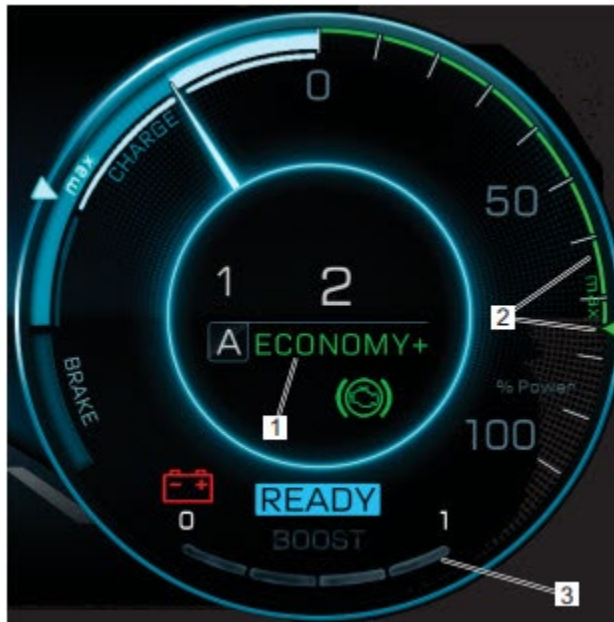
The red battery telltale typically indicates that the low voltage (LV) 12V batteries were at a low state of charge when the vehicle was turned ON. When this telltale is on, there is a risk of certain LV components operating in a protection mode and/or not receiving power at all. While the vehicle can be driven in this state, some components may not be functioning correctly, and the vehicle could be damaged. See **Fig. 1** and **Fig. 2**.

Fig. 1: Red Battery Telltale on a Dashboard

Fig. 2: Red Battery Telltale

If the red LV battery telltale is illuminated while the vehicle is in the 'READY' state, follow these steps to determine whether the LV batteries require service:

1. **Avoid driving at high speeds:** It is acceptable to move the vehicle around or take it into a service bay.
2. **Keep the vehicle ON:** Allow the vehicle to remain in the Powertrain 'READY' state for up to 30 minutes while it is parked and idling. This allows the on-board DC/DC converter to charge the LV batteries.

3. **Cycle the keyswitch:** After idling for a period, turn the keyswitch OFF. Wait until the instrument cluster has gone completely dark, and then turn the vehicle back ON. If the LV batteries and associated components can recover to normal function, the red battery telltale will not be illuminated after the keyswitch is cycled, and the vehicle can be driven normally.

4. **Repeat the steps if needed:** If the red battery telltale remains on after cycling the keyswitch, repeat the above steps at least once more. If the telltale continues to remain active even after giving the LV batteries time to recover, it may be necessary to replace the LV batteries.
