Preliminary Information

PIT6162 Theft Alert Message in DIC

Brand:	Model:	Model Years:	VIN:		Engine:	Transmissions:
			from	to		
BrightDrop	Zevo 600	2023 - 2024	All	All	All	All
BrightDrop	Zevo 400	2024	All	All	All	All

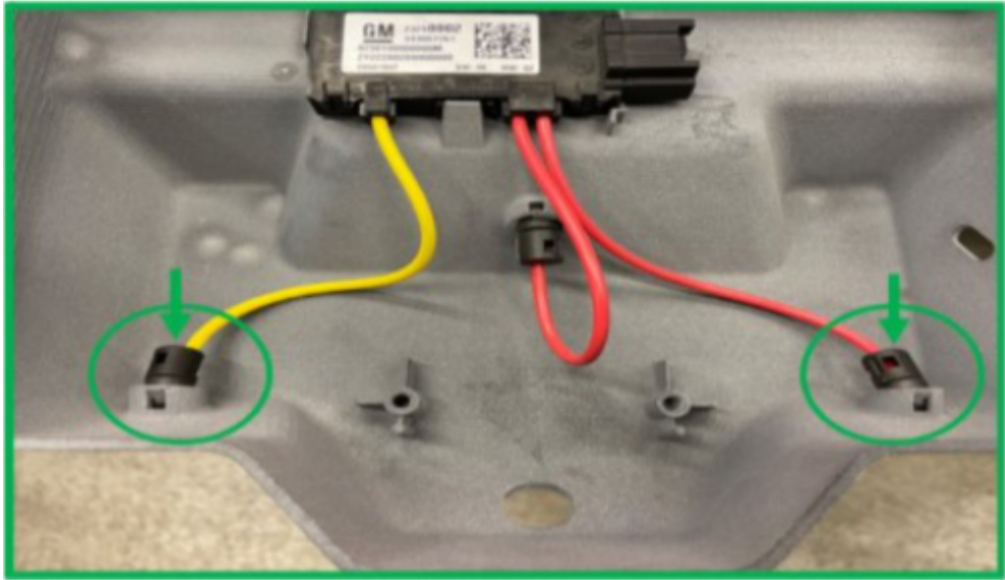
Example of cargo intrusion sensors installed correctly.

Verify the cargo intrusion sensors are installed correctly into the mounting housing.

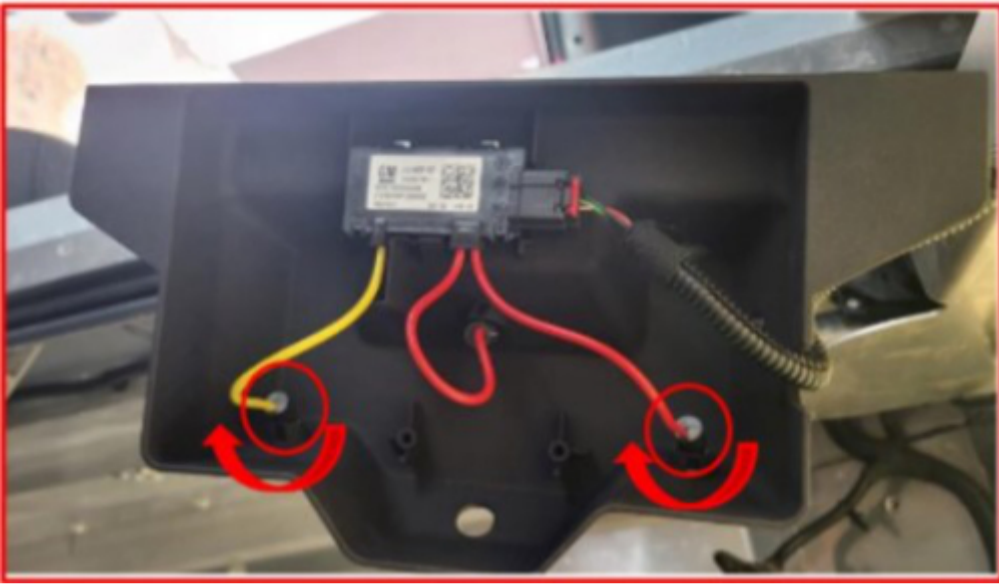
Involved Region or Country	North America
Condition	A customer may comment that they have a Theft Alert message in the DIC.
Cause	The cargo intrusion sensors may be installed out of position and not fully seated in housing.

Example of cargo intrusion sensors out of position.
