TRANSFER CASE NOISE

Range Rover

- 24MY Range Rover Sport

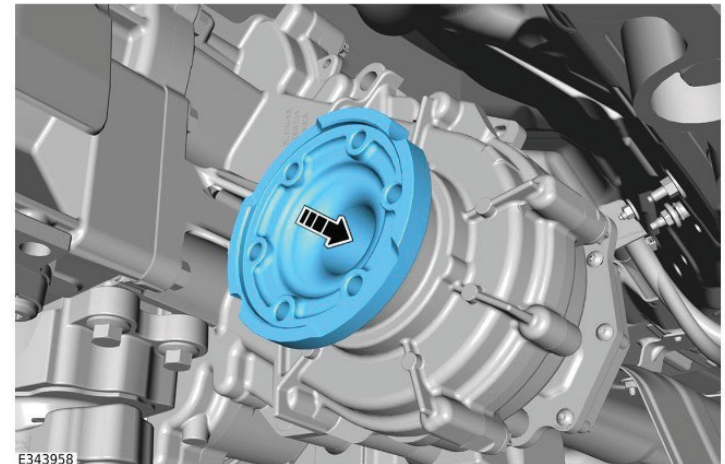
- The output flange on the transfer case is possibly not seated correctly.

- Inspect the transfer case for any areas of fluid leak.
- Refer to the TOPIx workshop manual for repair instructions.

Refer to TOPIx 315-00C: Transfer Case - INGENIUM I6 3.0L Petrol,
or 315-00D: Transfer Case - V8 T/C 4.4L Petrol
