HVAC SYSTEM VENT CONTROLS

Range Rover

- 23-24MY Range Rover

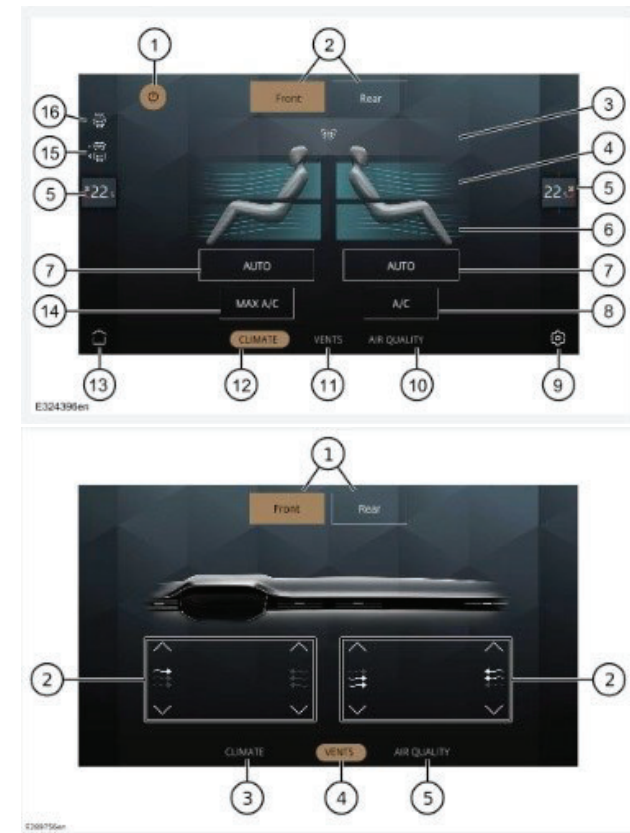
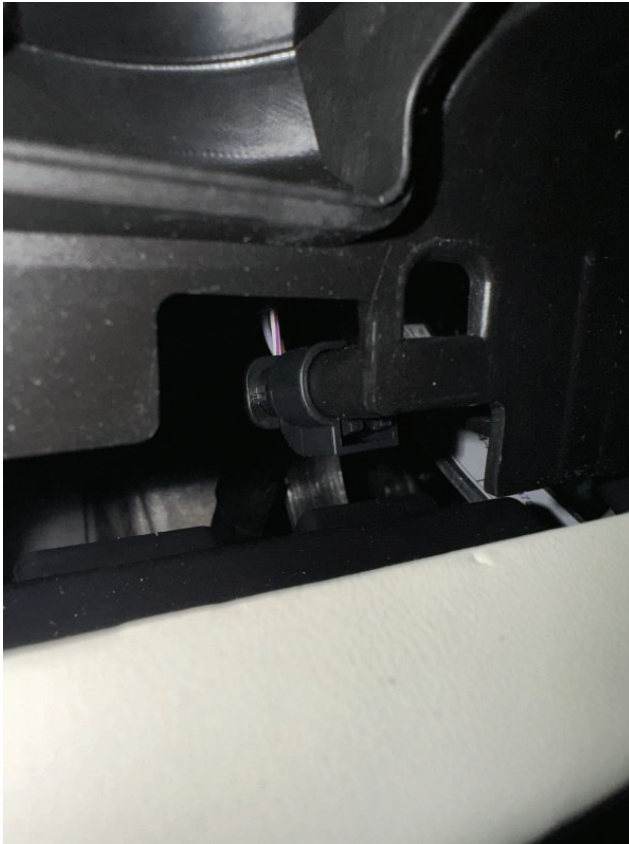
- New for Range Rover L460 mode variants, instead of having thumb wheels on the face vent registers to open and close the individual vents, the individual vents are controlled electronically through the touch screen.
- Depending on the mode and temperature selected, the face registers may close automatically, then when the face vent mode is selected the registers may not automatically open.
- Should a customer express a concern, please verify that the individual face vent registers are open on the touch screen menu.
- The HVAC modes and register controls are covered in the OHB.

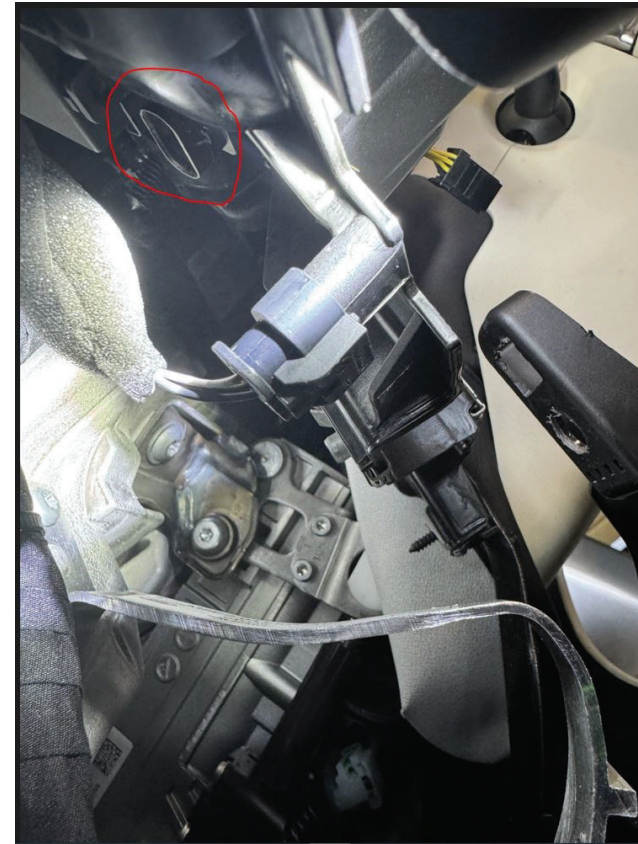
Ensure that the particulate matter sensor is connected under the instrument panel.
