# TECHNICAL SERVICE BULLETIN

Classification: BT22-023A	Reference: NTB22-104A	Date: April 25, 2024
------------------------------	--------------------------	-------------------------

## DIAGNOSING DOOR LOCK OPERATION

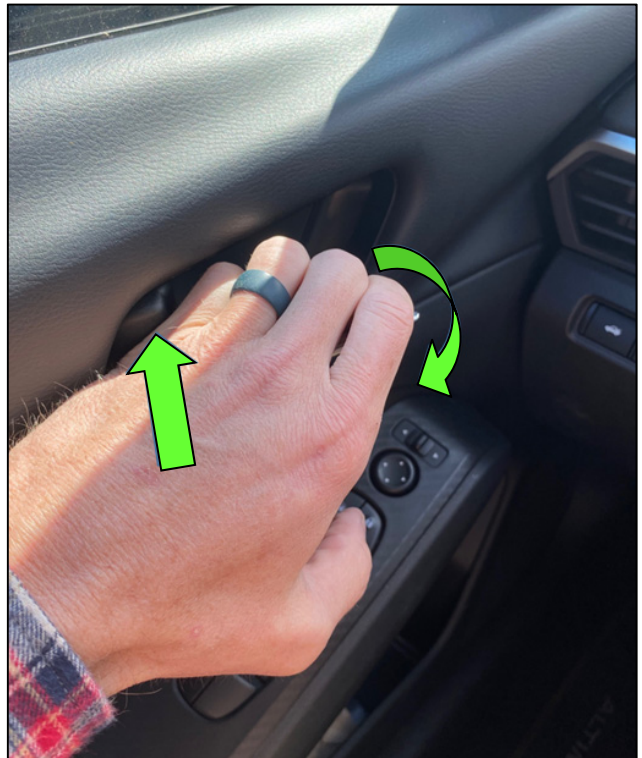
Figure 1

- If the Inside Lock Knob is positioned somewhere between fully locked and fully unlocked, it can result in the door becoming stuck in the half-lock position, and cause the power lock to be unresponsive.

- Demonstrate to the customer what is believed to be causing their concern.
      - a. Show that it is possible to inadvertently move the Inside Lock Knob with the heel of your hand when pulling the Inside Handle to exit the vehicle.

- b. If the concern happens again, ask the customer to confirm if the Inside Lock Knob is partially or fully locked. The concern should be resolved by manually unlocking the door with the Inside Lock Knob.
  - If this concern is confirmed, a slightly altered approach to opening the door can be used to avoid inadvertent contact with the Inside Lock Knob.
- c. If the issue persists and it is confirmed that the Inside Lock Knob was not moved, proceed to step 4.
