# Service Bulletin

Bulletin No.: 21-NA-148

**Subject:** Diagnostic Aid – DTC P2797, P2798 or P0C2D for Transmission Fluid Pump Performance

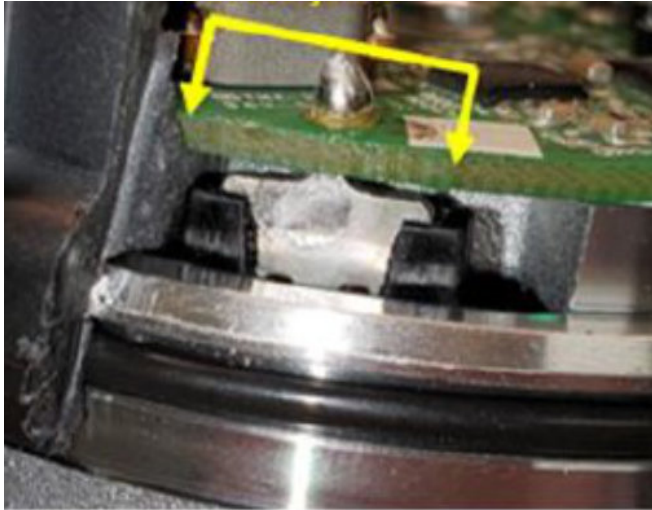
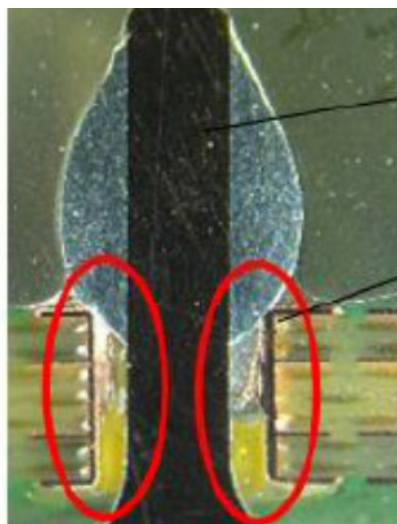
A part quality spill has been identified with the low voltage electric transmission fluid pump attached to the driver side of the transmission. A soldering process was out of specification like the illustration above.

**Note:** The pump motor is not internally serviceable and the pictures provided are only for helping to visually show the issue.

<b>Correction</b>	Replace the transmission fluid pump. <b>Important:</b> The pump motor is not internally serviceable.
-------------------	---

If you encounter a vehicle with the above concern, replace the transmission fluid pump. Refer to *Transmission Fluid Pump Replacement* in SI.
