# Service Bulletin

Bulletin No.: 23-NA-151

**Subject: Hybrid/EV Battery, High Priority DTCs, Potential Loss of Isolation, Vehicle Handling and RESS Shipping Requirements**

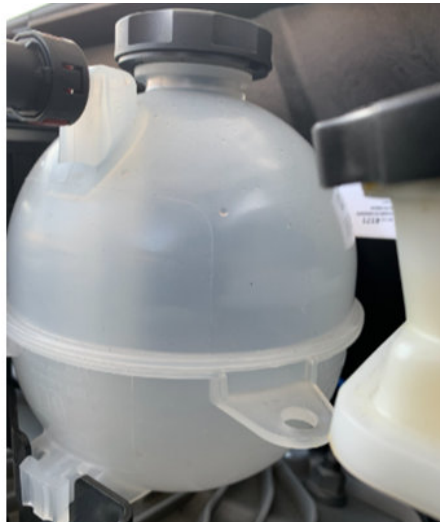
Figure 1

4. Visually inspect and document the coolant level in the high-voltage battery surge tank (Fig 1) and document via photo. Inform TAC if coolant has previously been added.
