Technical Service Bulletin

90 Instrument Cluster: The right turn signal indicator LED is permanently illuminated

90 24 92 2069362/2 May 21, 2024. Supersedes Technical Service Bulletin Group 90 number 23-03 dated February 2, 2023 for reasons listed below.v

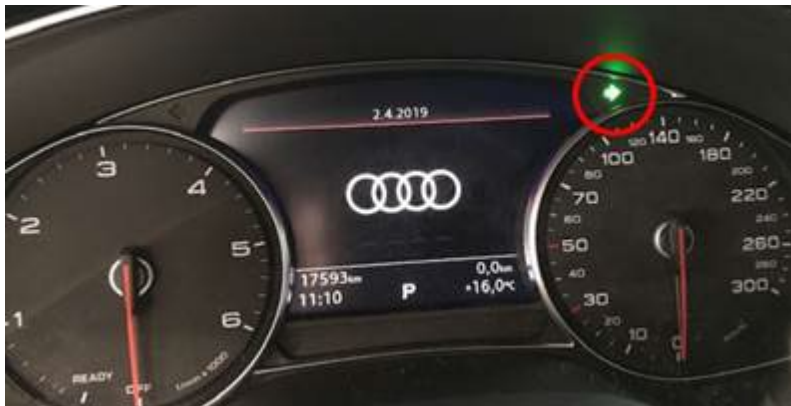
- The right turn signal indicator LED is permanently illuminated (see Figure 1).

Figure 1: right turn signal indicator permanently illuminated.

- No relevant DTCs are stored.

A hardware malfunction of the instrument cluster may cause the customer complaint described above.

1. Please take a picture of the customer complaint and upload it to DOC-IT.
The picture should clearly show the customer complaint and include the VIN of the vehicle.
2. Replace the instrument cluster according to the instructions in the repair manual.
