TO: Mercedes-Benz Dealer Principals, General Managers, Sales Managers, Service Managers, Parts Managers	FROM: Gregory Gunther, Senior Manager, Vehicle Compliance and Analysis, Engineering Services
RE: Service Campaign Launch Notification Replace B-Pillar Certification Label – Wave 1 and 2 Update MY22-25 GLE, GLS, EQB, GLA, EQE SUV, EQS SUV, and GLC (167, 243, 247, 294, 296, and 254)	DATE: June 14, 2024

Campaign No. 2024060001, June 2024

SUBJECT: **Models GLE/GLS, EQB, GLA, EQE, EQS, and GLC
(167, 243, 247, 294, 296, and 254 platform)
Model Year 2022 – 2025**

Replace Certification Label on B-Pillar – Wave 1 and 2

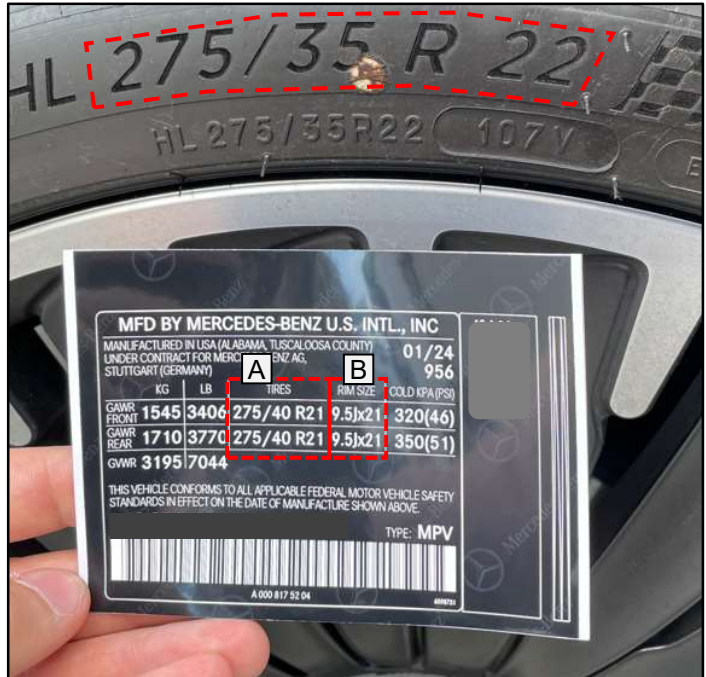
Figure 1

1. Check B-Pillar label TIRES (Figure 1, A) and RIM SIZE (Figure 1, B) information.

- a. If TIRES and RIM SIZE information is **INCORRECT** (Figure 1), return label to your Dealer facing PDC.
