| RE: <b>Service Campaign Launch Notification</b><br><b>Replace B-Pillar Certification Label – Wave 3</b><br><b>MY22-25 GLE, GLS, EQB, GLA, EQE SUV, EQS SUV, and GLC (167, 243, 247, 294, 296, and 254)</b> | DATE: June 18, 2024 |

# Service Campaign Bulletin

SUBJECT: **Models GLE/GLS, EQB, GLA, EQE, EQS, and GLC  
(167, 243, 247, 294, 296, and 254 platform)  
Model Year 2022 – 2025**

## **Replace Certification Label on B-Pillar – Wave 3**

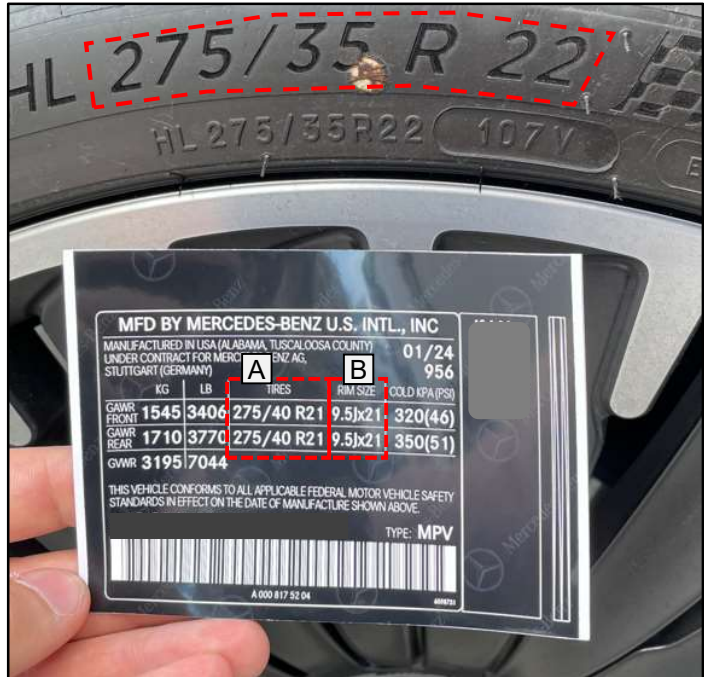
Figure 1

1. Check B-Pillar label TIRES (**Figure 1, A**) and RIM SIZE (**Figure 1, B**) information.

- a. If TIRES and RIM SIZE information is **INCORRECT** (**Figure 1**), return label to your Dealer facing PDC.

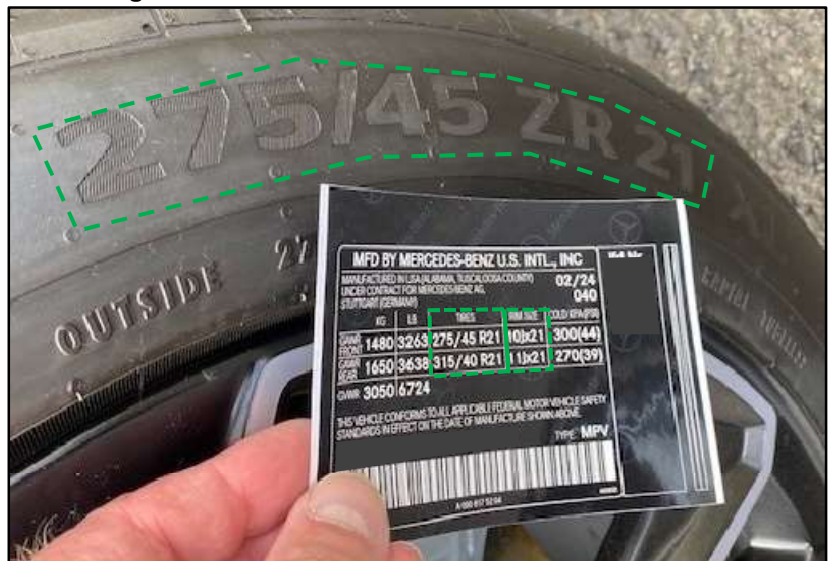
Figure 2

- b. If TIRES and RIM SIZE information is **CORRECT** (**Figure 2**) continue to **Check Procedure Step 2**.

**i** **Note:** If the vehicle is equipped with staggered TIRES and RIM SIZE, confirm both front and rear match what is on the vehicle!
