Drivers Information Display (DID) Inoperative After Cluster Replacement And Programming

Published Date 7 June 2024

Mack AN,GR,CHU,CXU,PI and Volvo VNR,VNR,VNX,VHU,VHD Model Year 2021 to Current

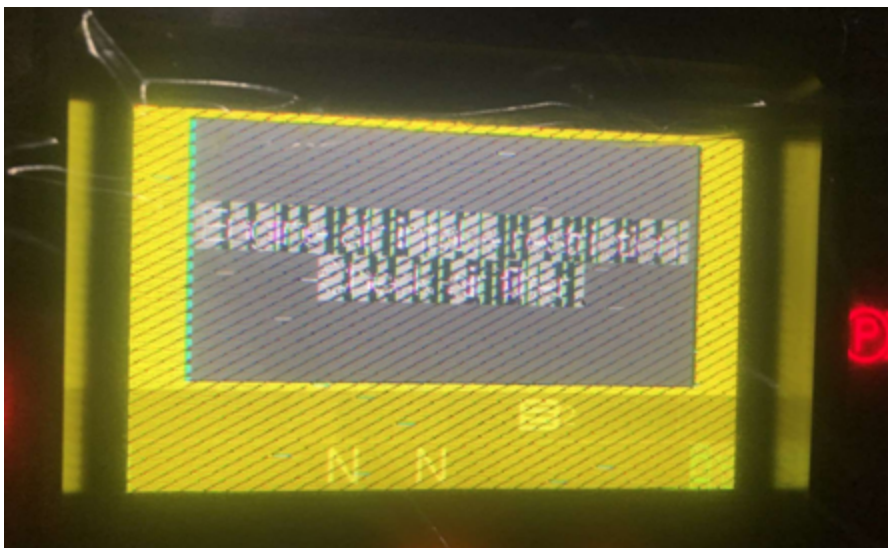
After cluster replacement and programming, the Driver Information Display (DID) may not function as designed. See Image below.

New software has been released to fix this issue. Please reprogram the IC and confirm the repair.
