Technical Service Bulletin

57 Noises heard in doors while opening and closing

57 24 44 2074129/1 June 5, 2024.

Model(s)	Year	VIN Range	Vehicle-Specific Equipment
Q7, and SQ7	2023	011769 - 99999	Not Applicable
	2024	000001 - 015020

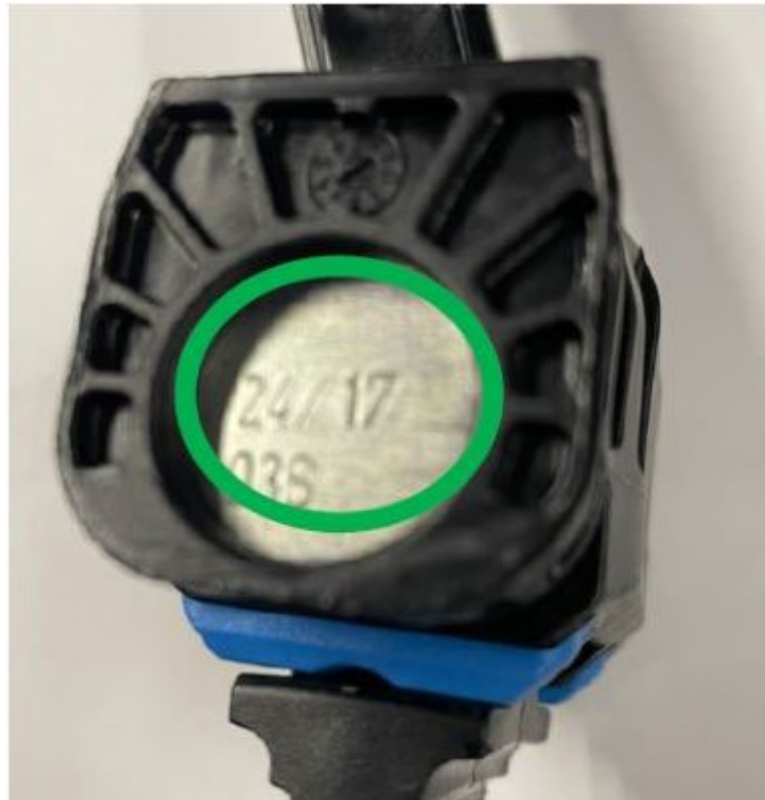
1. Replace the door arrester creating the noise in these cases. The improved door arrester can be identified by production date and part version number. This information is stamped into the part with a date structure production year / production week (YY / WW) where the first two characters are the last two numbers of the year, and the second two numbers are the calendar week of that year). In the example in Figure 1 the production date is week 17 of 2024. The three characters beneath the date is the part version number. In this case the part is version '03S'.

Figure 1. Location on the door arrester of the production date and part version.

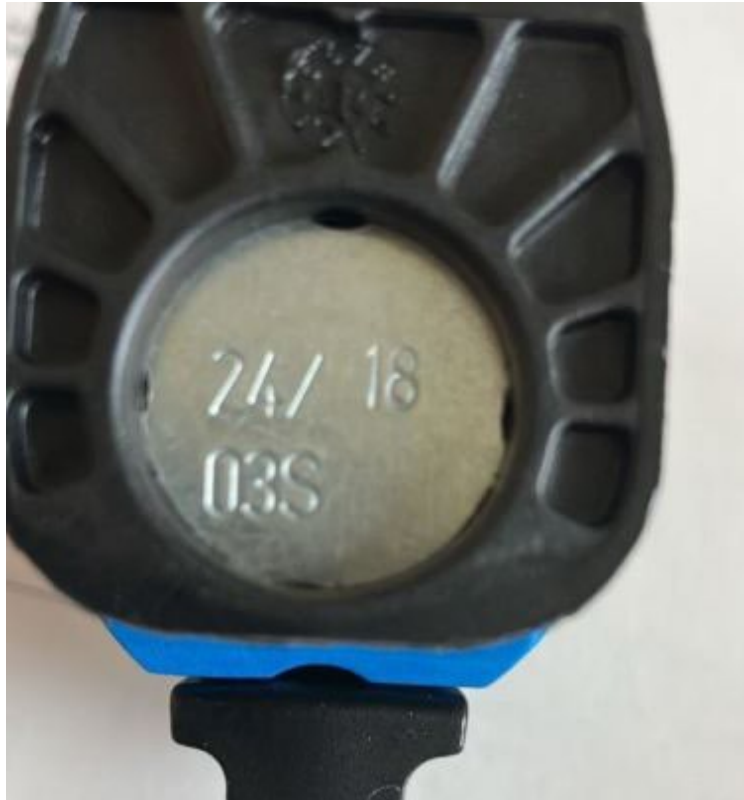
2. The improved door arrester will have a production date greater than or equal to week 17 of 2024 (e.g., 24 / 17). It must also have a part version greater than or equal to '03S'. Figure 2 shows a door arrester that meets the date and version criteria for an improved part.

Figure 2. Door arrester of the improved type by date and version.

3. While a stock clearing of old version parts is underway, check the date and version of the replacement part before installation.
4. Please take a short video of the noises in the door(s) as they are opened and closed. Also take photos of the door arrester, specifically the date and version of the door arrester. Upload them into DOC-IT with the repair order. Photos should
- Have a date stamp and VIN reference.
 - Be taken in focus and with sufficient light.
