REFERENCE NO: RF-24-09

SUBJECT: *UPDATE* CHECK ENGINE LIGHT ON WITH DTC P0126:00

A new repair procedure has been developed to address DTC P0126:00 on SKYACTIV-G 2.0/2.5L engines (non-turbo). Mazda has introduced a replacement kit of the thermostat located within the Coolant Control Valve (CCV).

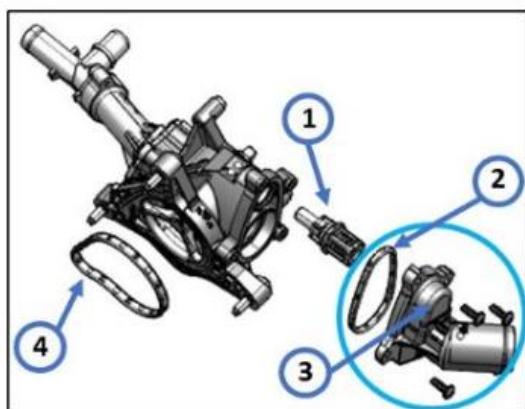
- 1. Thermostat
- 2. Thermostat cover gasket
- 3. Thermostat cover
- 4. Water outlet gasket

This new repair is outlined in TSB 01-005/24, which will replace the current TSB 01-005/23. Sales orders for the new kits are available through the LPO screen on eMDCS.
