# Corolla Cross Right and Left Roof Rail Loose to Roof Panel

22-24MY Corolla Cross/Corolla Cross HV

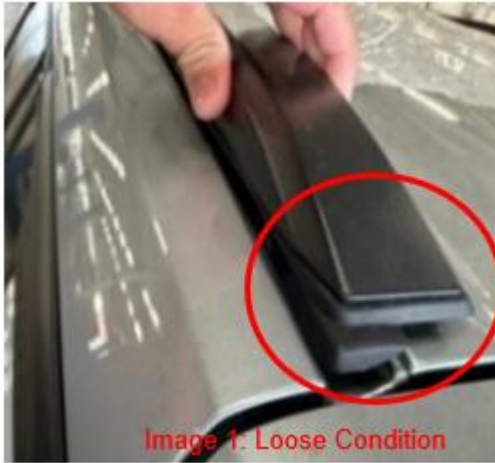
Some 2022-2024 model year Corolla Cross and Corolla Cross HV may exhibit a loose roof rail condition at the front or rear roof rail (see image 1).

Confirm the condition exists on 1 or both roof rails. Replace roof rails per the following part numbers:

- Rack Assy, Roof, RH (62403-0A042)
- Rack Assy, Roof, LH (62404-0A042)

Refer to TIS, applicable model and model year Repair Manual to fix this condition.
