## LEAKING COOLANT HEATER HOSES – 3.0L/P6

303-03B: Engine Cooling - INGENIUM I6 3.0L Petrol

24MY Range Rover  
24MY Range Rover Sport

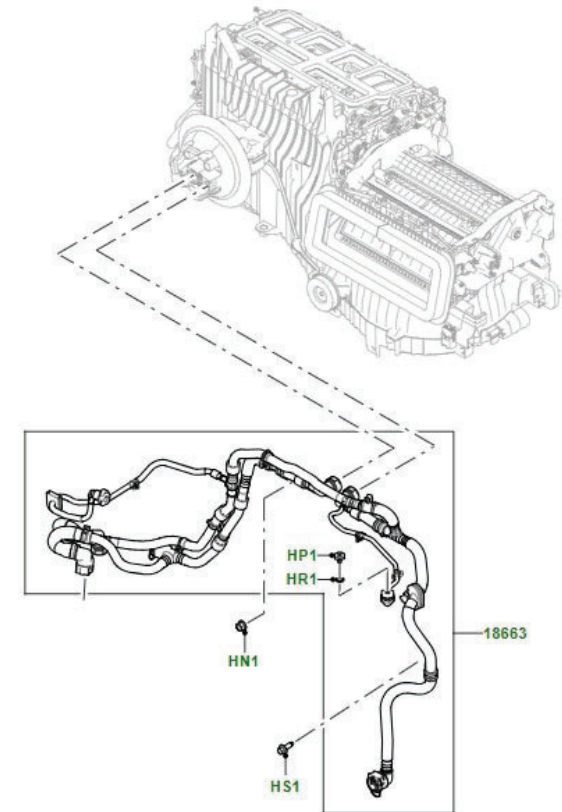
- The coolant heater hose at firewall is leaking.

- Follow TOPIX workflow and check system for leaks.
- If you have found a leaking hose, please order the replacement part (28104123488) ZBR and open an EPQR.
- Where there is no coolant light or smell of coolant, a proactive inspection of the heater hose for defamation or leak can be conducted during PDI by removing right side cowl panel.
