LEAKING COOLANT PUMPS – 2.0L/P4

303-03B: Engine Cooling - INGENIUM I4 2.0L Petrol

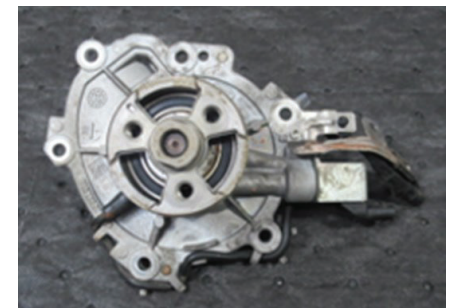
- The engine cooling pump is misting from the front seal onto the coolant pump pulley.

- Follow TOPIX workflow. It will direct you to:
 - Please inspect and take a photo of outer casting under a UV light, showing the whole component.
 - Please inspect and take a photo under a UV light of the inside of each of the spaces between the hub spokes.
- Raise a TA for the attention of Local Engineering who will dispatch sample bottle.
- USE SAMPLE BOTTLE ONLY to take 4 ounce Coolant sample before repair.
- Dispatch coolant sample using FEDEX label provided.
- Retain removed water pump for collection via PRR.
