Service Bulletin

Bulletin No.: 22-NA-248

Subject: HVAC Heat Intermittently Inoperative, DTCs B2B05 and/or B2B06 Set

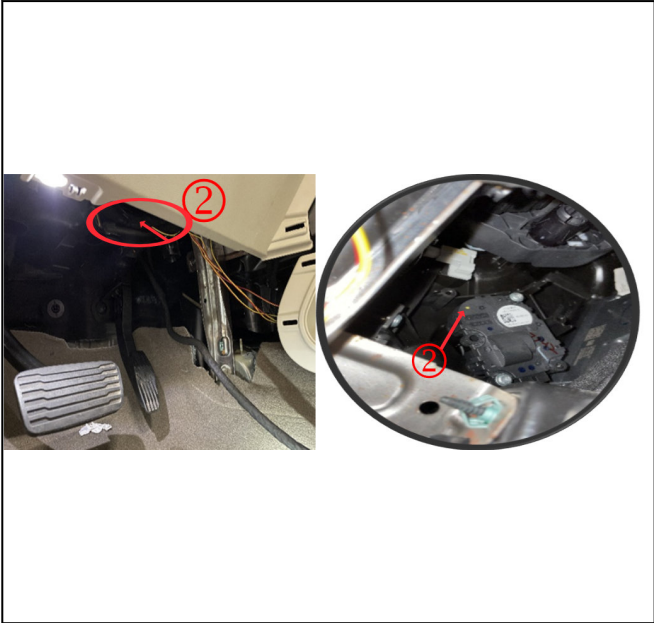
6213261

Involved Region or Country	North America
Condition	Some customers may comment on the HVAC heat intermittently inoperative. Technicians may find one or both of the following DTCs set in the BCM. <ul style="list-style-type: none"> • B2B05 - HVAC Temp Motor - Front 1 Performance • B2B06 - HVAC Temp Motor - Front 2 Performance
Cause	The condition may be caused by a mismatch of B020 firmware and B018 parameters.
Correction

Visually inspect the right-side temperature valve actuator (2) and the left-side temperature valve actuator (1) for a yellow dot, as shown in the pictures above, that indicates the parts were manually re-flashed. If the yellow dot is present, replace the temperature valve actuator.

Refer to *Temperature Valve Actuator Replacement* in SI.
