| RE: <b>Service Campaign Launch Notification</b><br><b>Replace B-Pillar Certification Label - REPRINT</b><br><b>MY20-24 G-Class (463 platform)</b> | DATE: July 20, 2024 |

# Service Campaign Bulletin

## **Replace B-Pillar Certification Label – REPRINT**

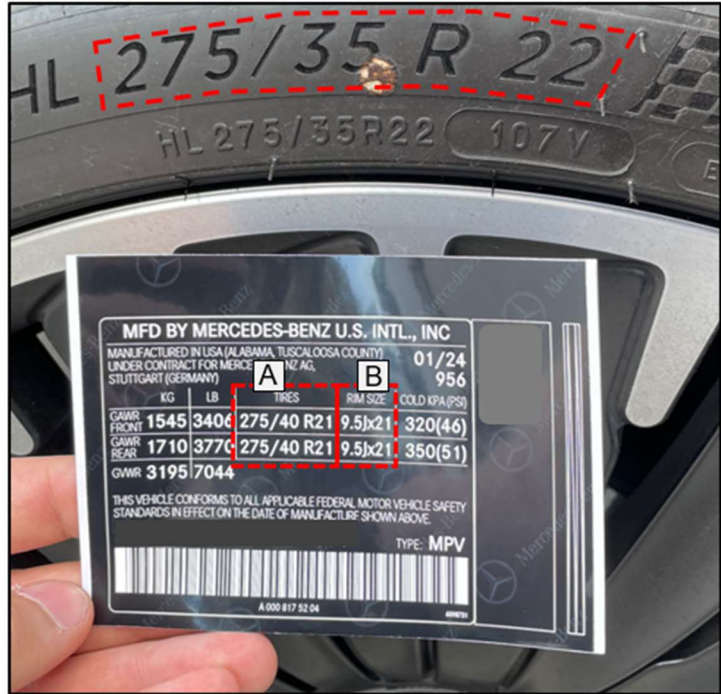
Figure 1

1. Check B-Pillar label TIRES (**Figure 1, A**) and RIM SIZE (**Figure 1, B**) information.

- a. If TIRES and/or RIM SIZE information is **INCORRECT** (**Figure 1**), **return label to your dealer-facing PDC** using the “SCM authorized special return in Paragon”.

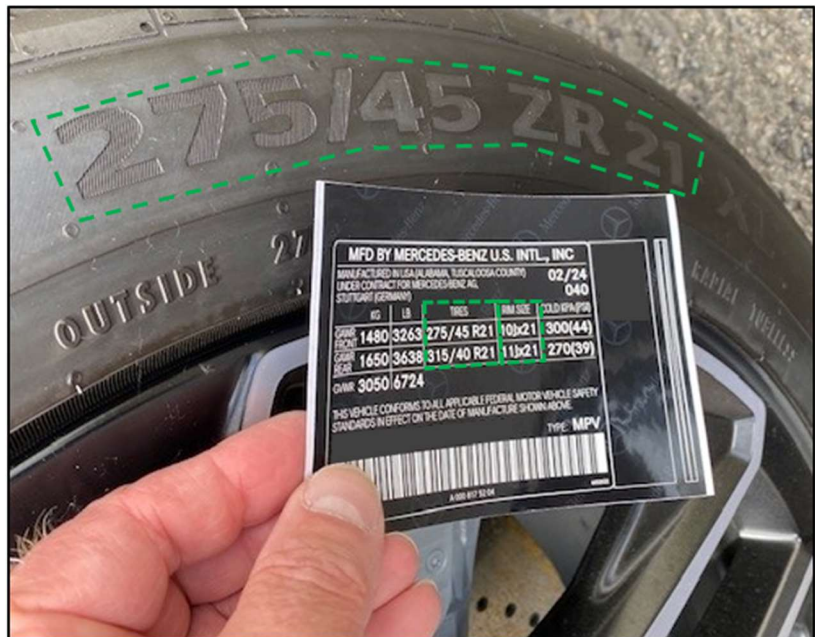
Figure 2

- b. If TIRES and RIM SIZE information is **CORRECT** (**Figure 2**) continue to **Work Procedure**.

**i** **Note:** If the vehicle is equipped with staggered TIRES and RIM SIZE, confirm both front and rear match what is on the vehicle!
