Campaign No. 2024060001, July 2024

SUBJECT: **Models GLE/GLS, EQB, GLA, EQE, EQS, and GLC
(167, 243, 247, 294, 296, and 254 platform)
Model Year 2022 – 2025**

Replace Certification Label on B-Pillar – Wave 5

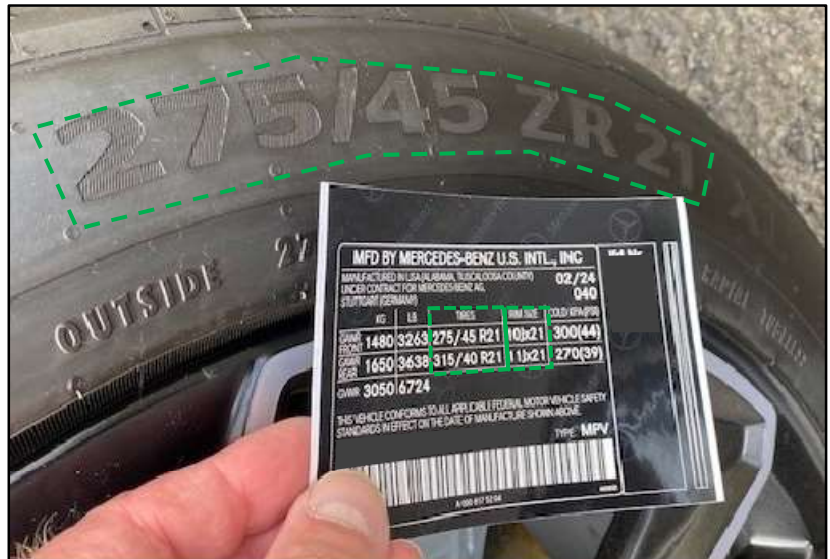
Figure 2

- b. If TIRES and RIM SIZE information is **CORRECT** (Figure 2) continue to Check Procedure Step 2.

i Note: If the vehicle is equipped with staggered TIRES and RIM SIZE, confirm both front and rear match what is on the vehicle!
