# Service Bulletin

Bulletin No.: 24-NA-055

**Subject: Removable Sky Panel Creak Pop Snap Noise, Hot Interior Temps**

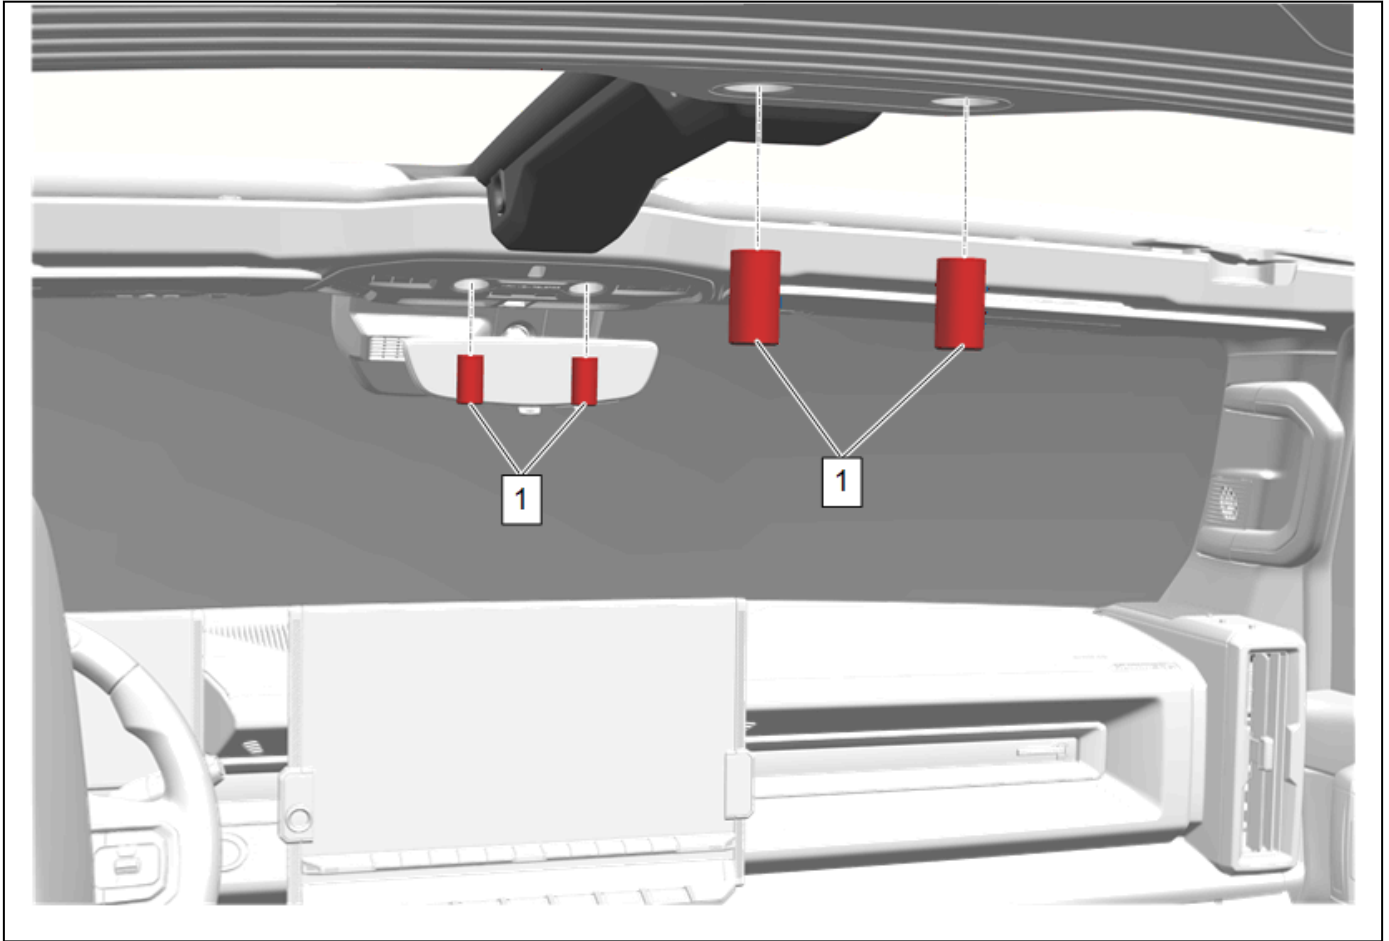
5832341

1. Remove the four nuts (1) from the Front I-Bar.

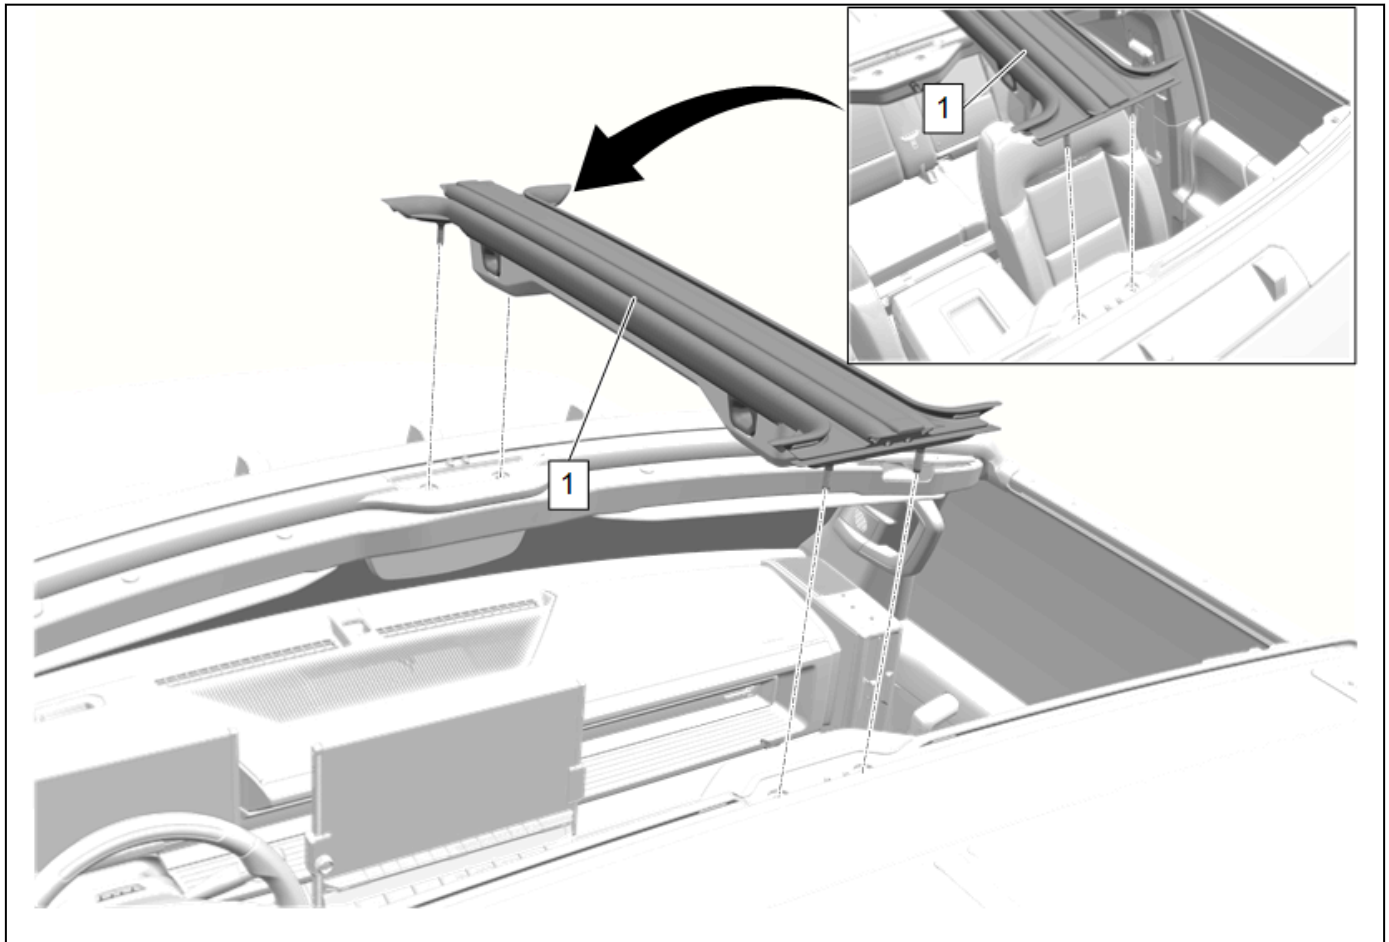
5832364

2. Remove the Front I-Bar (1).

**Note:** Be careful not to damage the weather—strip cover around the panel when removing the panel.

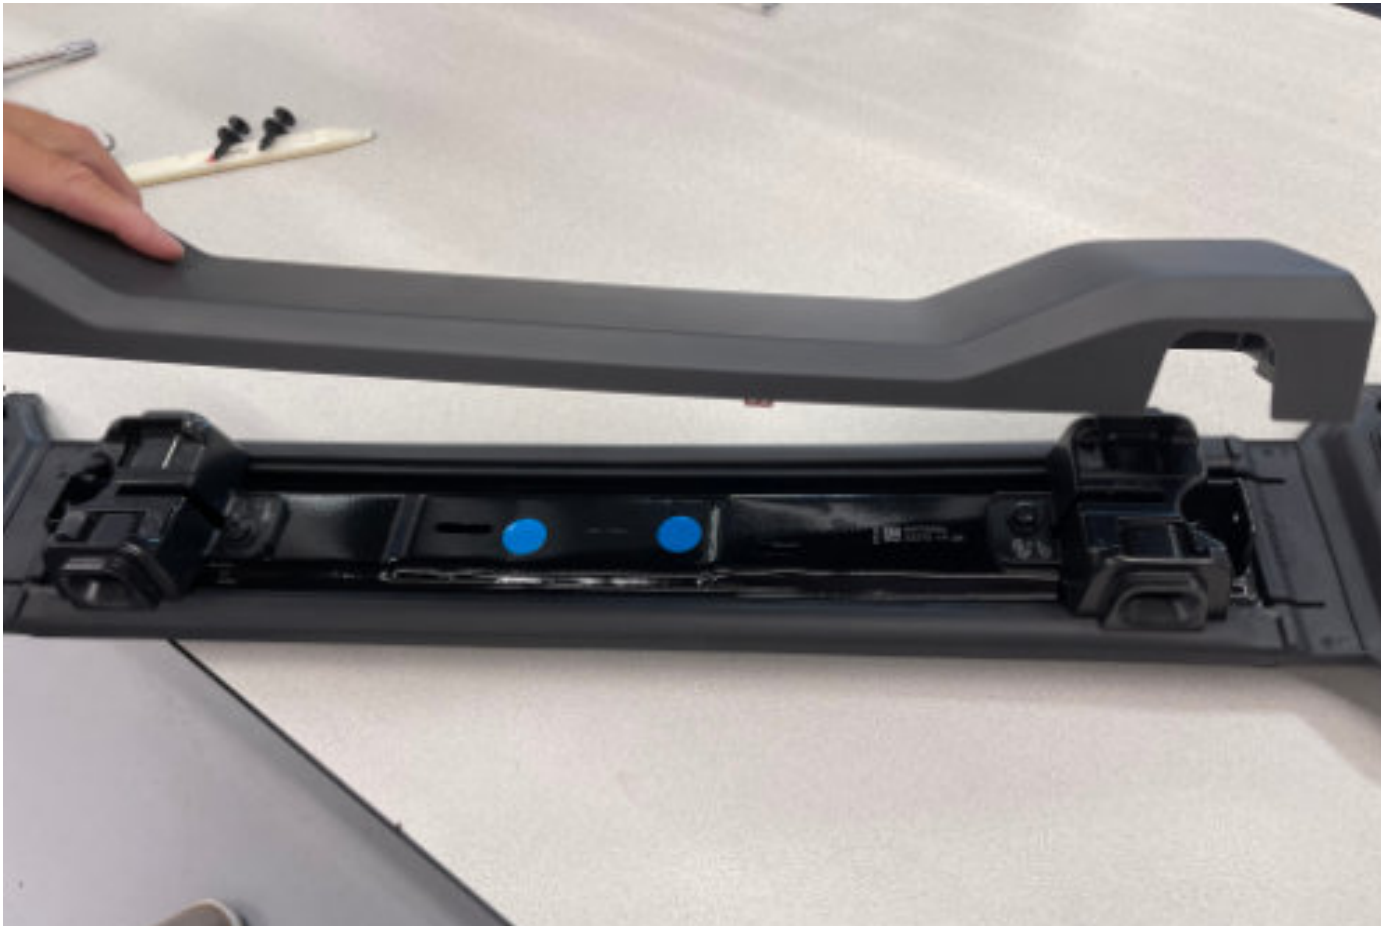
6425255

4. Remove the two trim panel push-pin retainers and remove the I-Bar panel cover.

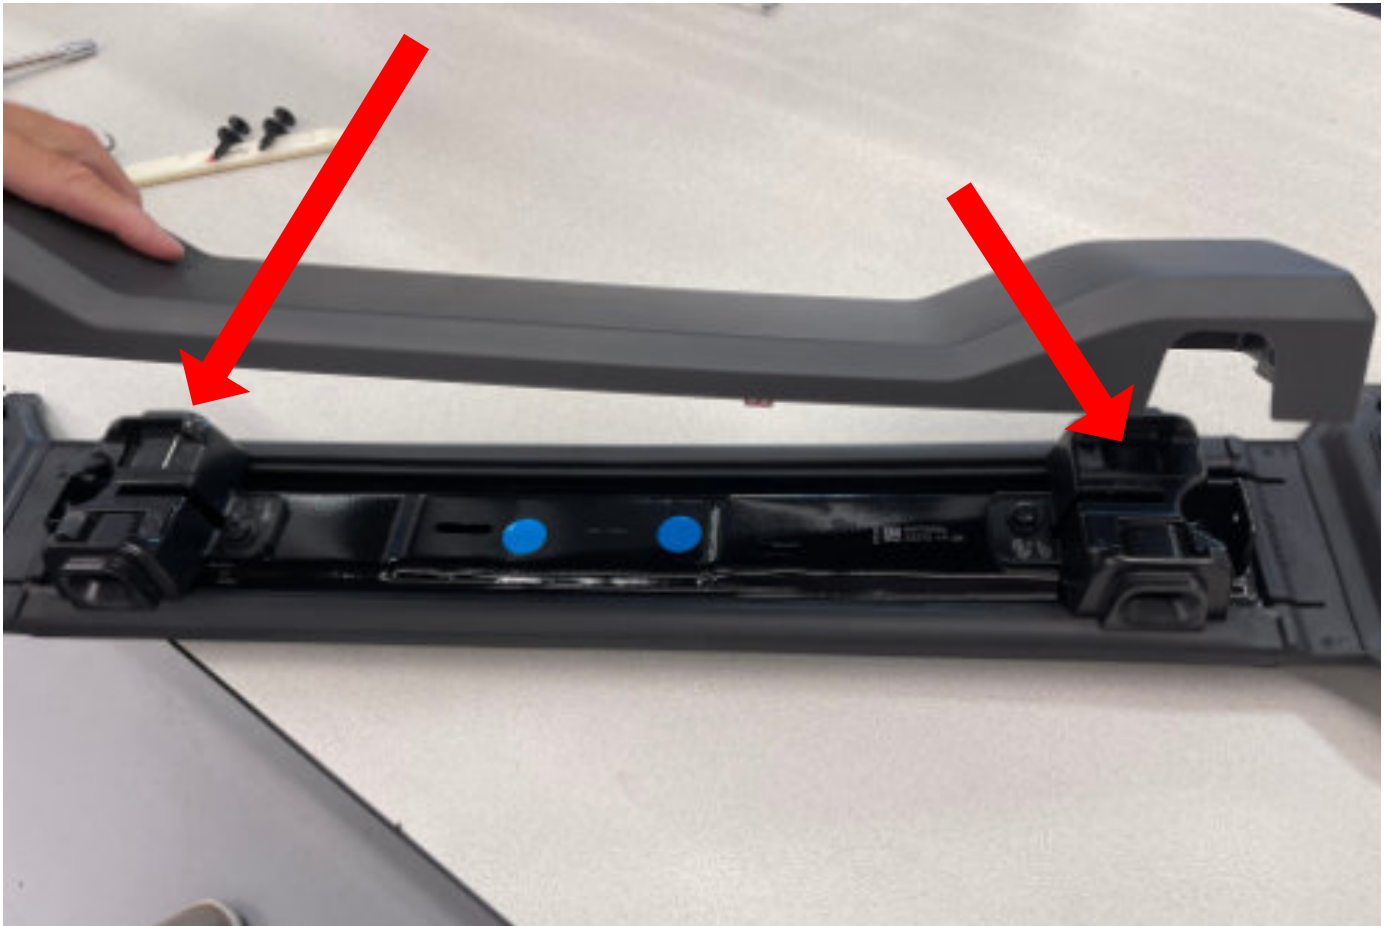
6425256

5. Unscrew the I-Bar pocket receivers from the I-bar.

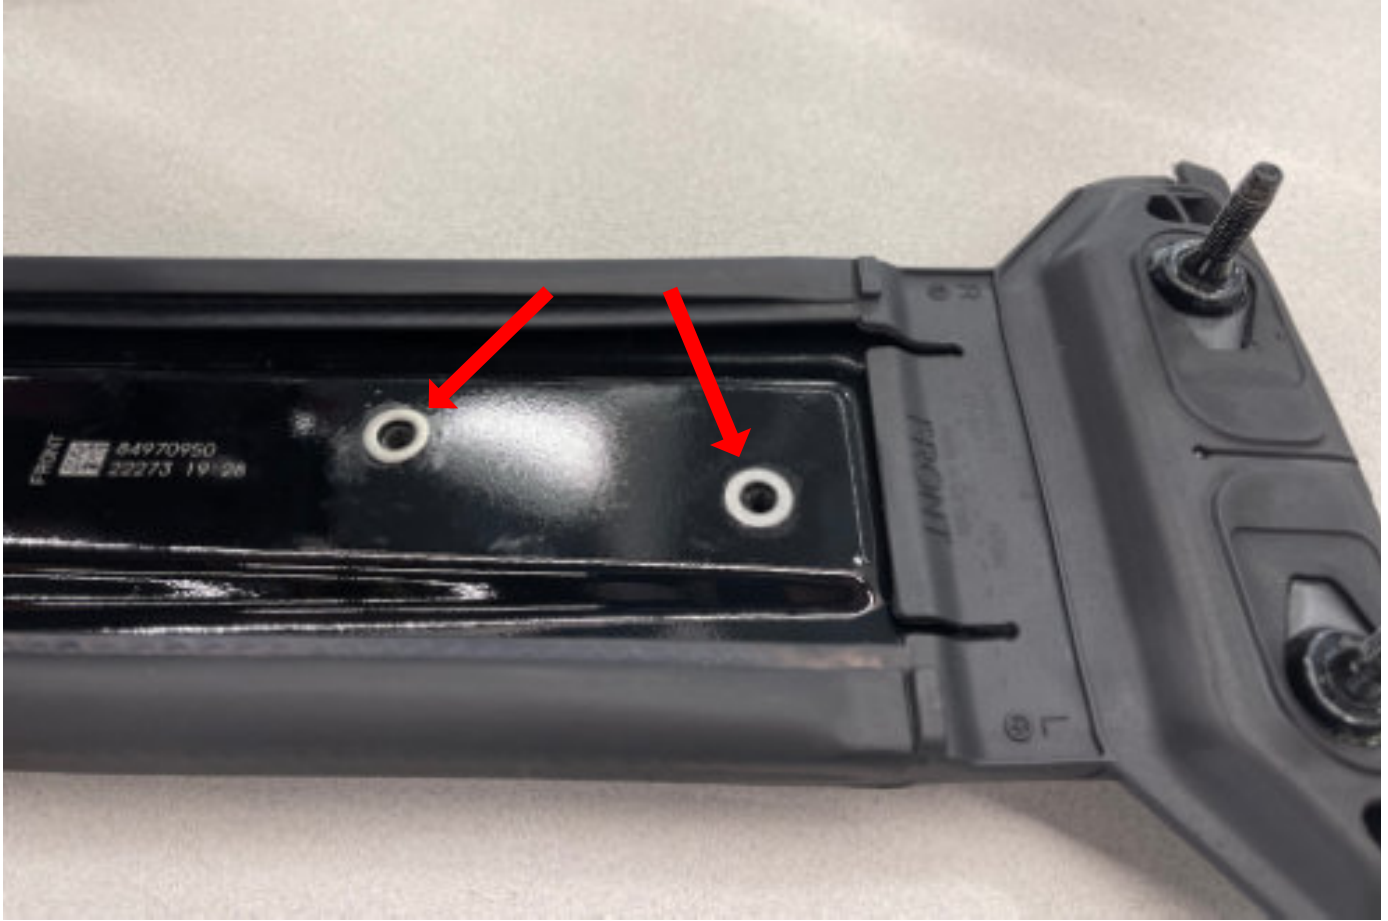
6425388

6. Place a washer at each of the four bolt holes underneath the pocket receivers.
7. Reinstall the pocket receivers, torque to 9 nm.
8. Reattach the trim cover and push-pin fasteners. Reinstall the front I-Bar in the correct orientation.

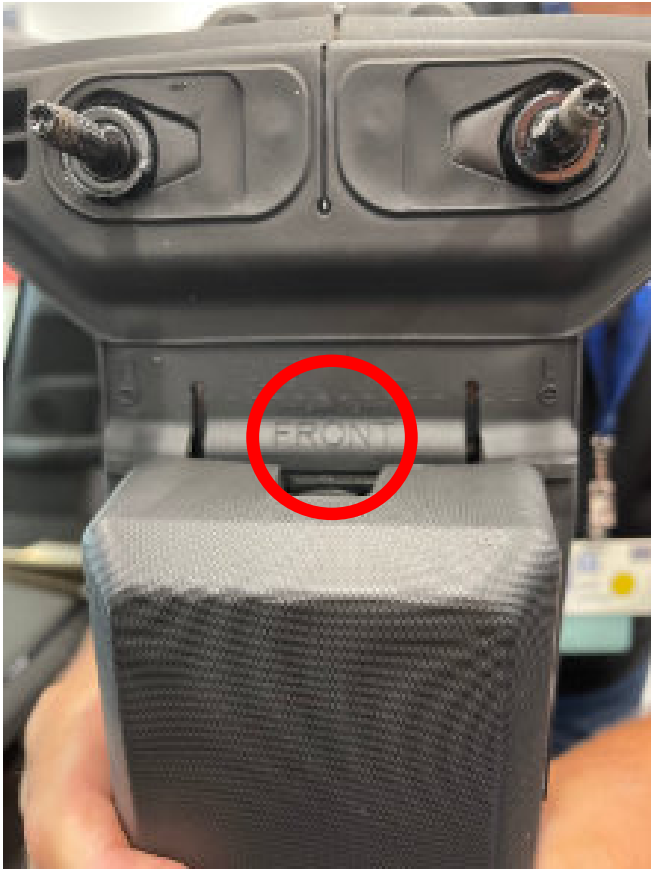
6425390

The Center Roof Lift Off Panel is labelled Front, ensure it's properly aligned when reattaching.

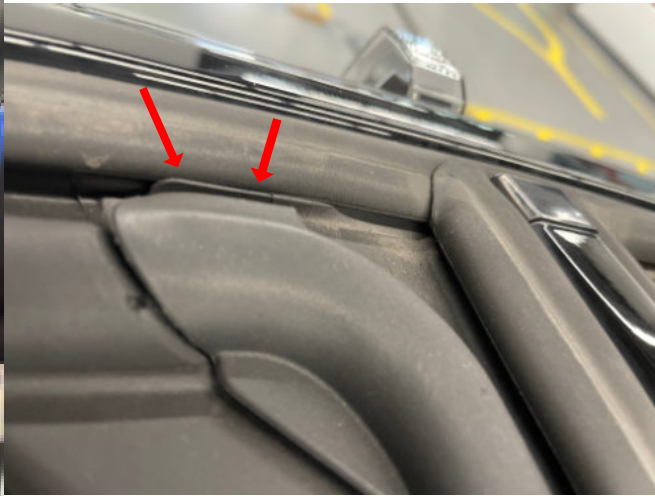
6425393

**Important:** Ensure the weather-strip is secured and properly sealed.

- Example of an unseated weather-strip. If the weather-strip is left unseated, it can cause water leaks into the vehicle.

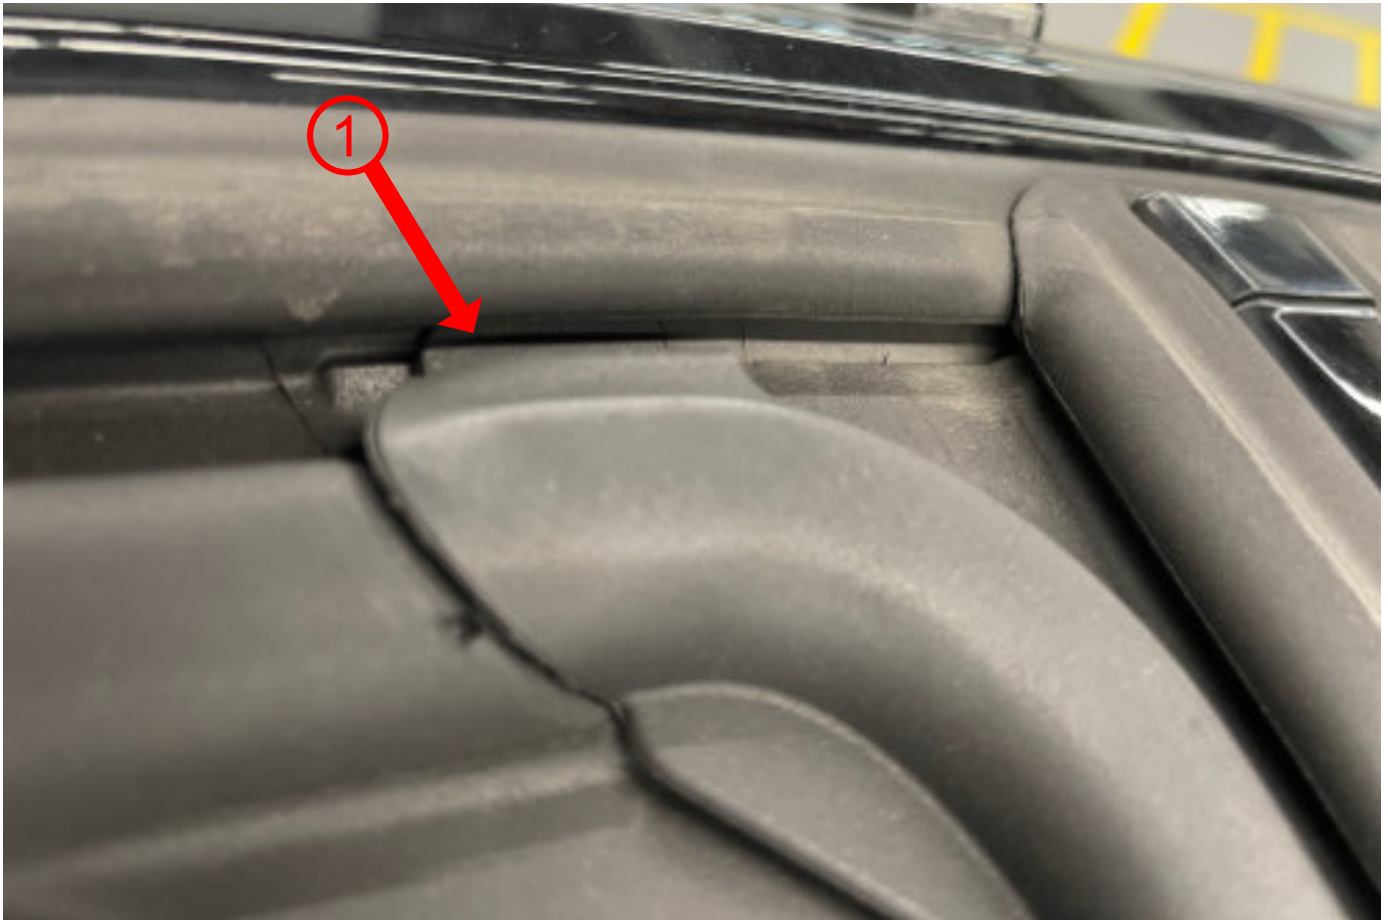
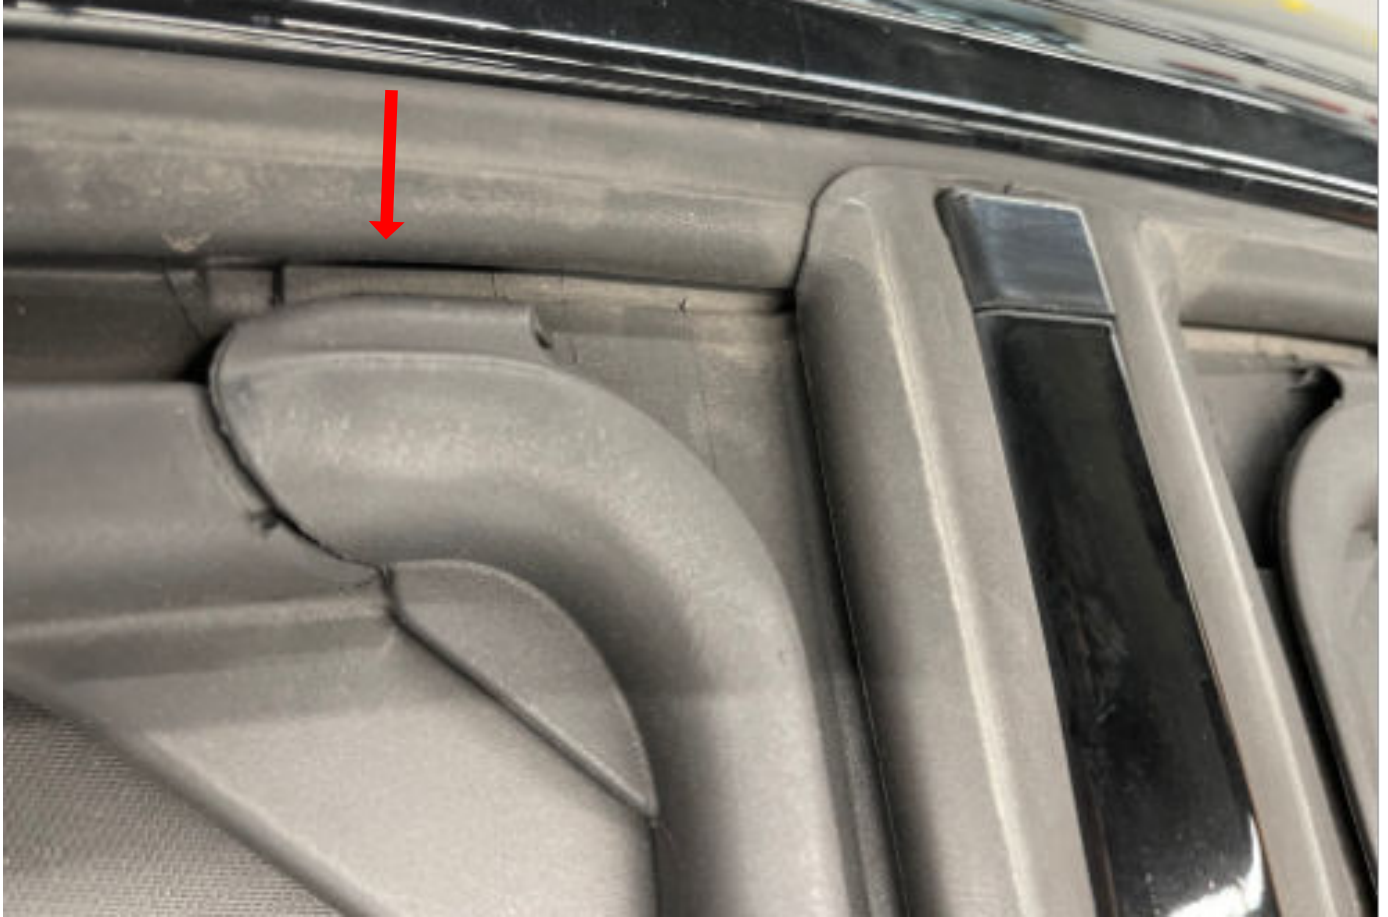
6425397

- Example of the proper weather-strip seal.
9. Use soapy water to clean the weather strips and then apply a very light application of AC Delco Super Lube to the weather strips.
  10. Reattach the front sky panels.

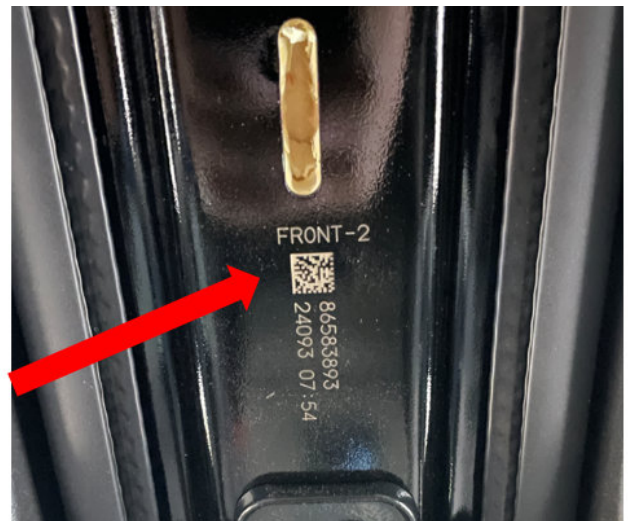
6693889

Before proceeding, inspect the rear I-Bar for proper orientation on MY2024 vehicles ONLY.

**FRONT** should point towards the front of the vehicle. If the rear I-Bar is reversed, follow SI DOC ID 5835570 to remove and re-install the rear I-Bar.

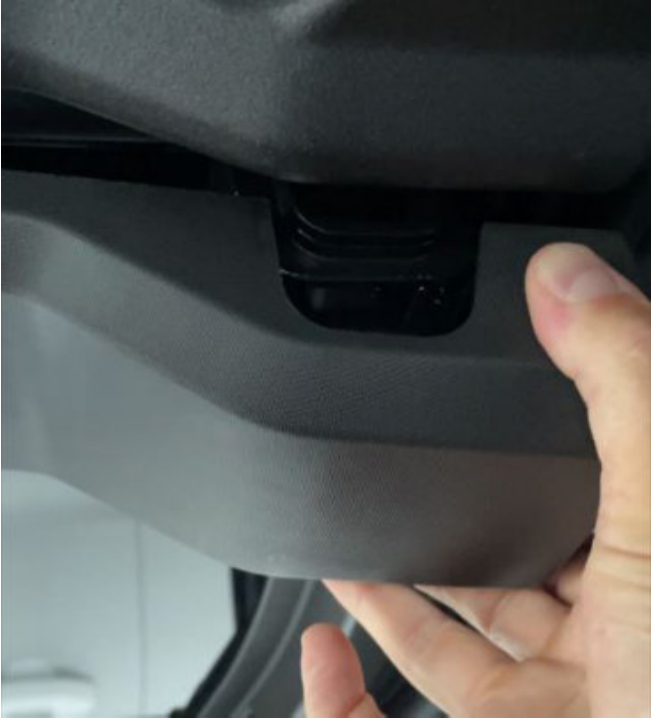
6430469

1. Remove the rear I-Bar trim panel by pulling down on the panel to disengage the retainers.

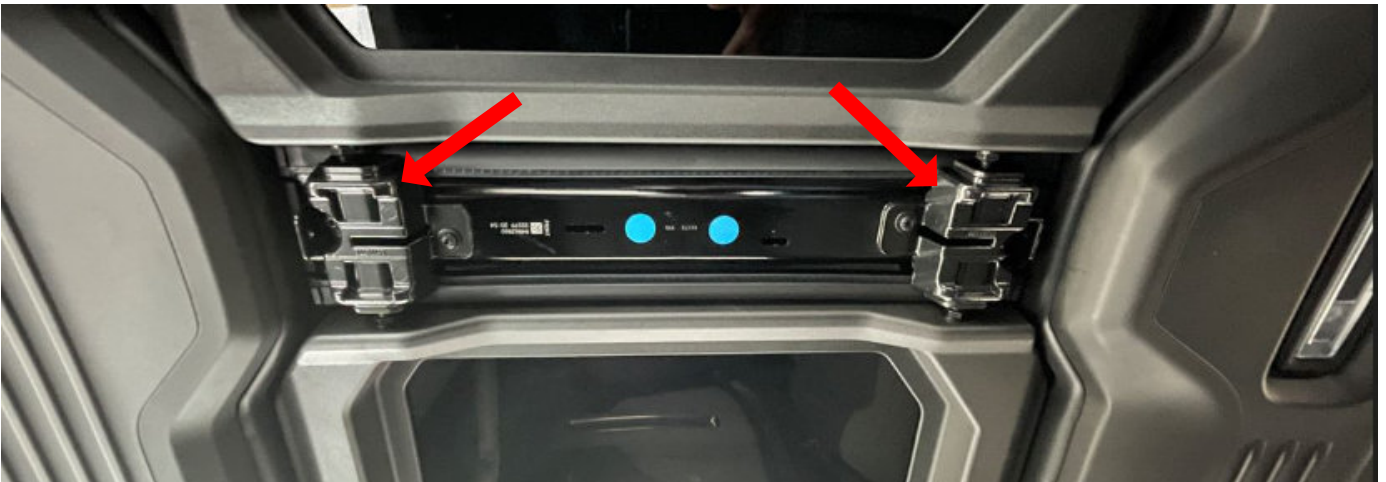
6430466

2. Remove both I-Bar pocket receivers.

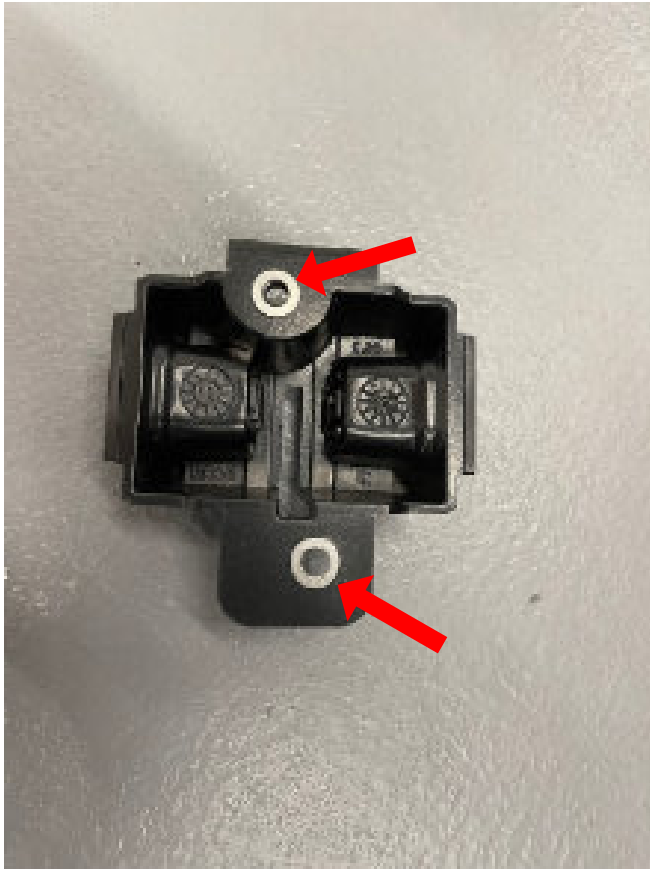
3. Place a washer at each of the four bolt holes underneath the pocket receivers.
4. Reinstall the receivers to the I-Bar, torque to 9nm.
5. Reattach the rear I-Bar trim cover.
6. Use soapy water to clean the weather strips and then apply a very light application of AC Delco Super Lube to the weather strips.
