## Drivers Information Display (DID) Inoperative After Cluster Replacement And Programming

Mack AN,GR,CHU,CXU,PI and Volvo VNR,VNR,VNX,VAH,VHD Model Year 2021 to 2024 with a Mid 140 instrument cluster

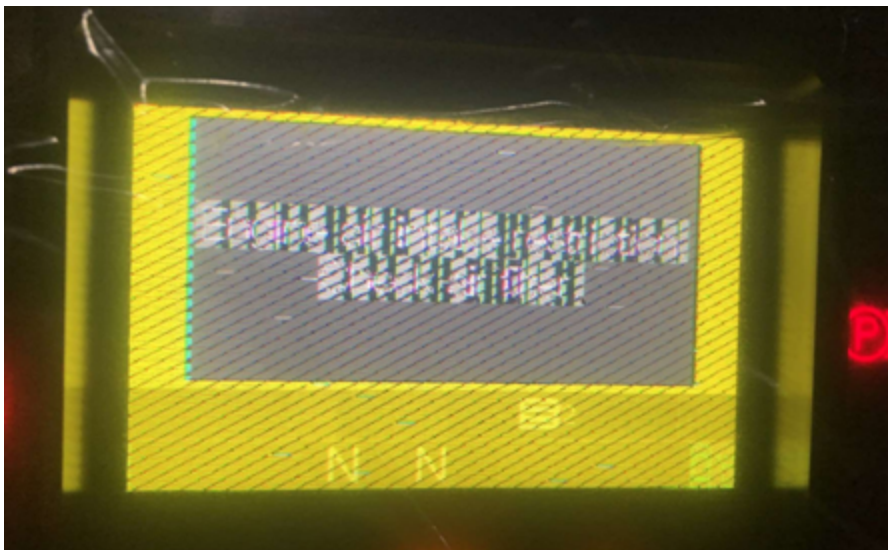
After cluster replacement and programming, the Driver Information Display (DID) may not function as designed. See Image below.

New software has been released to fix this issue. Please reprogram the IC and confirm the repair.

**NOTE:** In the rare case the IC will not program please run accessory kit # **85170265**.
