Volvo Chassis - Debris In 13L Cooling Systems Filled With Extended Life (VCS2)

Published 9 July 2024

All Volvo models Built July 2023 to Current

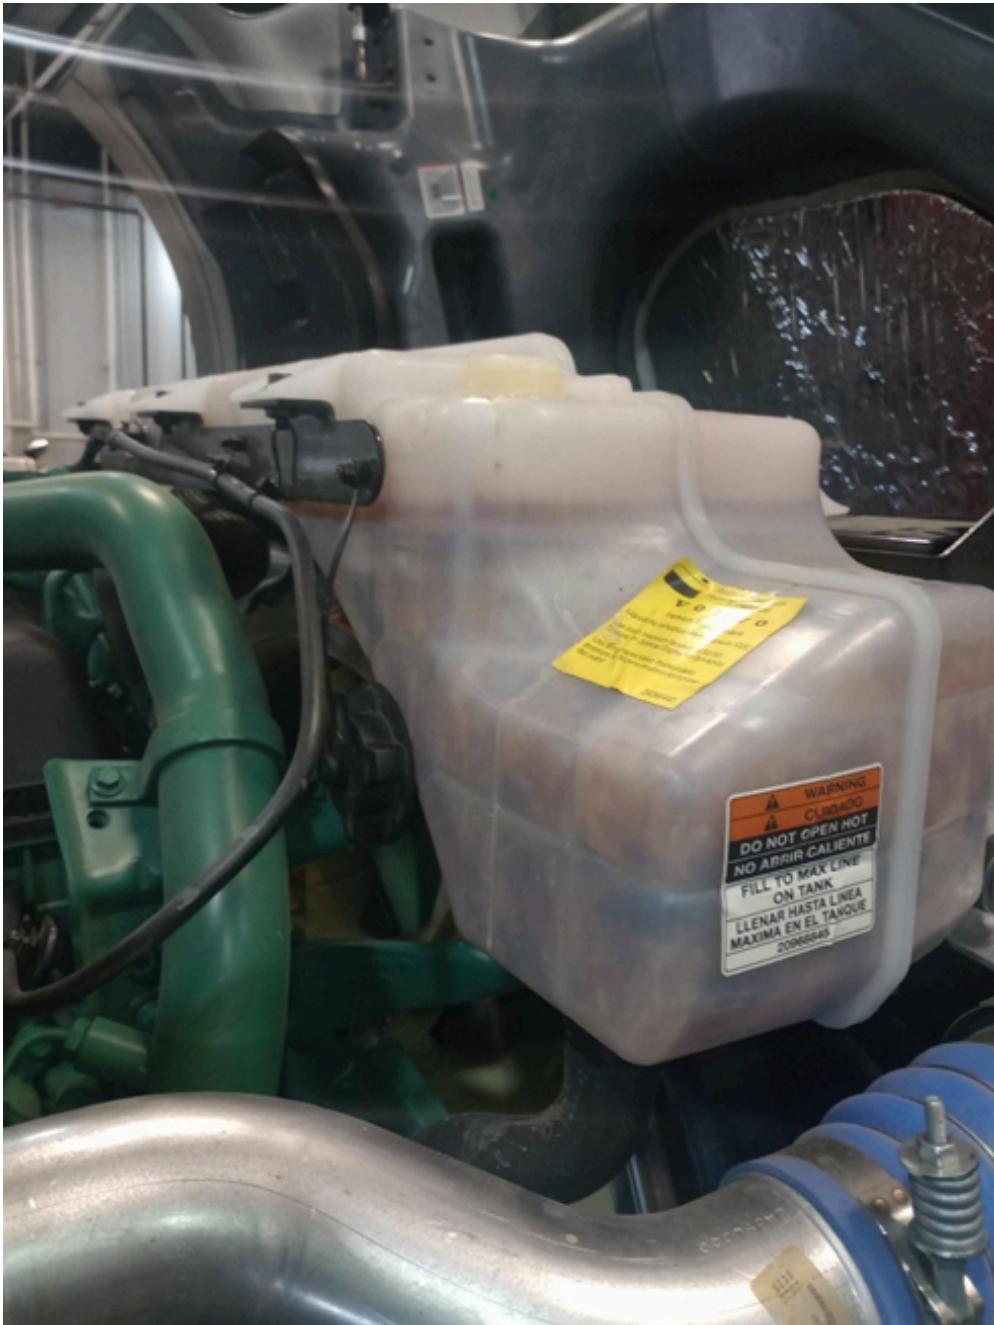
Observing debris within the cooling system is possible, with this debris potentially being dark and resembling sand. Such debris has the potential to cause blockages in both the heater core and oil cooler.

If the truck is unacceptable to be driven with the contamination (dark color, large deposits of debris), please start an e-service case (**Directed to the Reliability Group**) to document the issue, please include pictures and send a coolant sample to the address below. Verify cab heat and report findings in the e-service case.

Flush the coolant (per IMPACT 2609-11-03-01) and install a new coolant filter, over flow tank, and fill with new coolant.

23915461	Expansion Tank	1
21937327	Coolant filter	1
	Coolant VCS2
