# 42-080 ABS Wheel Speed Fault Code Correction for MBSP Equipped Vehicles

## TSB-42-080-FTL

► New Cascadia

This bulletin only applies to New Cascadia vehicles that were built after September 9, 2019, and are experiencing repetitive occurrence rear axle antilock brake system (ABS) fault codes. The following instructions provide information on how to diagnose and fix the ABS codes, thereby reducing the chances of future contamination that could lead to more fault codes. They also offer supplementary and improved guidelines for diagnosis and repair.

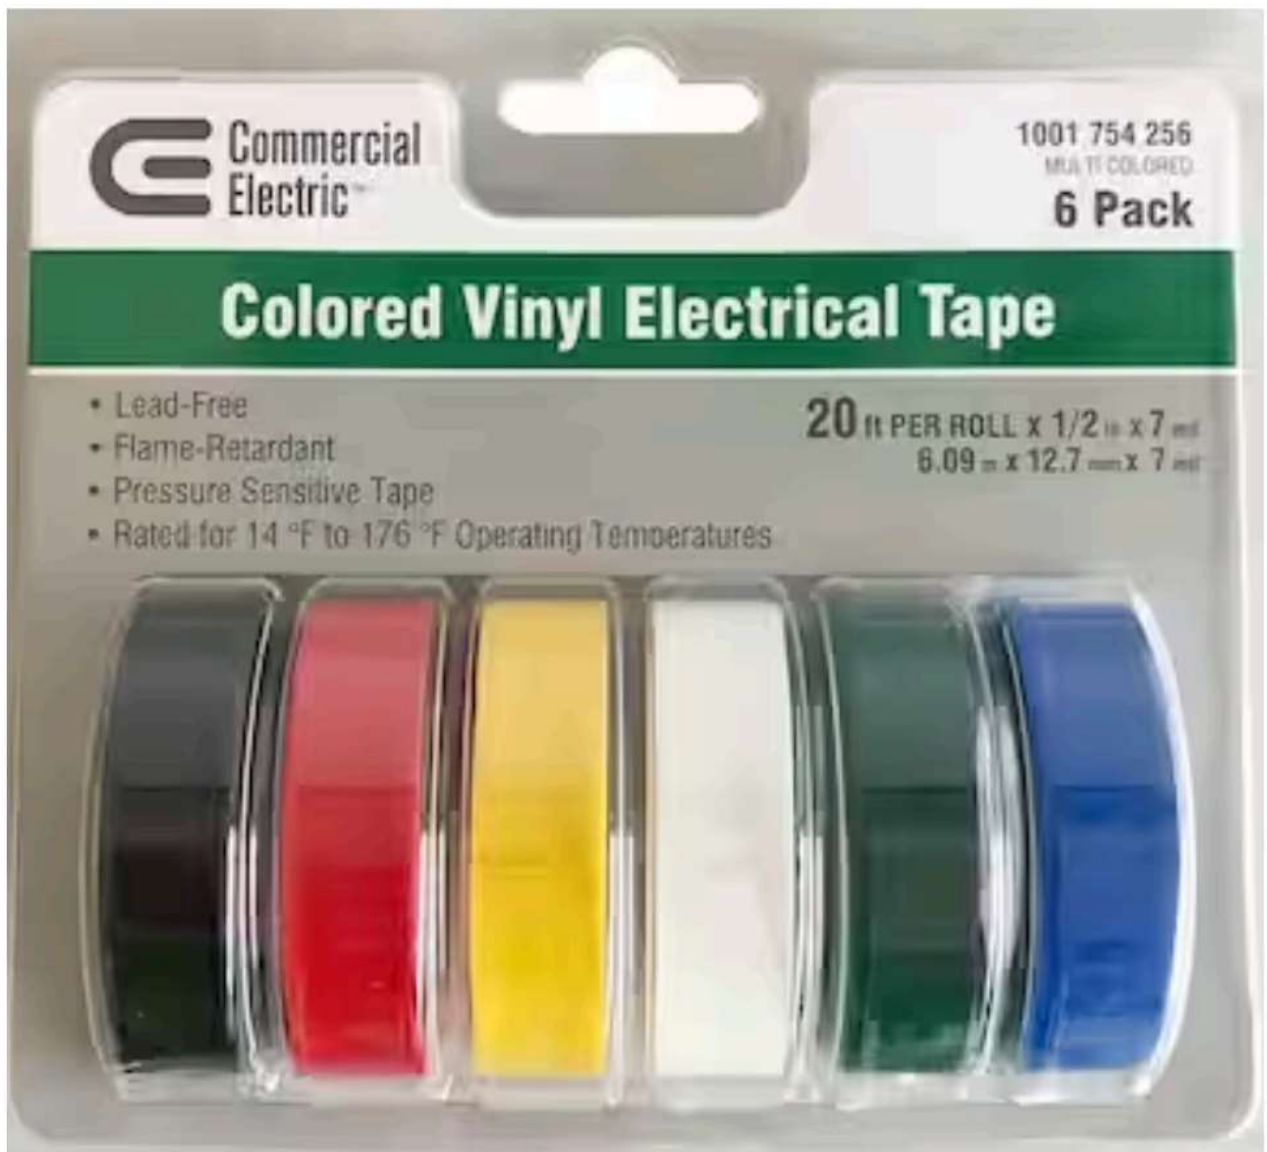
Fig. 5, Multicolored Tape

g.  Carefully mark all eight circuits in the four harnesses to be replaced. Remove and replace only one circuit at a time. Use separate colored tape at each end of the overlay harness in order to correctly identify and avoid mispinning the connector. See Fig. [5](#).

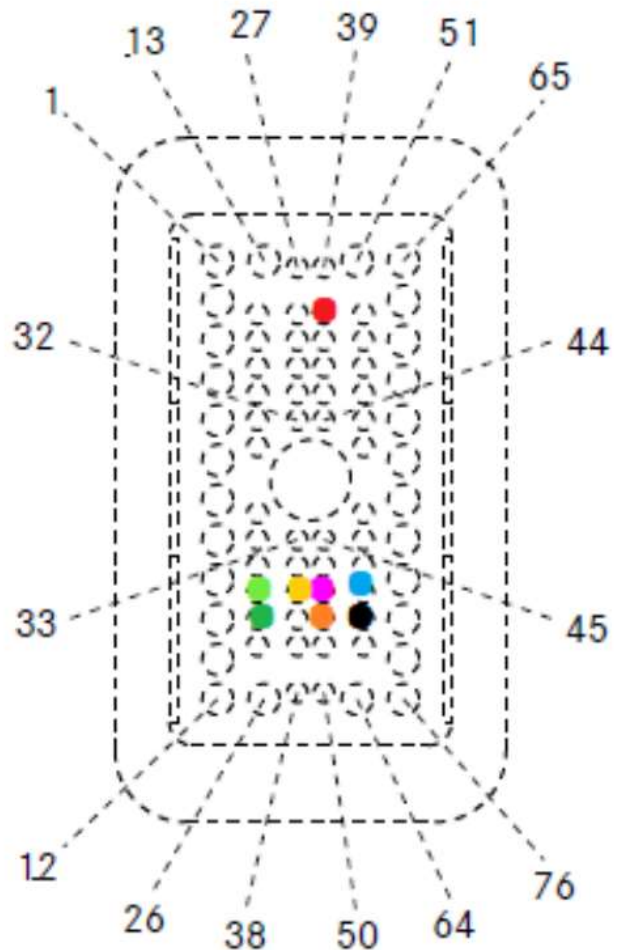
Fig. 6, BulkHead Connector BHB

j.  Verify that the terminals are installed into the correct cavity of the 76-pin bulkhead connector BHB. See Fig. 6.

ID:	CHAS_F_H_DASH_BHB_1B	
PN:	23-13153-016 REF	
	SEALED CONNECTOR	
CAV	CIR#	
—	—	
23	377LA- # 1701 (BK)	●
24	377LR- # 1701 (BK)	●
25	378LRO # 1701 (DKBL)	
34	378LAI # 1701 (BR)	
35	377LA+ # 1701 (BR)	●
37	378LRI # 1701 (BR)	
40	377LR+ # 1701 (BR)	●
41	378LAO # 1701 (DKBL)	
46	378RAI # 1701 (BR)	
47	377RA- # 1701 (BK)	●
48	377RR- # 1701 (BK)	●
49	378RRI # 1701 (BR)	
58	378T- # 1701 (BR)	
59	378T+ # 1701 (DKBL)	
60	378RAO # 1701 (DKBL)	
61	377RA+ # 1701 (BR)	●
62	377RR+ # 1701 (BR)	●
63	378RRO # 1701 (DKBL)
