SERVICE BULLETIN

NUMBER: 09-74-21R
DATE: 05/06/21
REVISED: **07/18/24**

SUBJECT: Cleaning Procedure for Carbon Deposit Removal to Address Engine Misfire DTCs, Black Smoke from the Exhaust, Lack of Power, Knocking (Ping) and / or Rough Idle Concerns

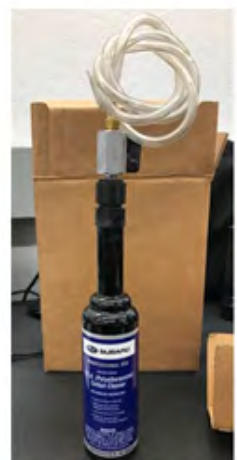
- **STEP 3 (all models):** Pour **ONE** full bottle of P.E.A. carbon cleaner into the vehicle's **FULL** fuel tank. **REMINDER:** The fuel tank **MUST** be **FULL**.
- **STEP 4:** With the valve **CLOSED** as shown below, remove the cap and thread the applicator tool onto the P.E.A. bottle. During use, try to keep the bottle vertical to insure all the contents are consumed.

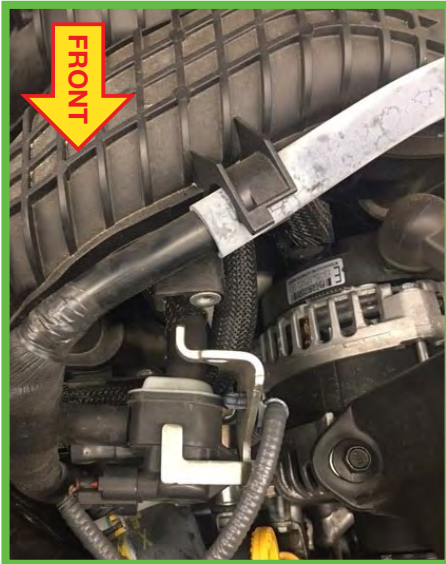
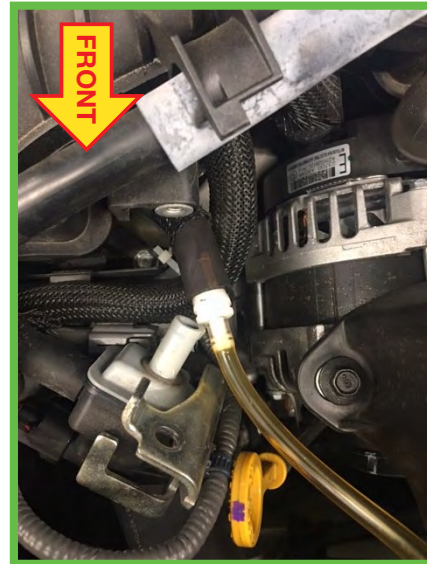
2.4 DIT

- **STEP 6:** Remove the purge hose and connect the hose from the applicator tool. Refer to the images below for the hose locations.
