Warning Message “Coolant Temperature Too High”: Checking Coolant Pump and Change-Over Valve (173/21)

Model Line: **Macan S (95B) / Macan GTS (95B) / Macan Turbo (95B)
Cayenne (9YA / 9YB)**

Concerns: **Change-over valve for coolant pump**

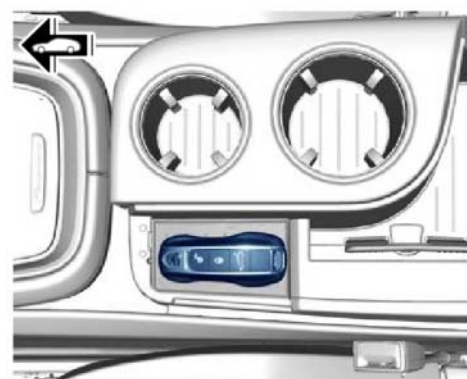
*Emergency start tray
(Exemplary illustration)*

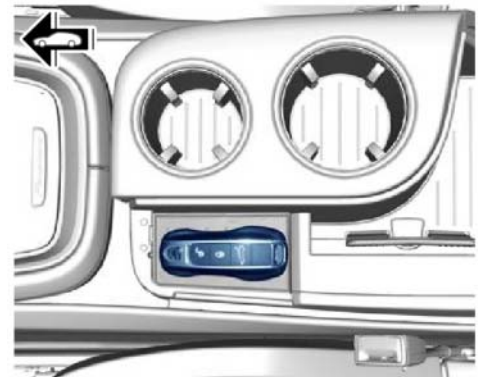
*Emergency start tray
(Exemplary illustration)*

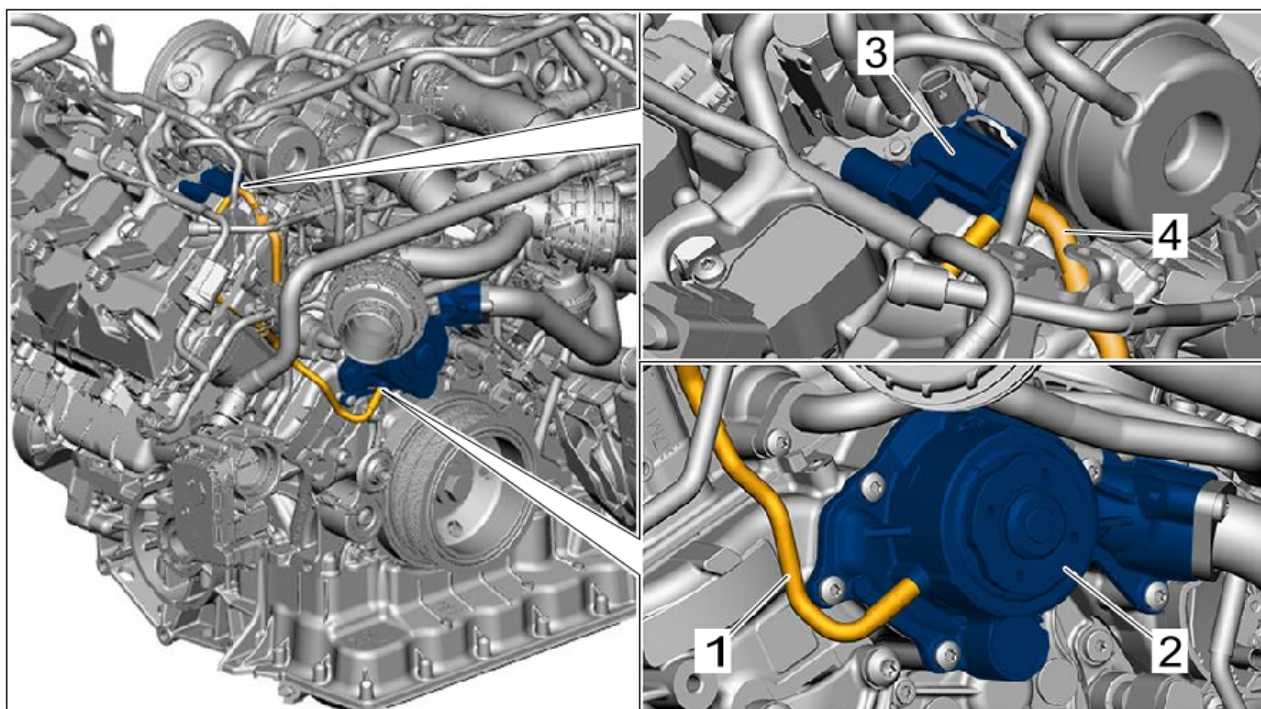
Position of change-over valve and coolant pump

- 1 Pull vacuum hose ⇒ *Position of change-over valve and coolant pump -1-* off the coolant pump ⇒ *Position of change-over valve and coolant pump -2-*.
- 2 Pull off vacuum hose ⇒ *Position of change-over valve and coolant pump -4-* from the control valve ⇒ *Position of change-over valve and coolant pump -3-*.
- 3 **VAS 6213 - Hand vacuum pump** must be ⇒ *Position of change-over valve and coolant pump -3-* connected to the change-over valve ⇒ *Position of change-over valve and coolant pump -4-* on the vacuum hose connection. Then build up vacuum.

Stop the test procedure if a vacuum cannot be built up. In this case, the change-over valve is faulty and must be replaced. Continue with Step 5. If a vacuum can be built up, continue with Step 4.

- 4.2 Select the **“Drive links/checks”** menu.
- 4.3 Select **“Drive links”** and press **•F12** Next to confirm.
- 4.4 Select **“Activation of vacuum switchover valve for main coolant pump”** and press **•F8** to start.
 - If the vacuum in the vacuum pump display changes, the change-over valve \Rightarrow *Position of change-over valve and coolant pump -3-* is intact. Continue with Step 5. In this case, only \Rightarrow *Position of change-over valve and coolant pump -2-* replace the coolant pump if it is faulty.
 - If the vacuum in the vacuum pump display does not change, the change-over valve \Rightarrow *Position of change-over valve and coolant pump -3-* and, if necessary, the coolant pump \Rightarrow *Position of change-over valve and coolant pump -2-* must be replaced, if the coolant pump is \Rightarrow *Position of change-over valve and coolant pump -2-* also faulty.

\Rightarrow *Workshop Manual '195019 Removing and installing coolant pump (V6 biturbo)'*
- 5 Disconnect **VAS 6213 - hand vacuum pump** from the vacuum hose \Rightarrow *Position of change-over valve and coolant pump -1-*.
- 6 Install vacuum hose \Rightarrow *Position of change-over valve and coolant pump -1-* on coolant pump \Rightarrow *Position of change-over valve and coolant pump -2-*.

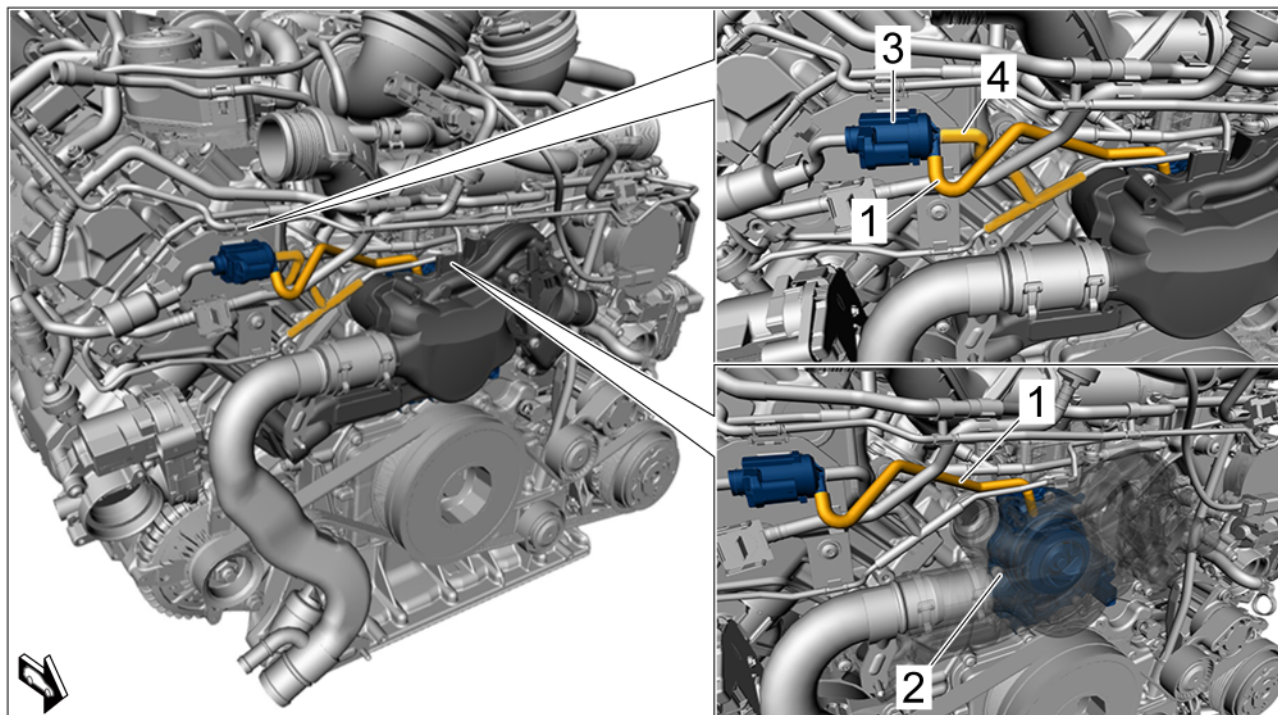
- 1 Pull vacuum hose ⇒ Position of change-over valve and coolant pump -1- off the coolant pump ⇒ Position of change-over valve and coolant pump -2-.
- 2 Pull off vacuum hose ⇒ Position of change-over valve and coolant pump -4- from the control valve ⇒ Position of change-over valve and coolant pump -3-.
- 3 **VAS 6213 - Hand vacuum pump** must be ⇒ Position of change-over valve and coolant pump -3- connected to the change-over valve ⇒ Position of change-over valve and coolant pump -4- on the vacuum hose connection. Then build up vacuum.

Stop the test procedure if a vacuum cannot be built up. In this case, the change-over valve is faulty and must be replaced. Continue with Step 5. If a vacuum can be built up, continue with Step 4.

- If the vacuum in the vacuum pump display changes, the change-over valve ⇒ *Position of change-over valve and coolant pump -3-* is intact. Continue with Step 5. In this case, only ⇒ *Position of change-over valve and coolant pump -2-* replace the coolant pump if it is faulty.

- If the vacuum in the vacuum pump display does not change, the change-over valve ⇒ *Position of change-over valve and coolant pump -3-* and, if necessary, the coolant pump ⇒ *Position of change-over valve and coolant pump -2-* must be replaced, if the coolant pump is ⇒ *Position of change-over valve and coolant pump -2-* also faulty.

- ⇒ *Workshop Manual '195019 Removing and installing coolant pump (V8 Biturbo)'*
- 5 Disconnect **VAS 6213 - hand vacuum pump** from the vacuum hose ⇒ *Position of change-over valve and coolant pump -1-*.

- 6 Install vacuum hose ⇒ *Position of change-over valve and coolant pump -1-* on coolant pump ⇒ *Position of change-over valve and coolant pump -2-*.
