Technical Service Bulletin

93 Q4 e-tron - yellow electrical system warning lamp B1581F4 / B168A00

93 24 64 2074258/1 July 1, 2024.

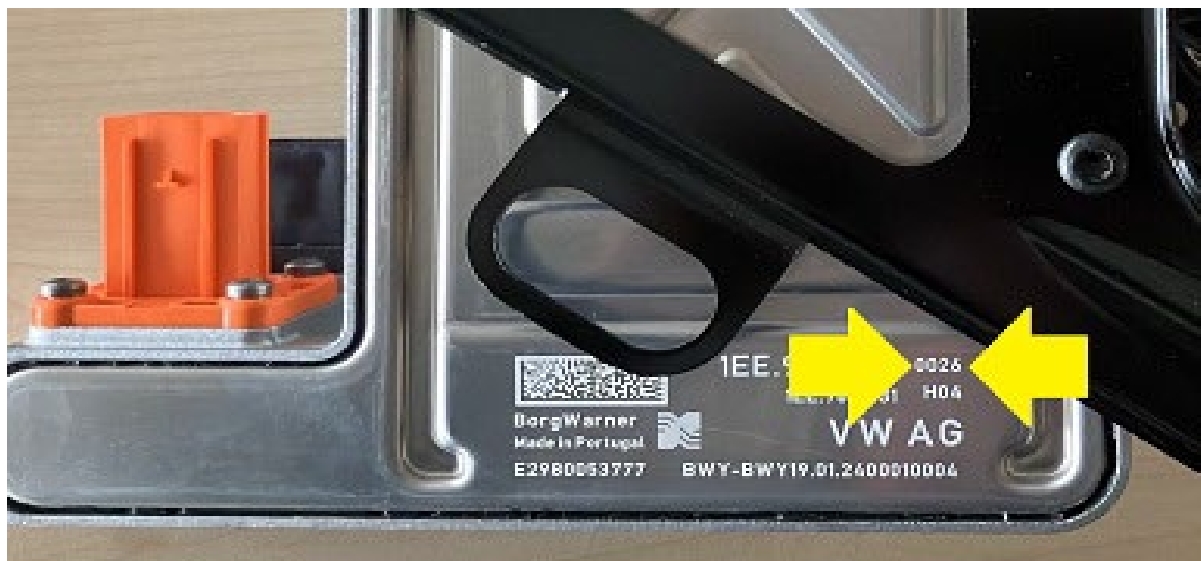
Please make sure that the new high-voltage heater Z132 has **software version number 0026 (or higher)**!

- The software version number is indicated on the label/embossing (refer to figure 2, yellow arrows).

Figure 2. Example of software version number (0026) on label/embossing on high-voltage heater Z132

- Replace high-voltage heater Z132 according to the [→ Workshop Manual/parts catalogue](#).

- The Genuine Parts department in Kassel now only supplies high-voltage heaters Z132 with software version number 0026 (or higher).
