POWERTRAIN

P0A78 CODE IN GEN 4 TRANSMISSION

Range Rover

- 24MY Range Rover
- 24MY Range Rover Sport

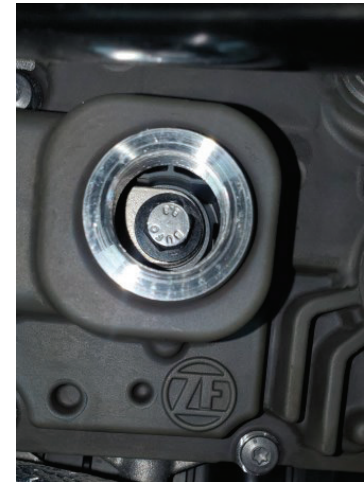
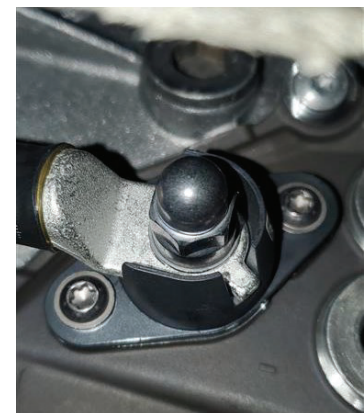
- P0A78 code in the Transmission control module.

- Follow TOPIX workflow for the code.
- Verify all 12V and 48V connections to the MHEV system by:
 - Be sure to remove anything covering the contacts so a thorough examination can be performed.
 - Examine them for any discoloration or deformation of the contacts, covers, or insulation.
 - Check the tightness of the contacts.
 - Please provide photos in an EPQR.

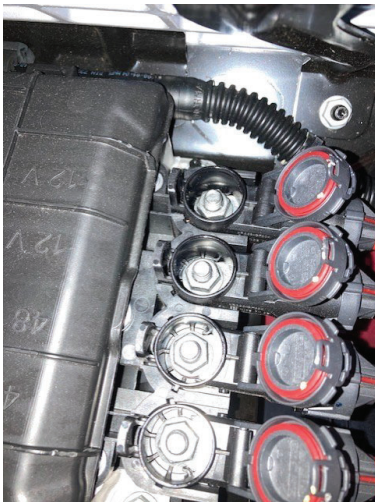
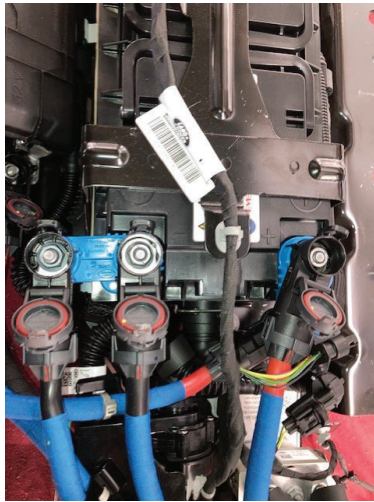
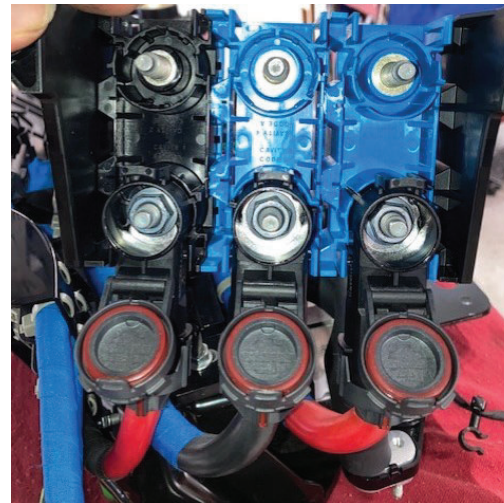
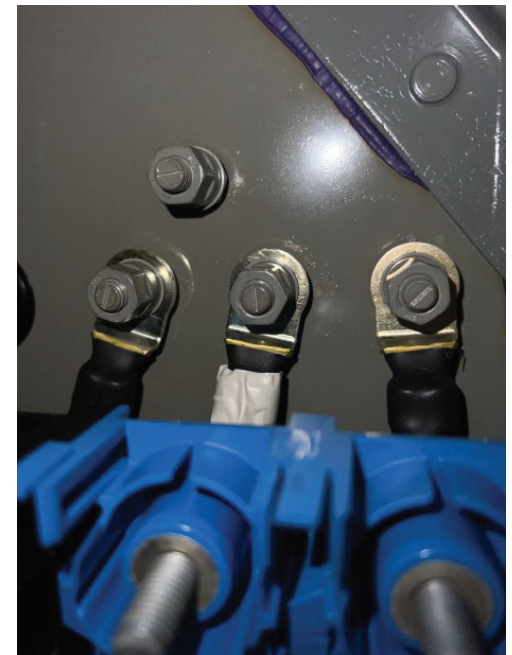
The connections examined should include, but not be limited to:

1. Six HV junction box studs.
2. All connections in the MHEV box. These include, but are not limited to:
 - The EPICD (DC/DC) : 48V+; 48V-; 12V+; and 12V- terminals.
 - You will need to remove caps to see the terminals.
 - Three BECM studs.
 - You will need to remove the MHEV box to check all of them.
3. The two 48V system and one 12V system ground studs to chassis on the bottom of the car.
