JLRTB02119NAS2

TECHNICAL BULLETIN

Rear Headliner Vent Poor Performance

MODEL:	MODEL YEAR:	VIN:	ASSEMBLY PLANT:
Range Rover (LK)	2022-2024	000124-089575	Solihull

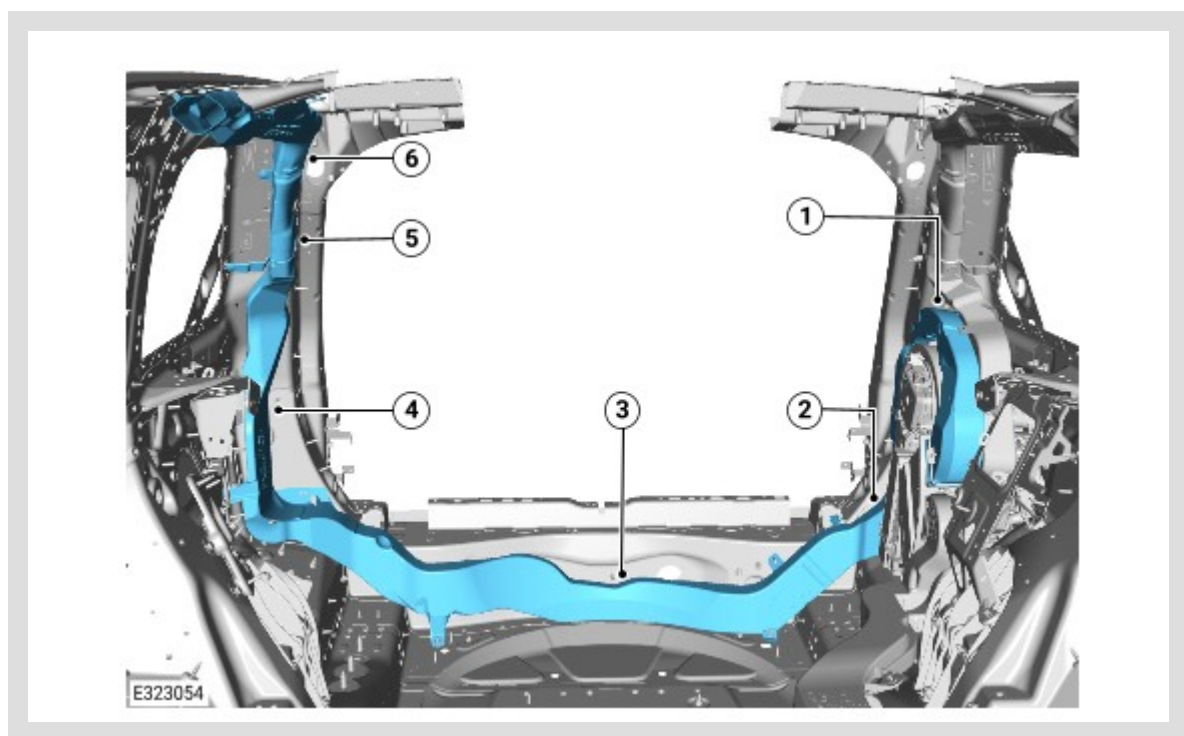
The illustration shows the 6 right air ducts which require removal.

1. Right air duct 1.
2. Right air duct 2.
3. Right air duct 3.
4. Right air duct 4.
5. Right air duct 5.
6. Right air duct 6.

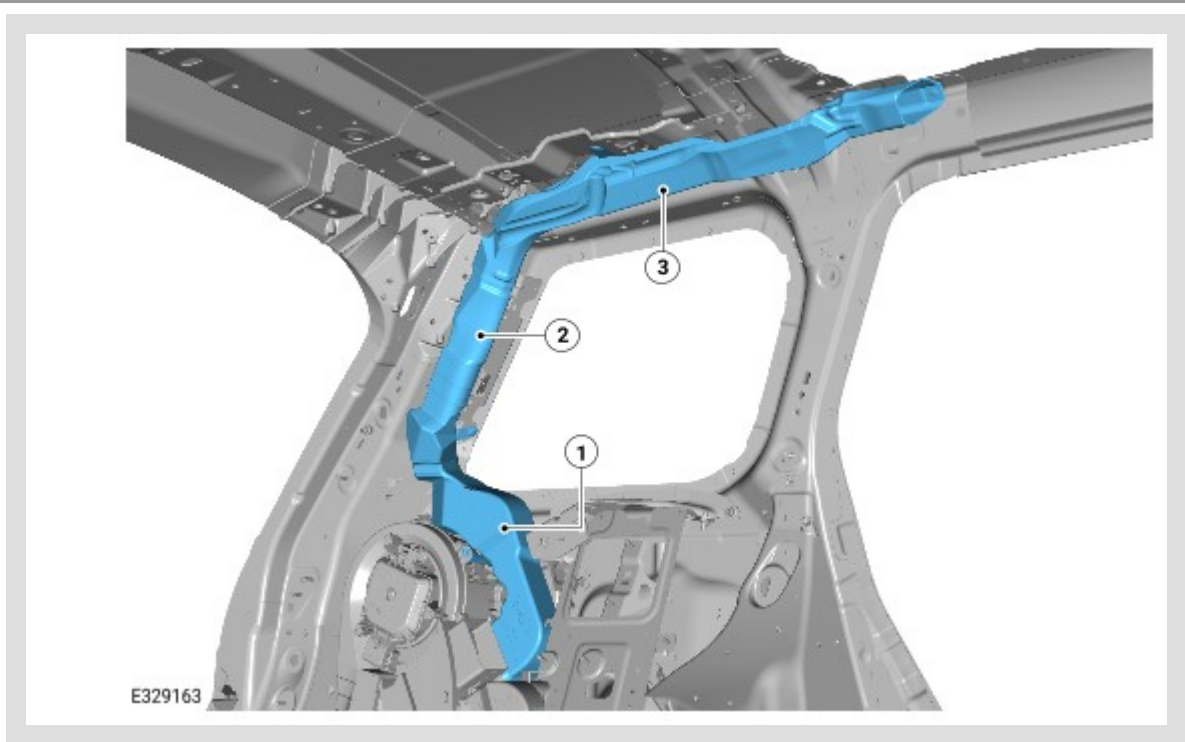
2.

The illustration shows the 3 left air ducts which require removal.

1. Left air duct 1.

Left air duct 2 will be removed during completion of the 'Headliner Lower For Access' procedure.

3. Left air duct 3.

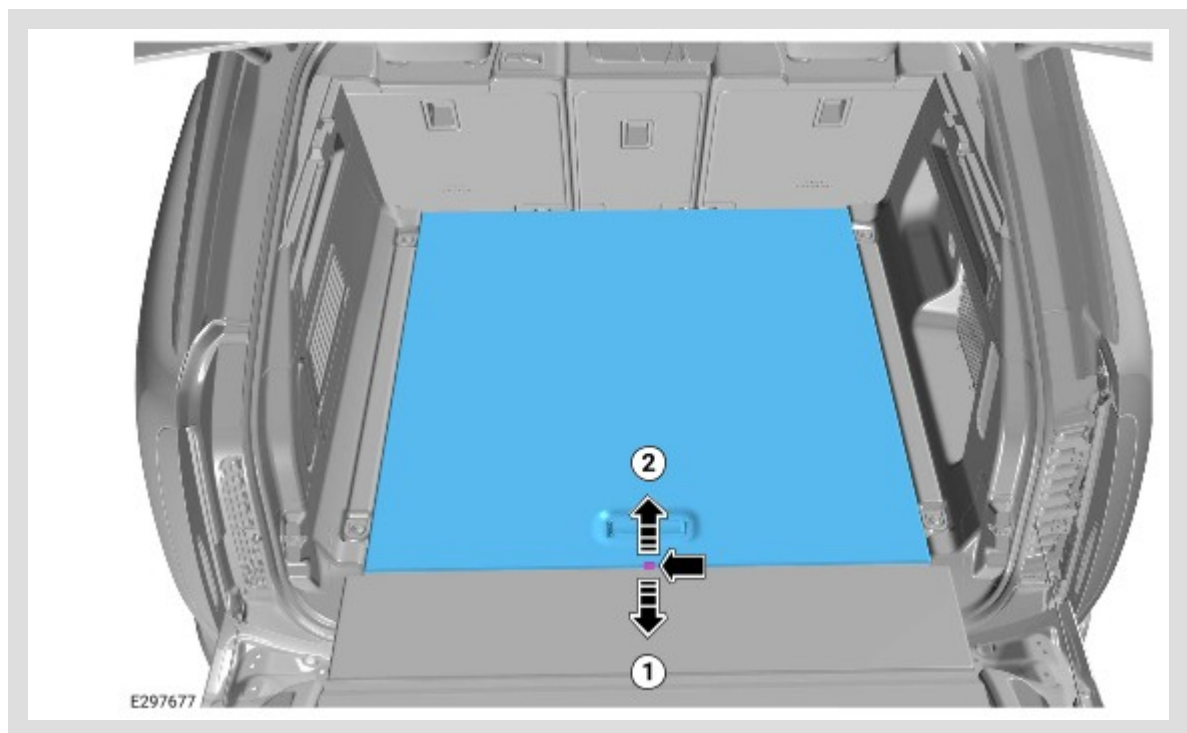
2.

Remove the loadspace floor trim.

- Release the latch.
- Remove the loadspace floor trim.

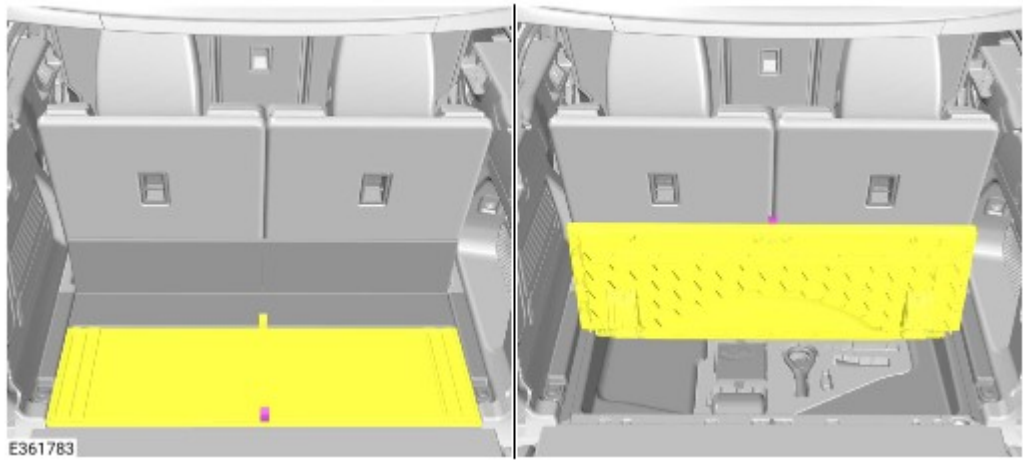
4.

Use the loop to release and open the smart loadspace compartment floor.

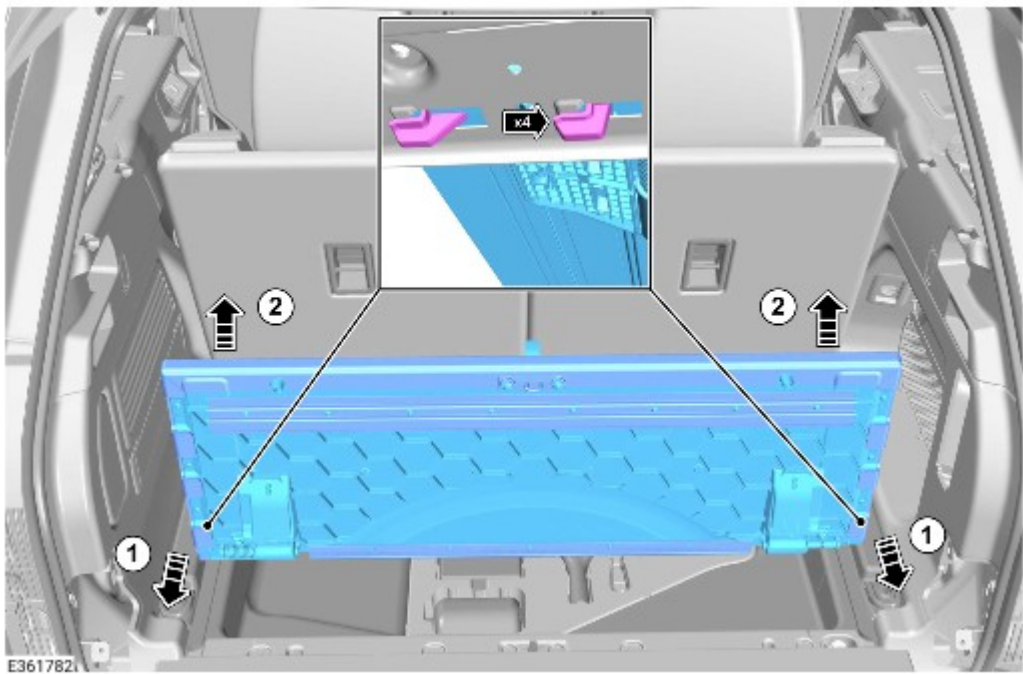
5.

Remove the smart loadspace compartment floor in the illustrated sequence.

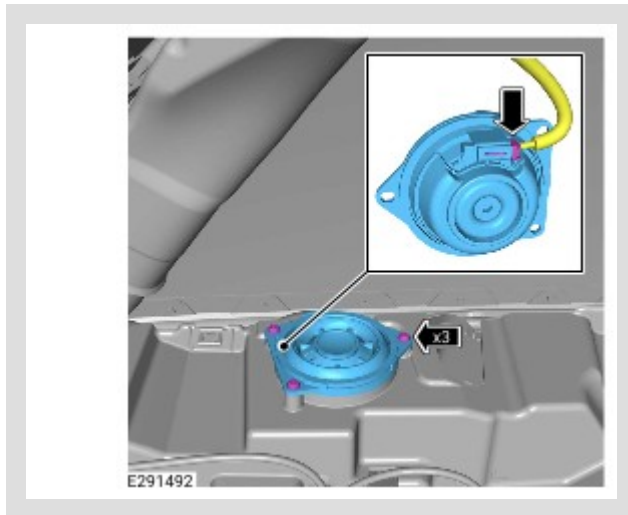
7.

Remove the right loadspace speaker.

- Remove the 3 screws.
- Release the loadspace speaker.
- Disconnect the electrical connector.

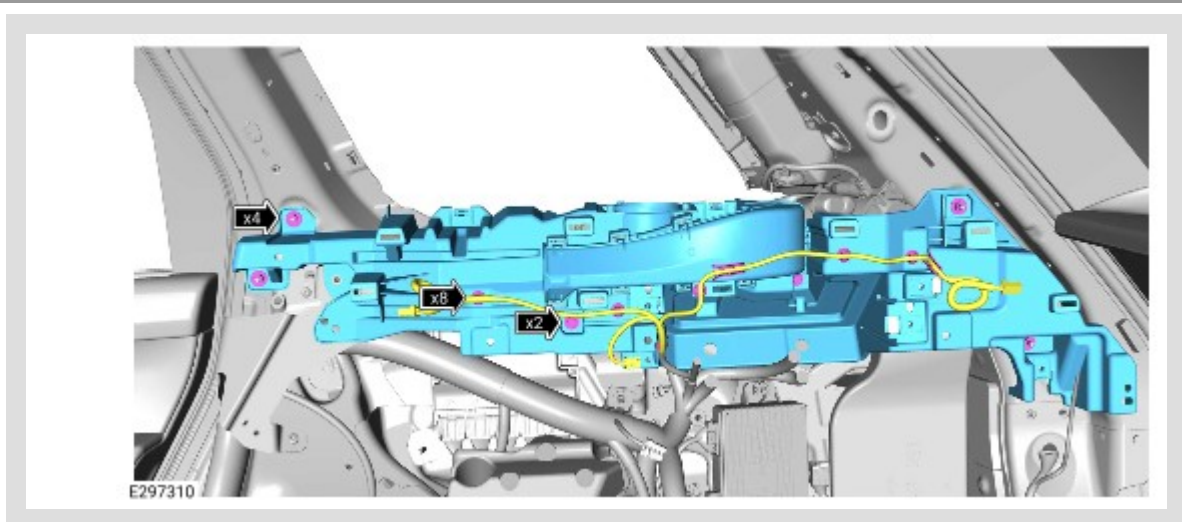
8.

Remove the right upper loadspace side bracket.

- Release the 8 wiring harness clips.
- Remove the 2 bolts.
- Remove the 4 nuts.

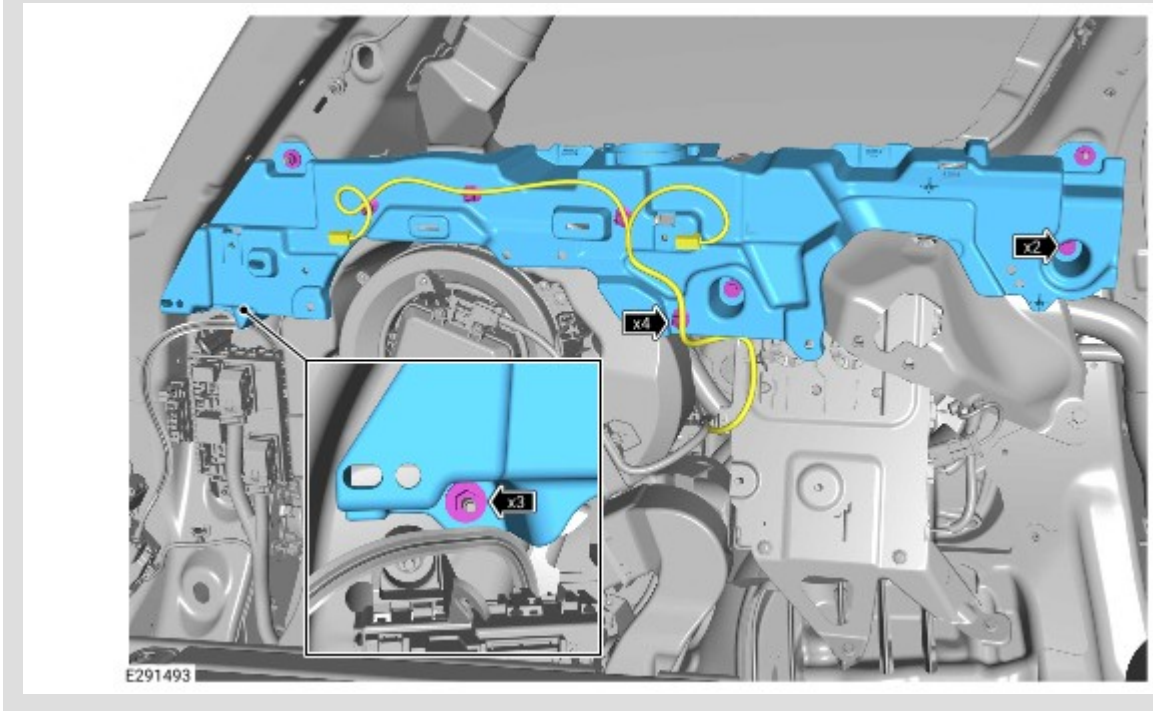
12.

Remove the left upper loadspace side bracket.

- Release the 4 wiring harness clips.
- Remove the 2 bolts.
- Remove the 3 nuts.

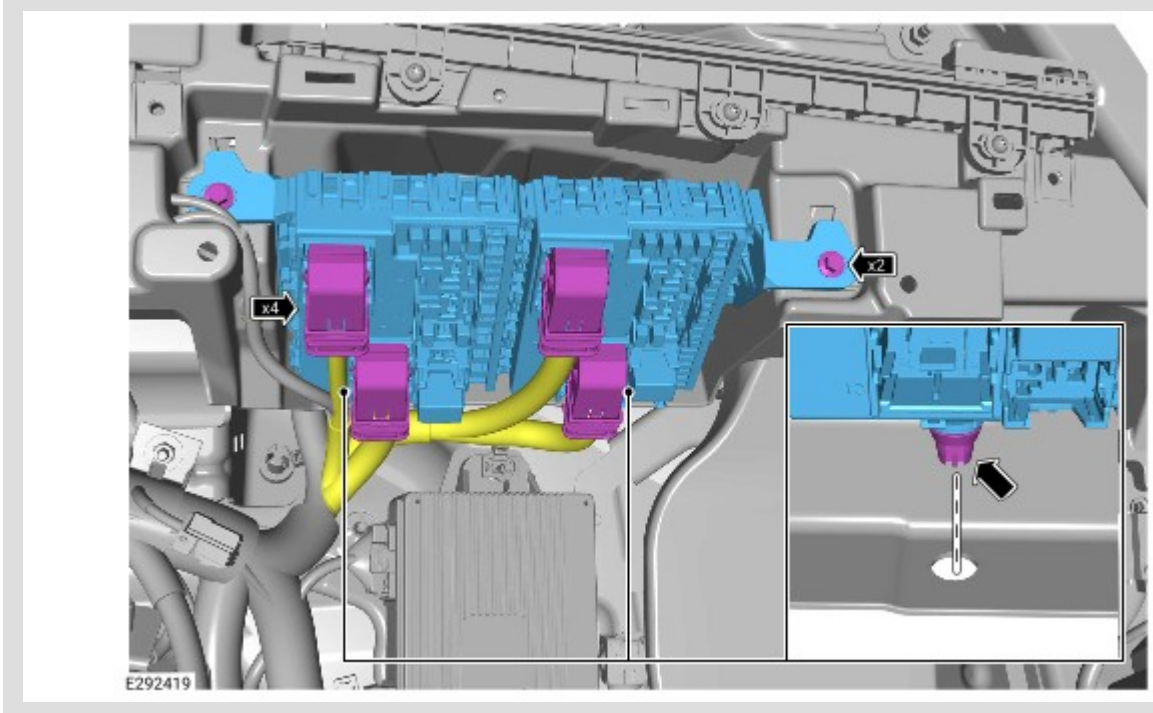
13.

Remove the rear right junction box assembly.

- Disconnect the 4 electrical connectors.
- Remove the 2 bolts.

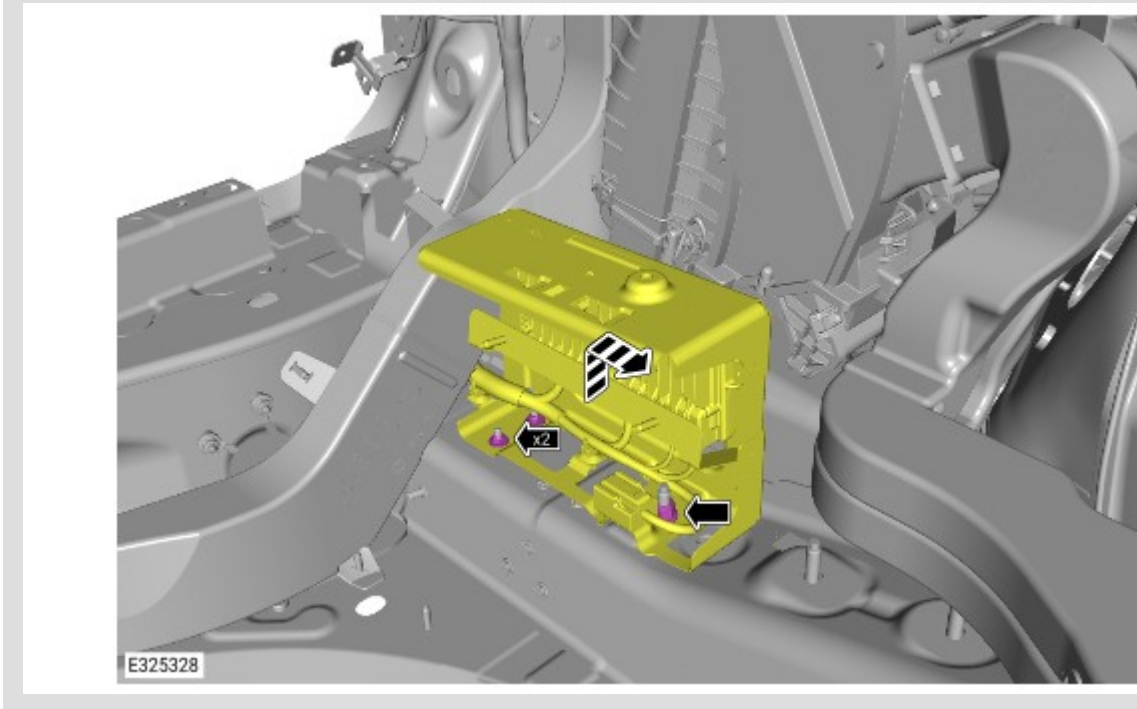
14.

Reposition the module housing bracket.

- Remove the 2 nuts.
- Remove the nut.

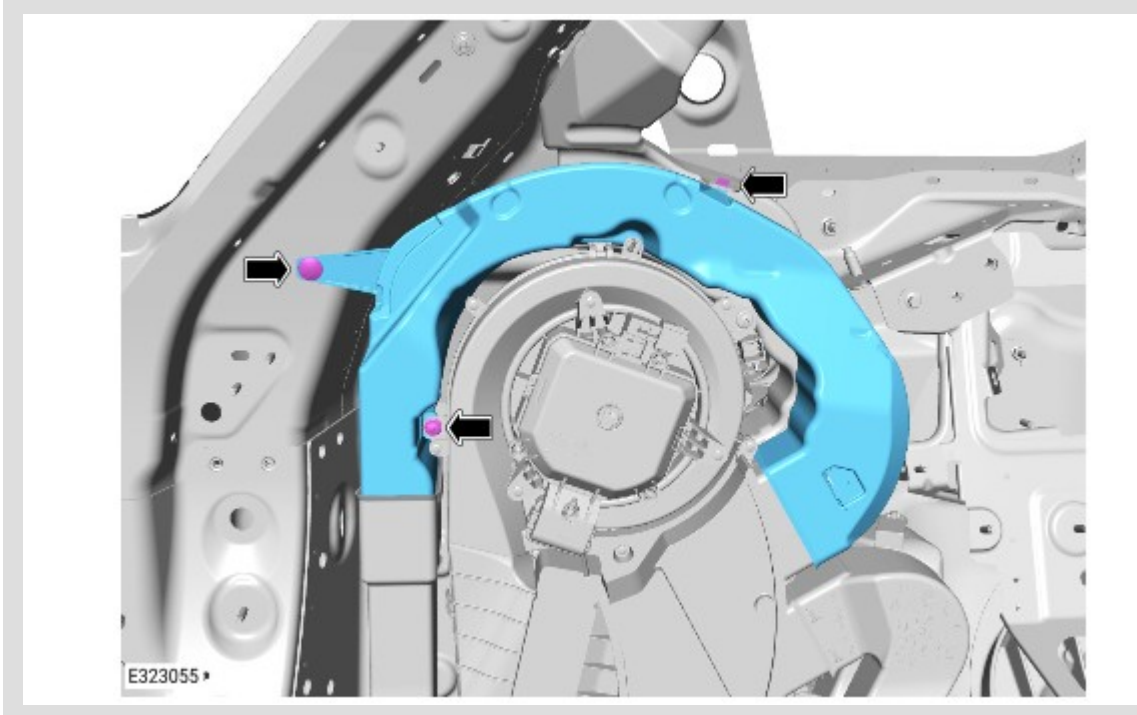
15.

Remove and discard the right air duct 1.

- Remove the 2 trim clips.
- Release the tab.

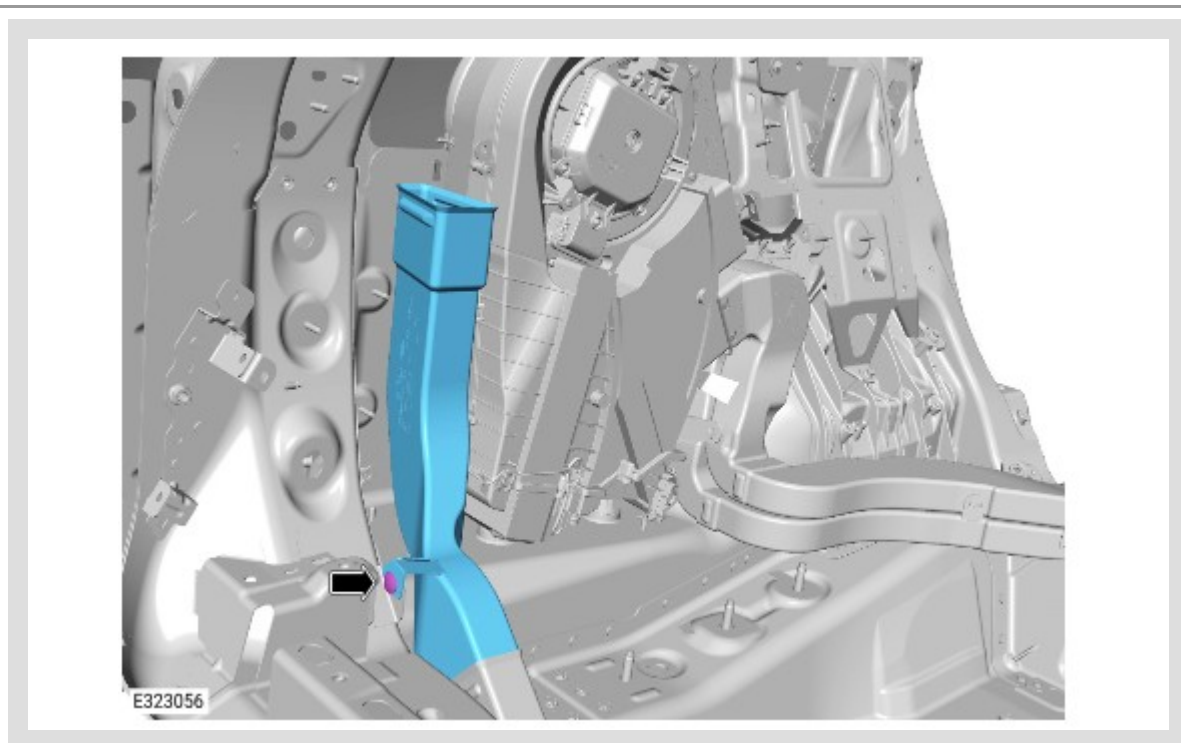
Remove and discard the right air duct 2.

- Remove the trim clip.

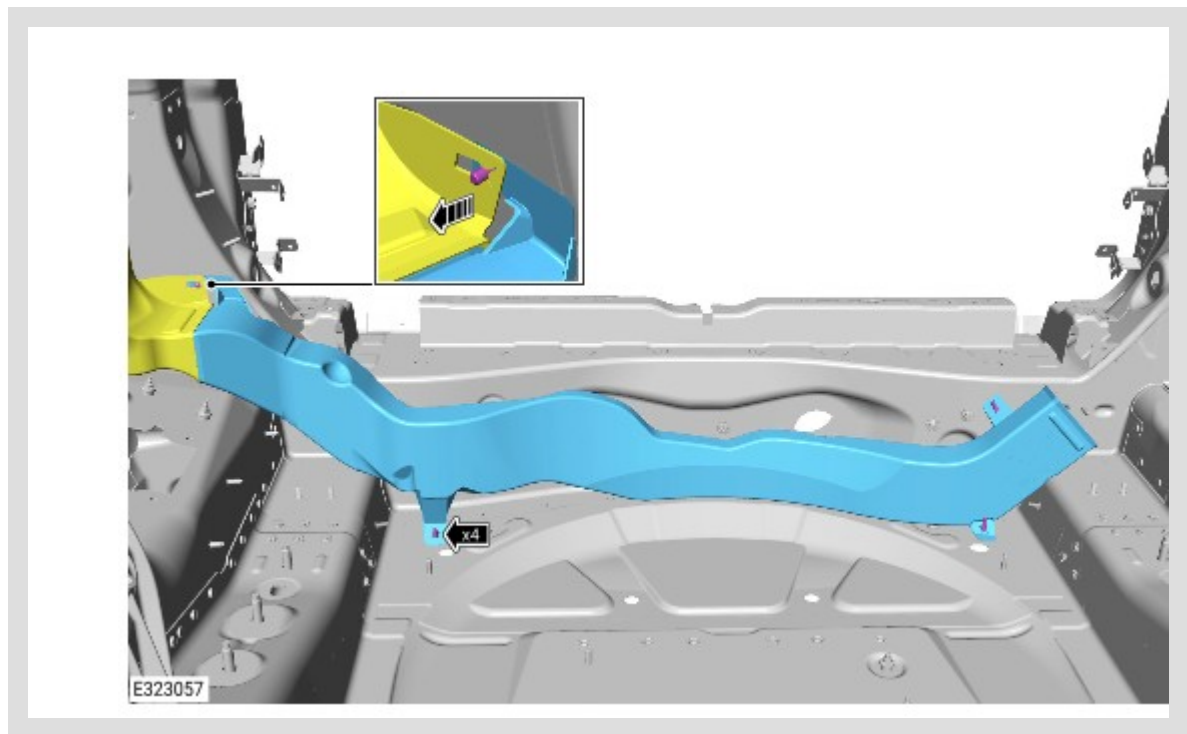
17.

Reposition right air duct 4 to allow for the removal of right air duct 3.

Remove and discard the right air duct 3.

- Release the 4 tabs from the 4 studs.

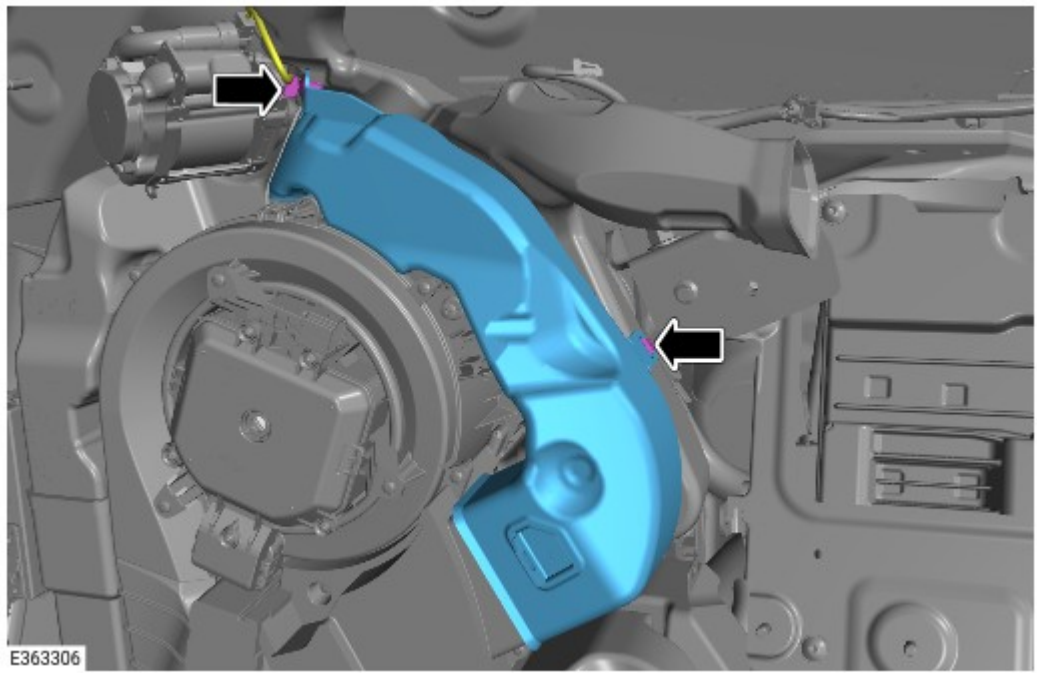
Remove and discard the right air duct 1 section 1.

- Release the clip.
- Release the wiring harness clip.

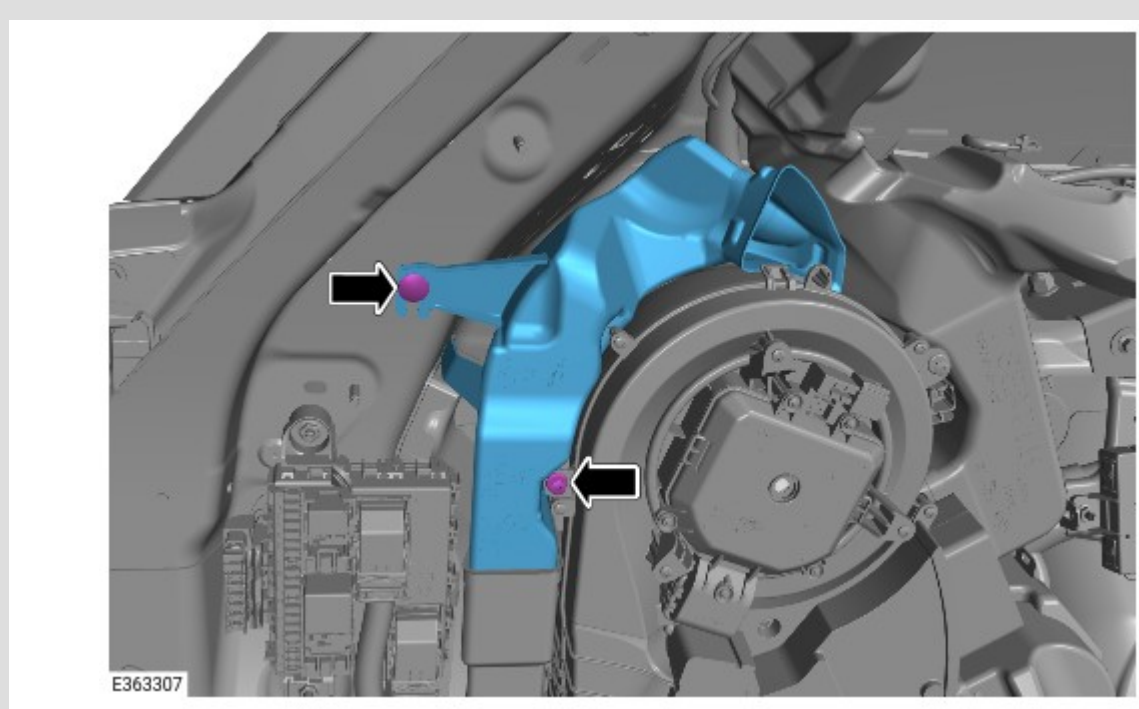
The right air duct 1 section 2 must not be discarded.

Remove the right air duct 1 section 2.

- Remove the 2 trim clips.

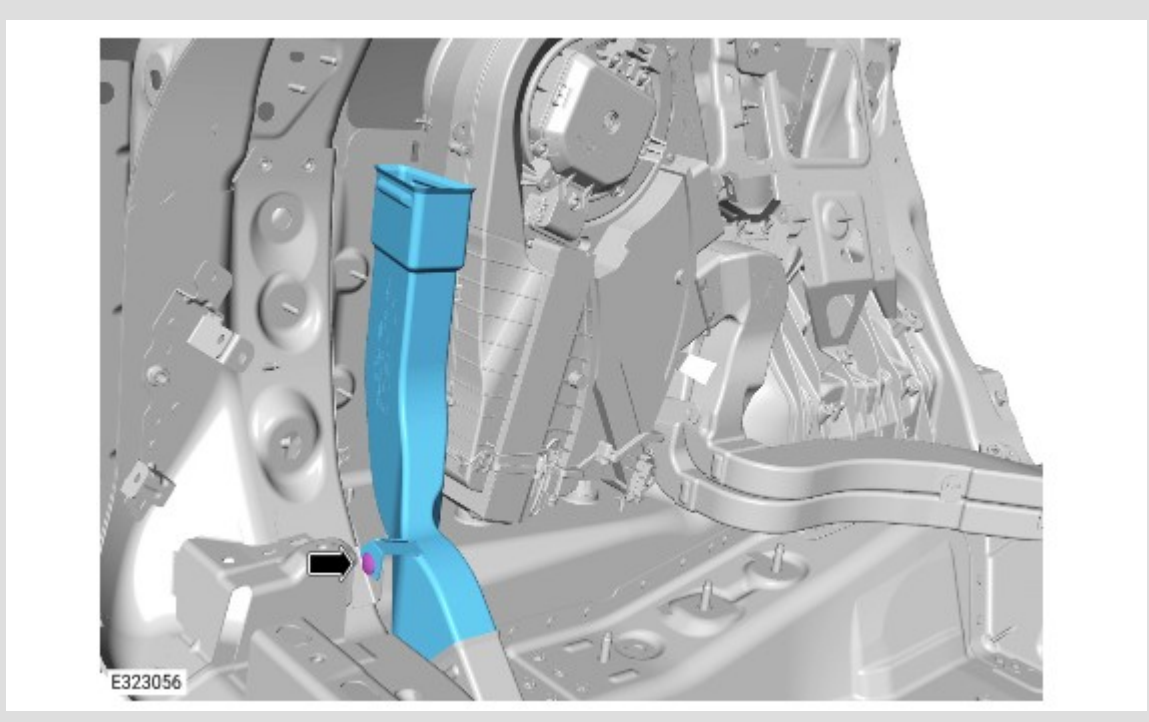
The right air duct 2 must not be discarded.

Remove right air duct 2.

- Remove the trim clip.

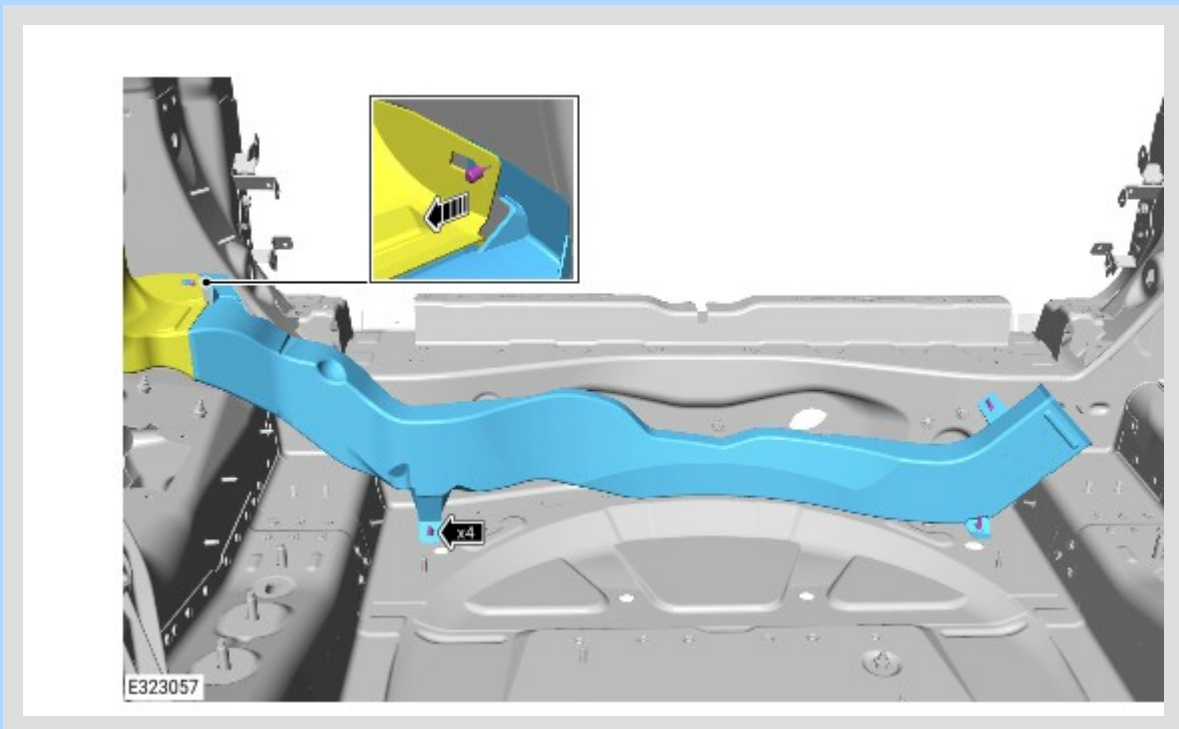
21.

The right air duct 3 must not be discarded.

Reposition right air duct 4 to allow for the removal of right air duct 3.

Remove the right air duct 3.

- Release the 4 tabs from the 4 studs.

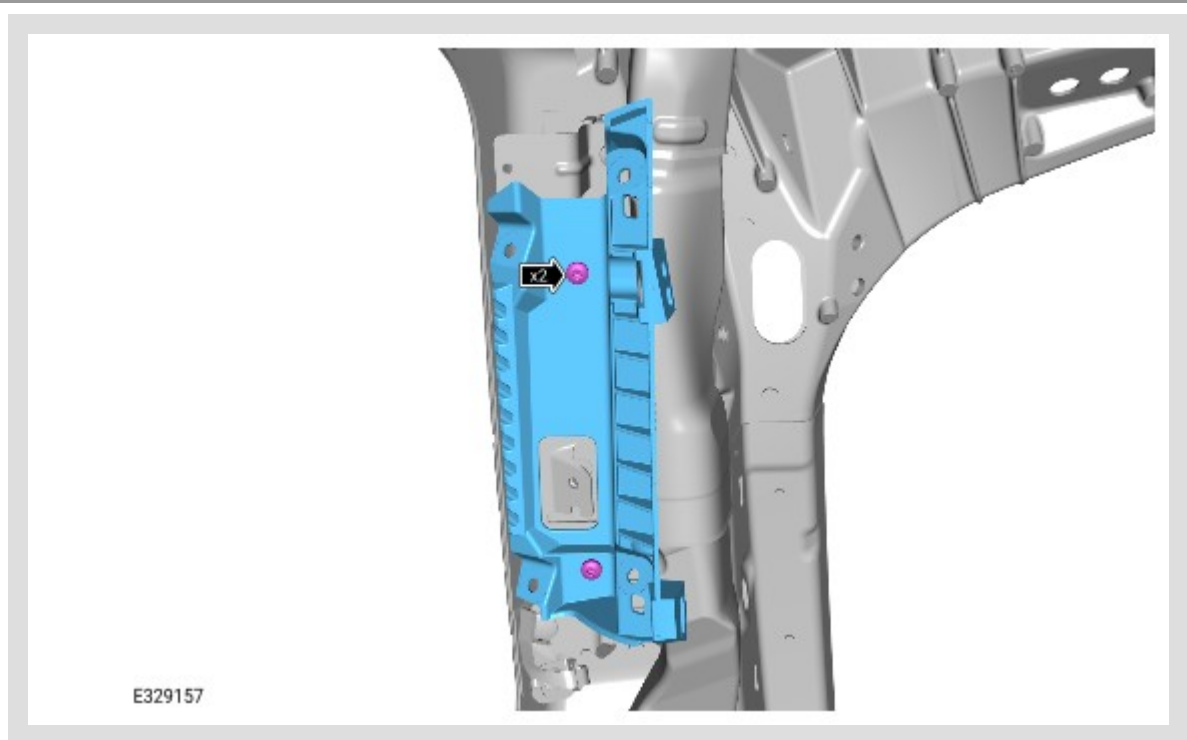
22.

Remove the right D-pillar trim panel mounting bracket.

- Remove the 2 screws.
 - Torque: **4.8 Nm**

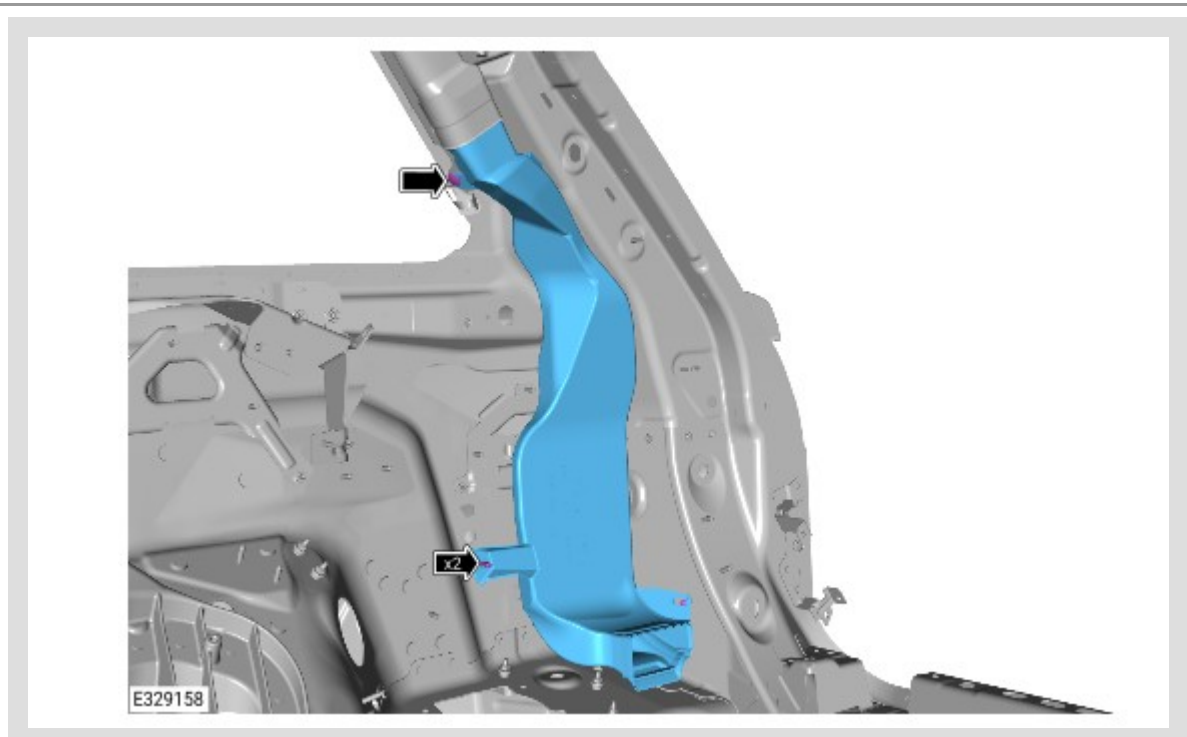
23.

Remove and discard right air duct 4.

- Release the 2 tabs from the 2 studs.
- Remove the trim clip.

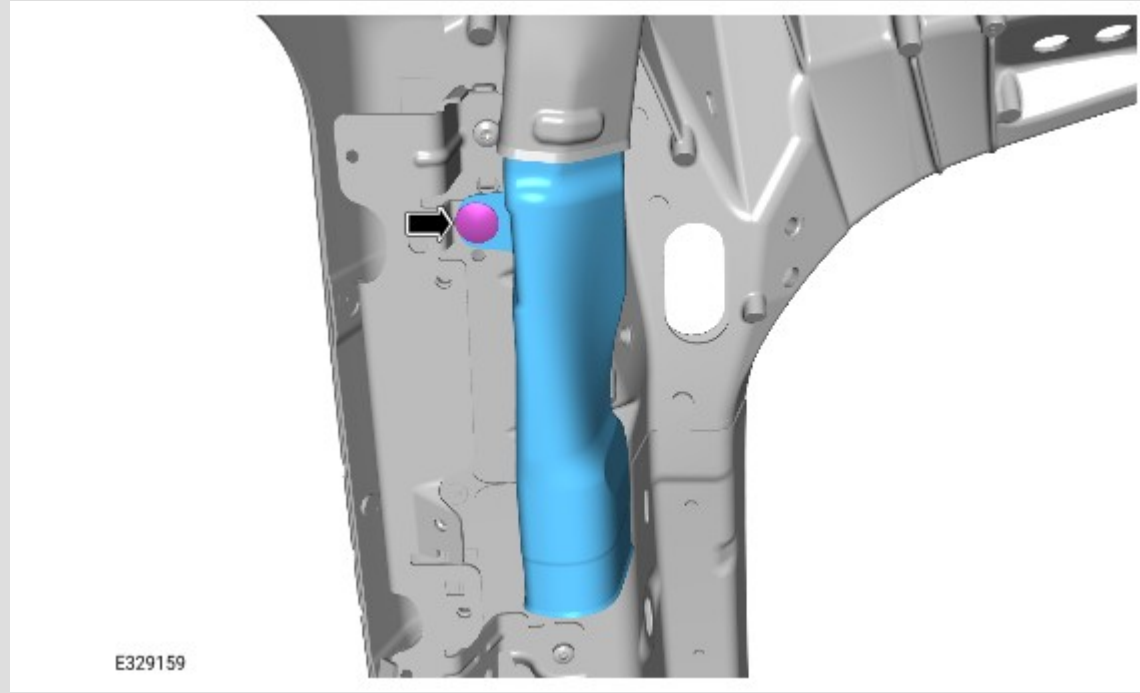
24.

Remove and discard right air duct 5.

- Remove the trim clip.

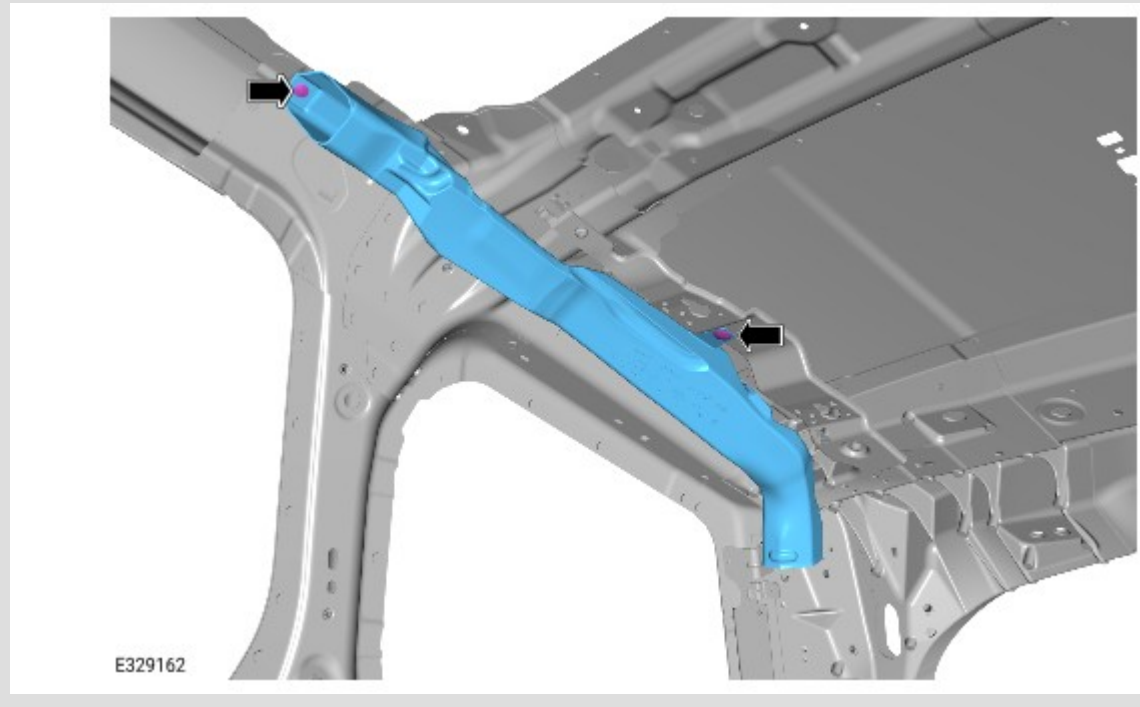
25.

Remove and discard right air duct 6.

- Remove the 2 trim clips.

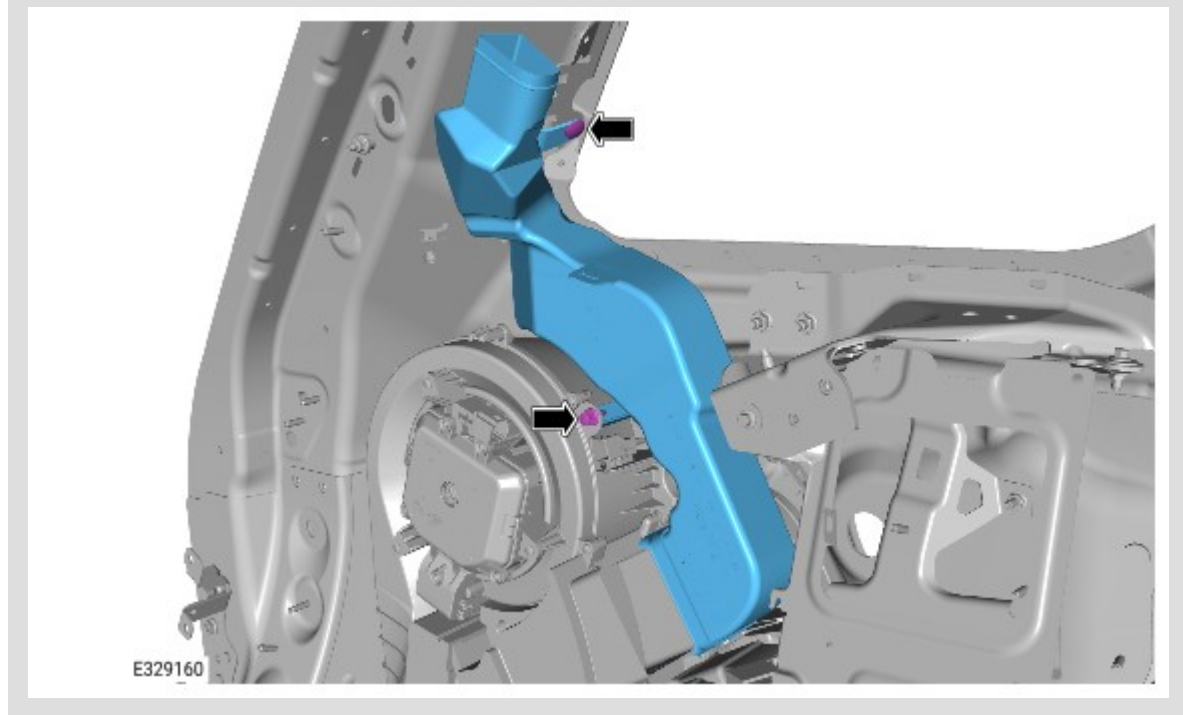
26.

Remove and discard left air duct 1.

- Remove the 2 trim clips.

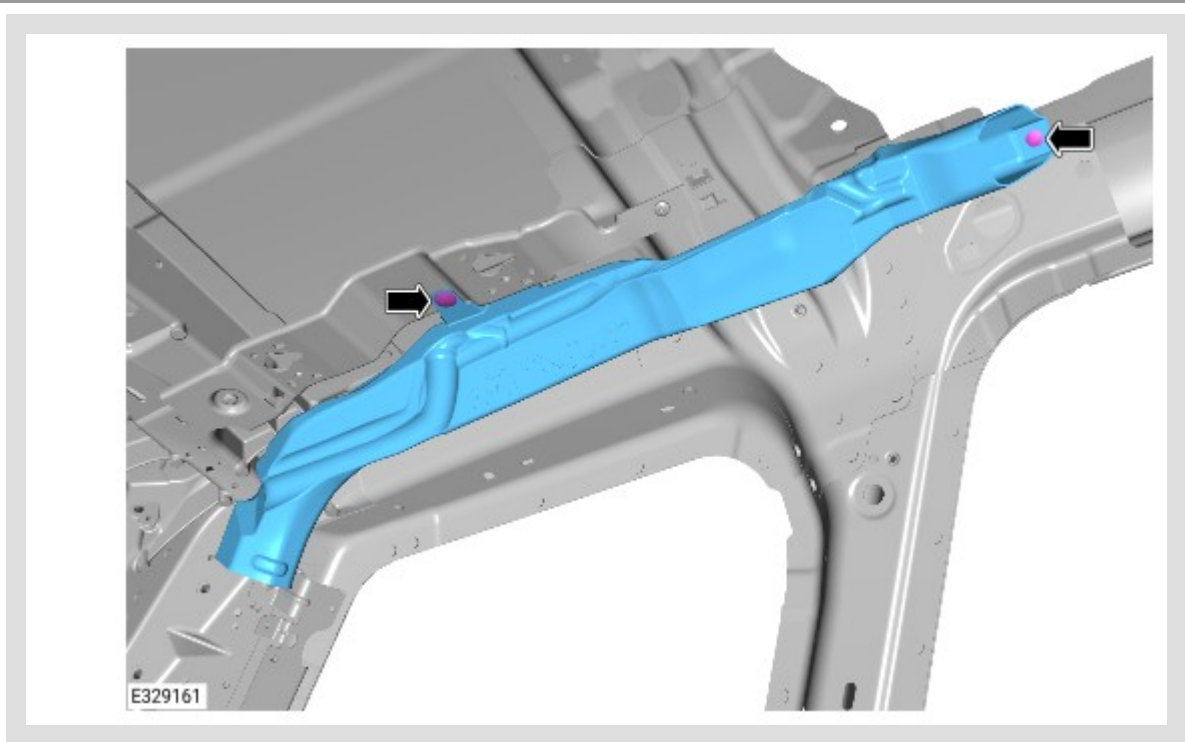
27.

Left air duct 2 must be discarded.

Left air duct 2 has been removed during completion of the 'Headliner Lower For Access' procedure.

Remove and discard left air duct 3.

- Remove the 2 trim clips.

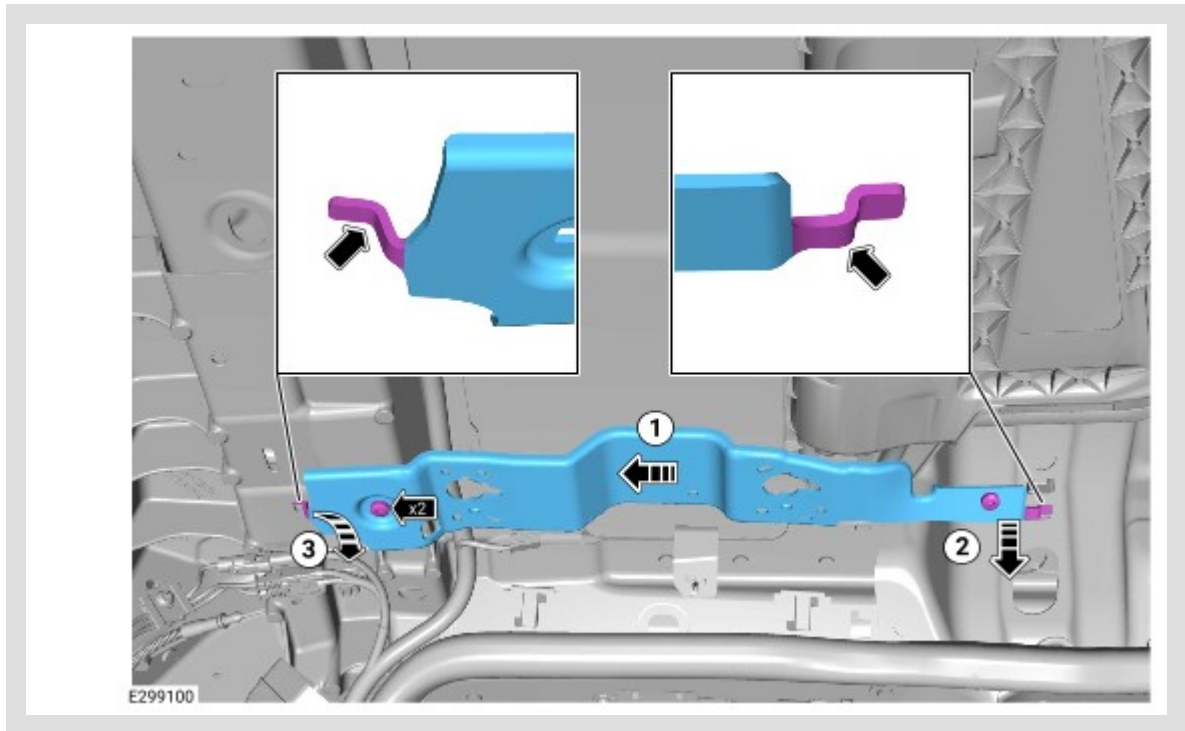
1.

Repeat this step for the other side.

Remove the cargo net bracket in the order shown in the illustration.

- Remove the 2 bolts.

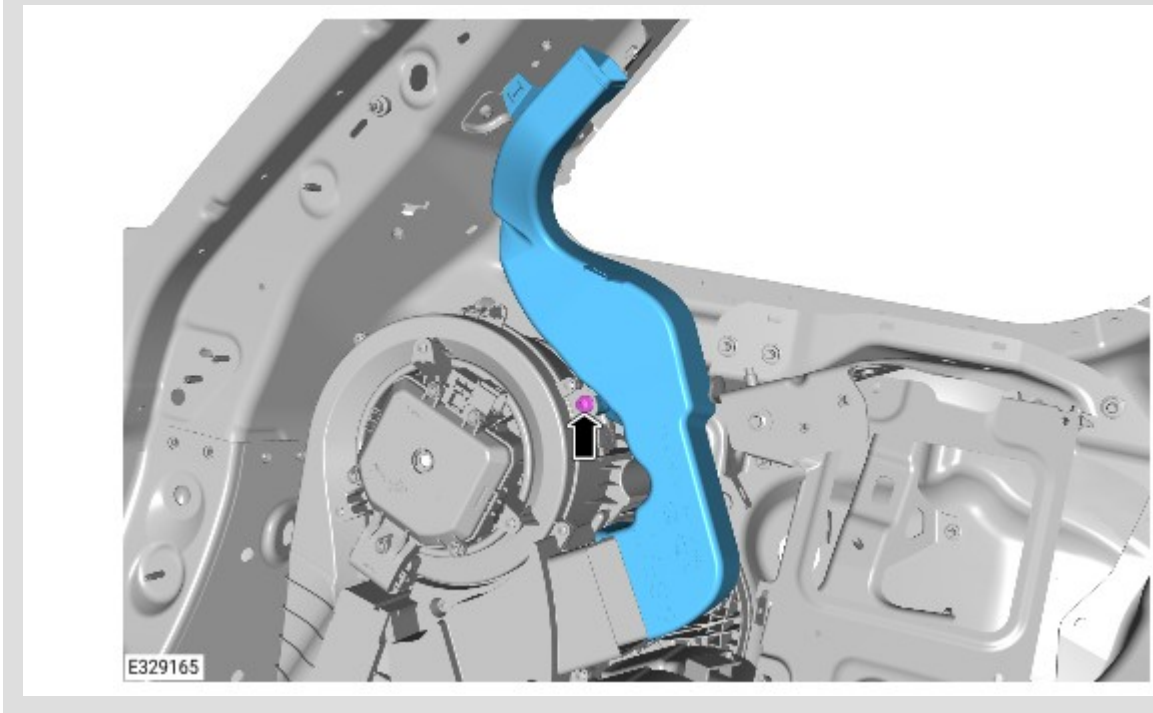
2.

Install the air duct.

- Install the trim clip.

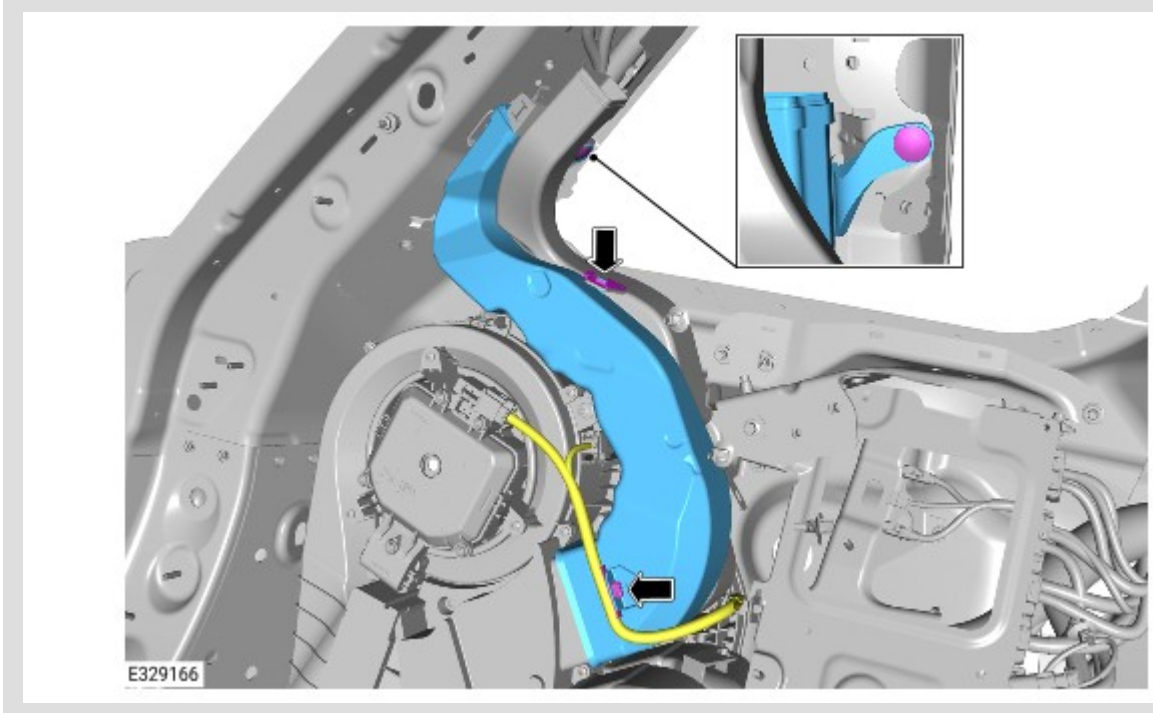
3.

Install the air duct.

- Install the trim clip.
- Secure the electrical wiring harness clip.
- Install the tab.

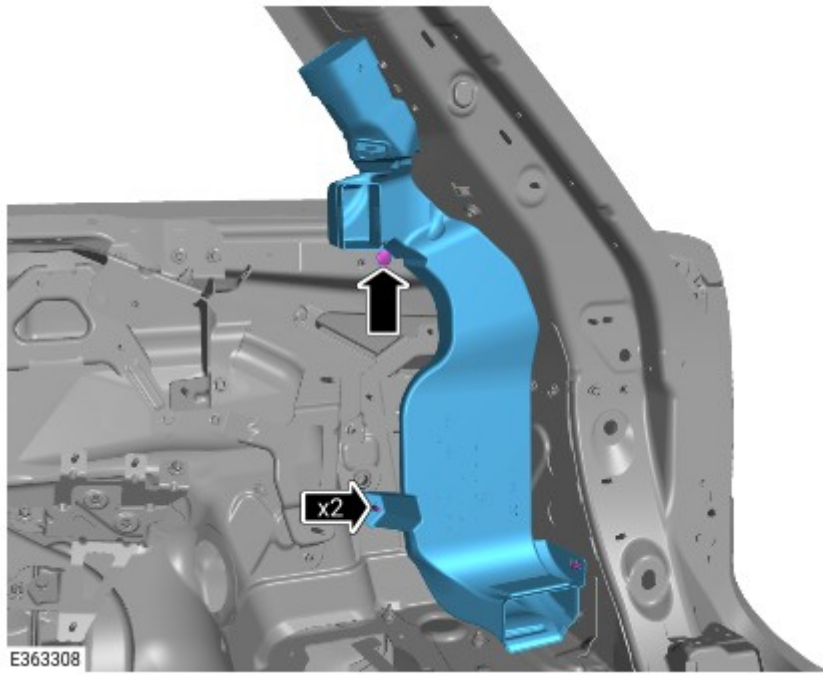
Install the right air duct 4.

- Install the 2 tabs to the 2 studs.
- Install the trim clip.

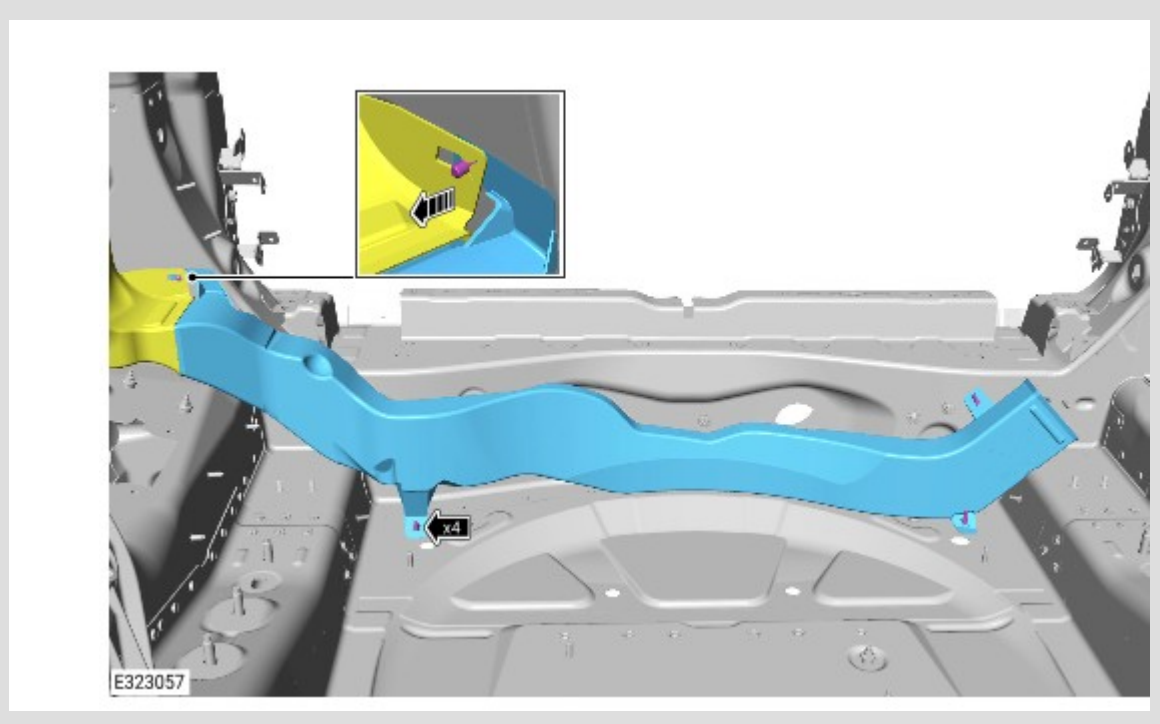
5.

Reposition right air duct 4 to allow for the installation of right air duct 3.

Install the right air duct 3.

- Install the 4 tabs to the 4 studs.
