JLRTB02119NAS2

TECHNICAL BULLETIN

Rear Headliner Vent Poor Performance

MODEL:	MODEL YEAR:	VIN:	ASSEMBLY PLANT:
Range Rover (LK)	2022-2024	000124-089575	Solihull

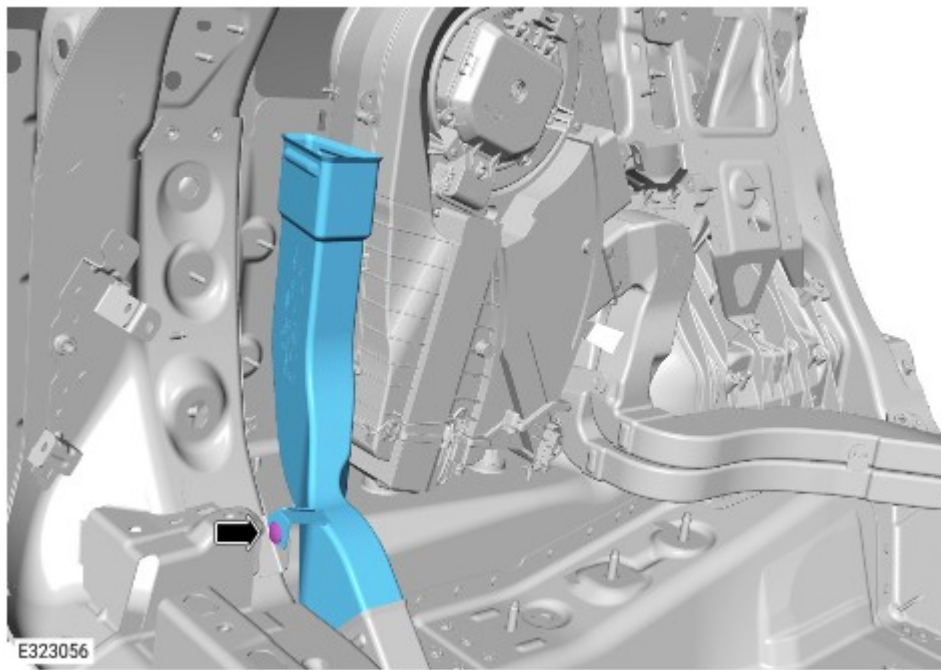
6.

Install the right air duct 2.

- Install the trim clip.

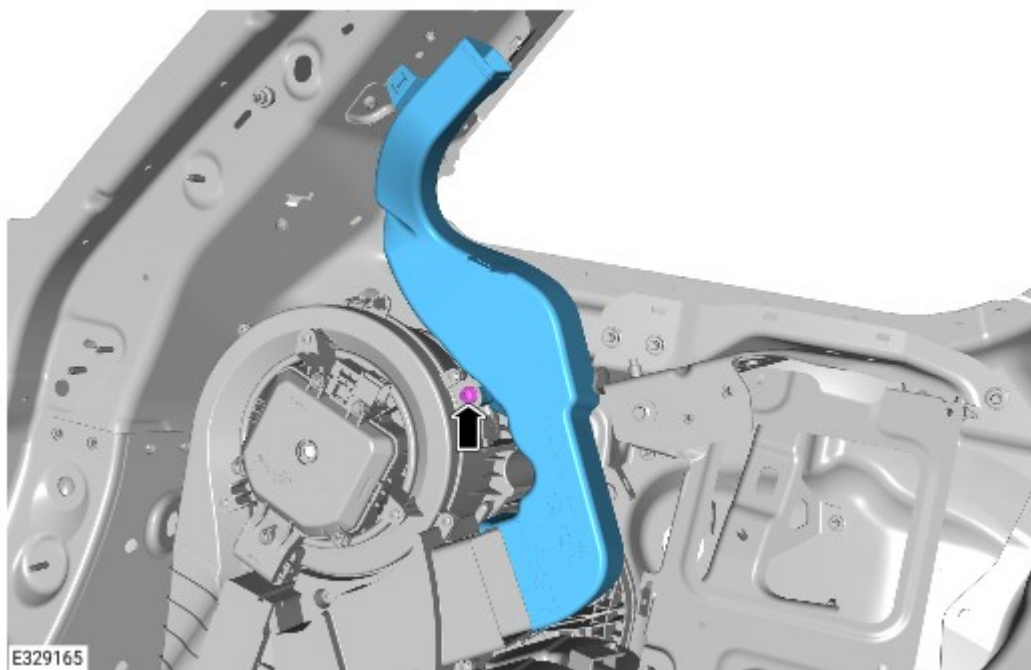
7.

Install the left air duct 1.

- Install the trim clip.

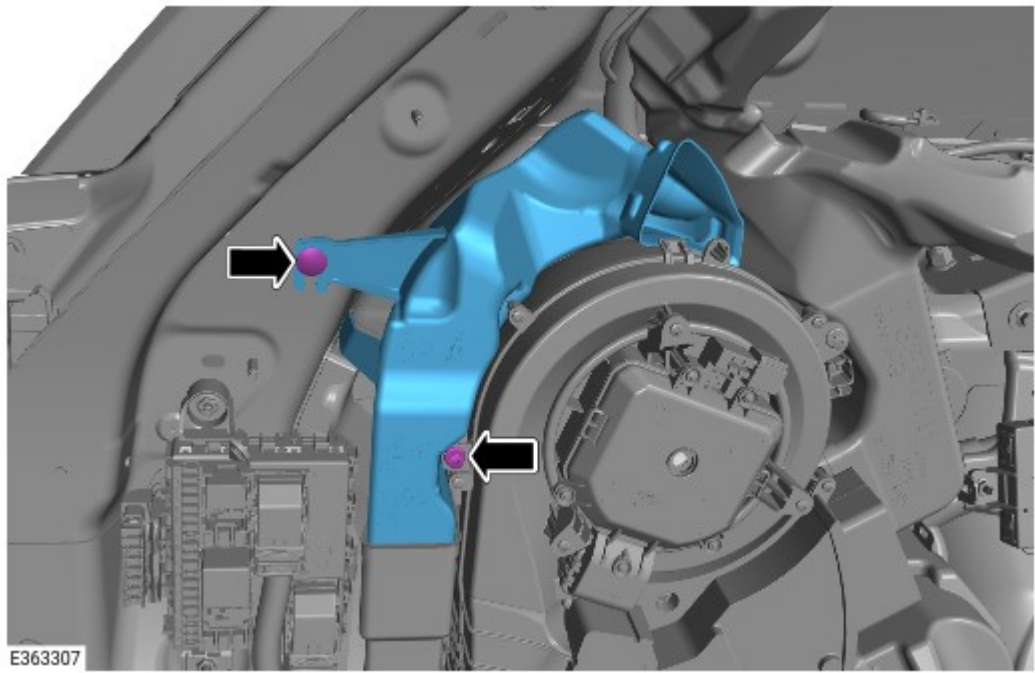
8.

Install the right air duct 1 section 2.

- Install the 2 trim clips.

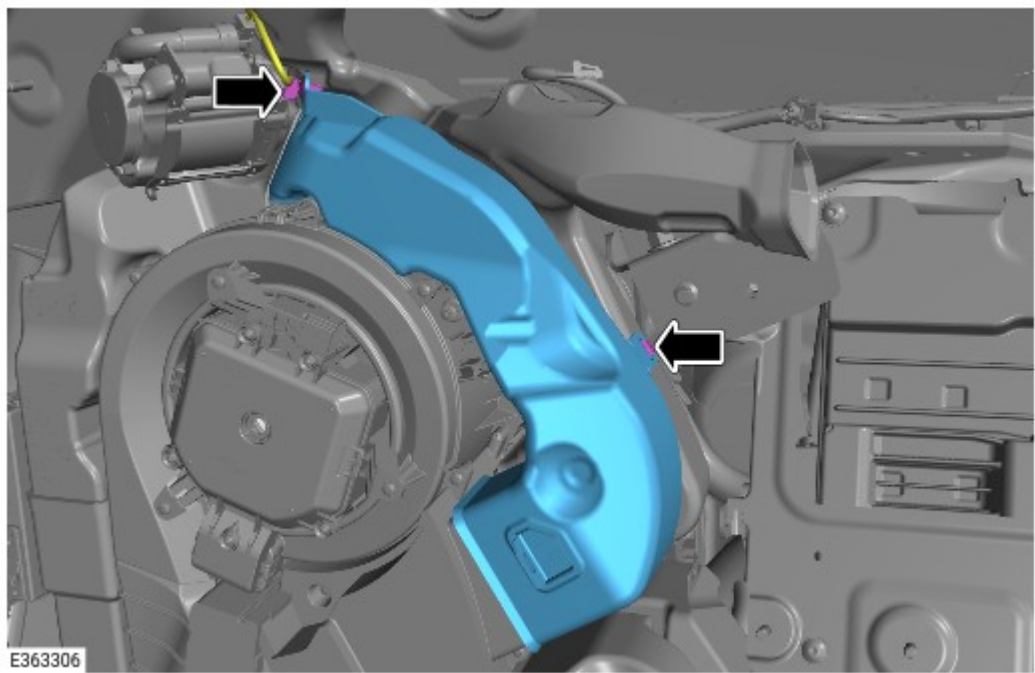
9.

Install the right air duct 1 section 1.

- Install the clip.
- Install the wiring harness clip.

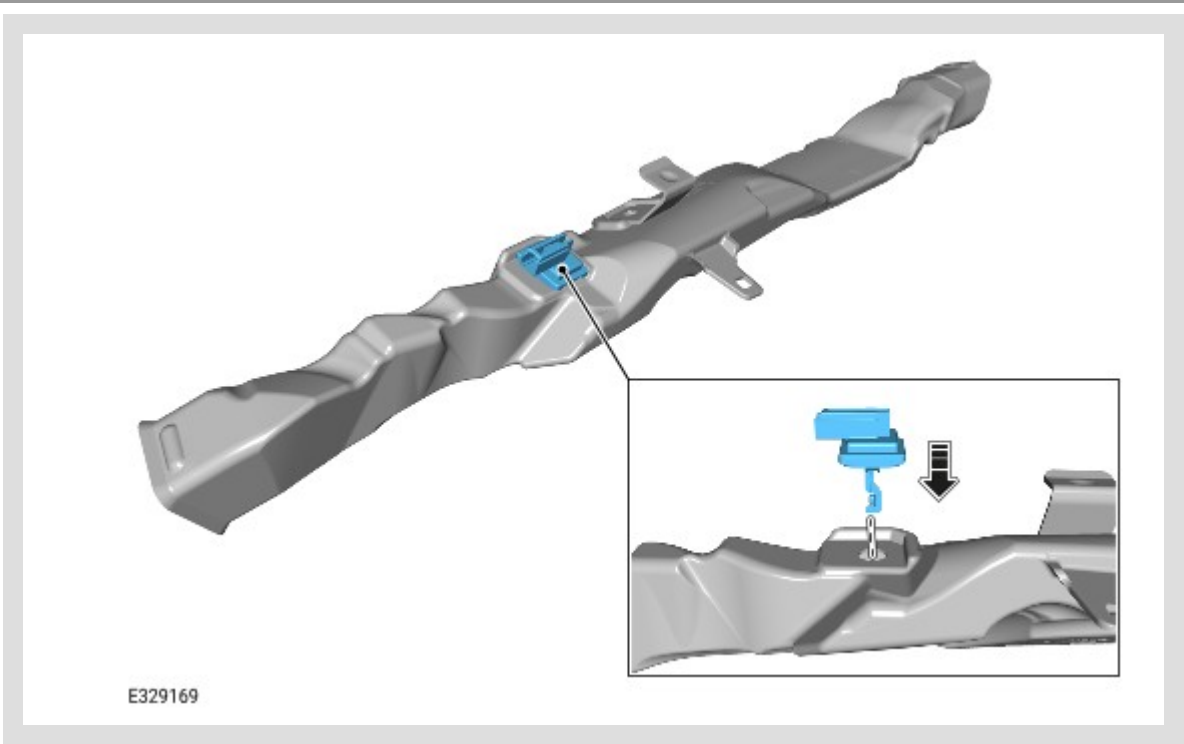
10.

Install the air temperature sensor into the air duct in the position shown in the illustration.

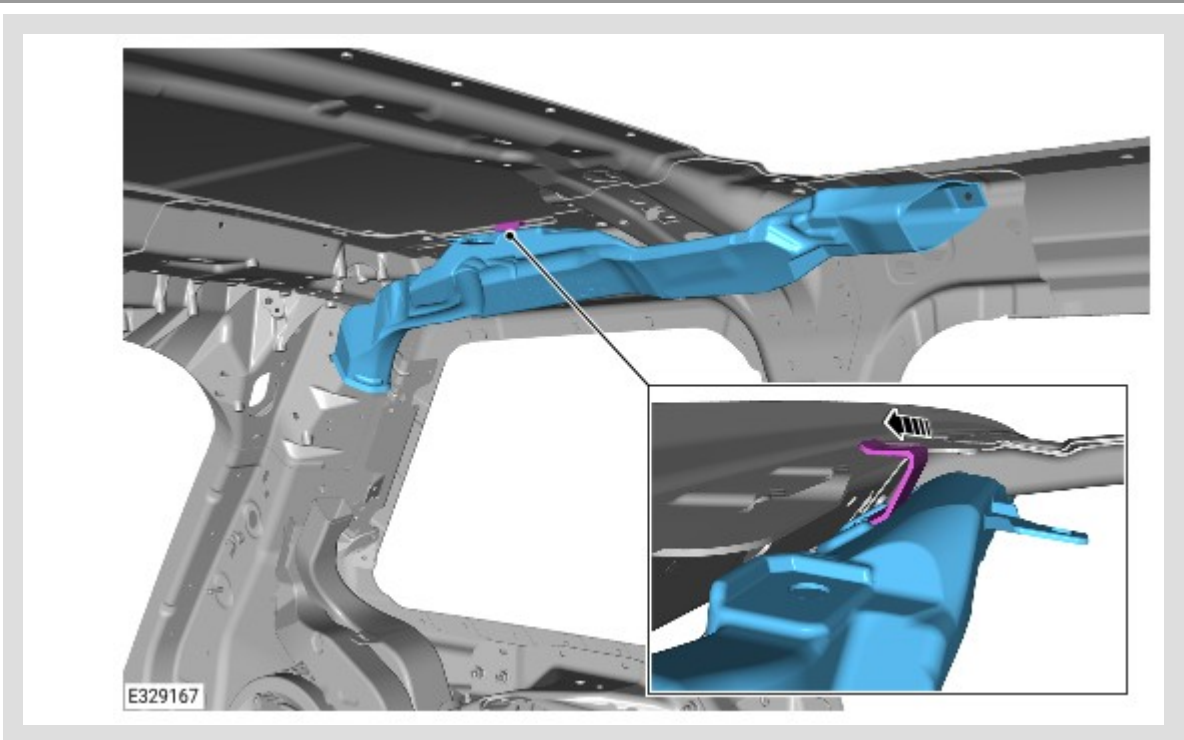
11.

Install the air duct.

- Secure the retaining tab.

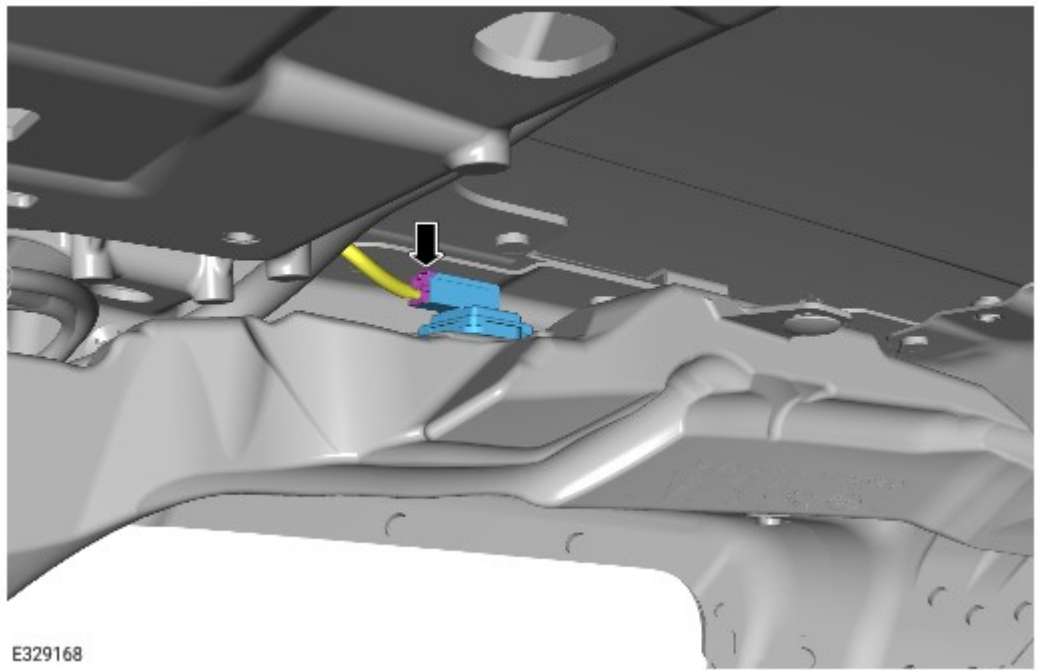
12.

Connect the air temperature sensor electrical connector.

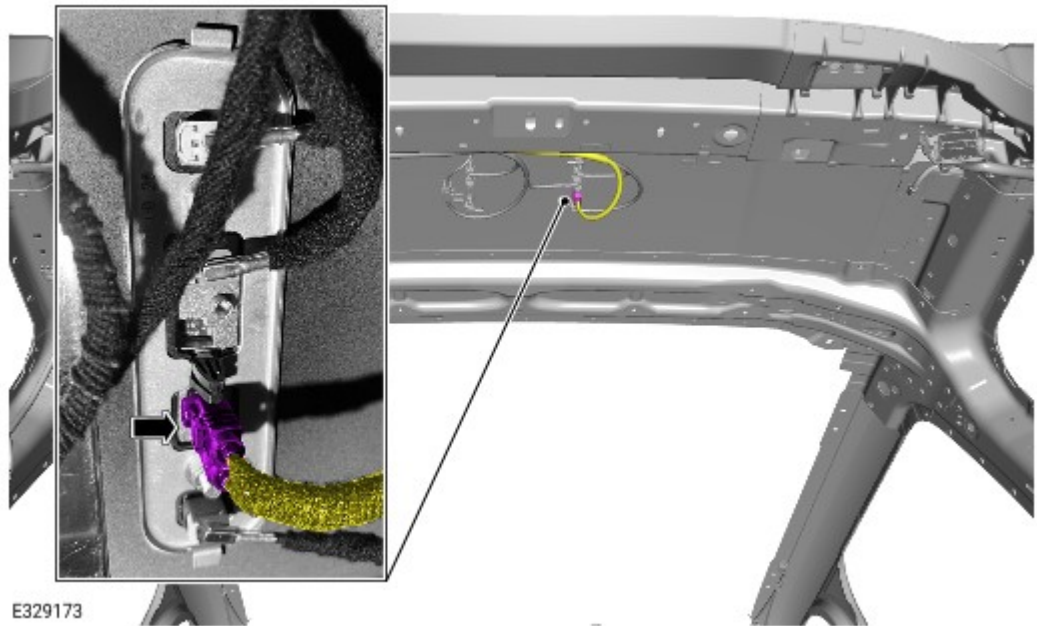
13.

Disconnect the electrical connector from the right roof pod.

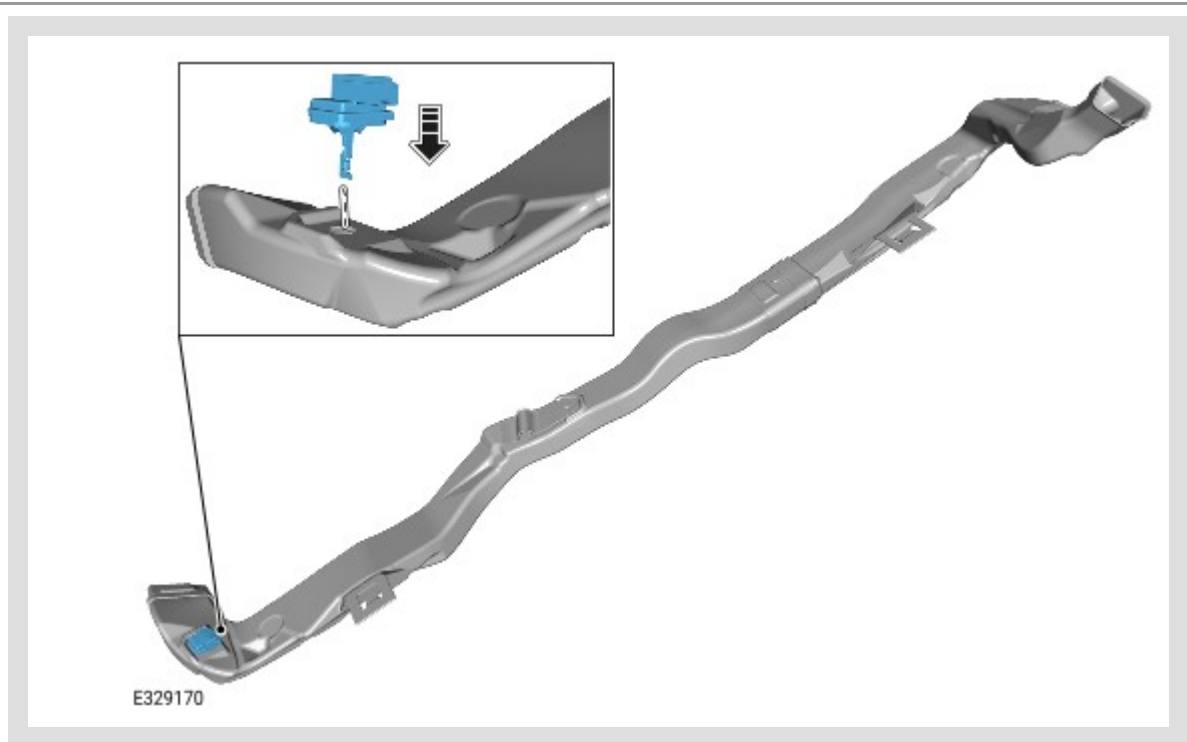
14.

Install the air temperature sensor into the air duct in the position shown in the illustration.

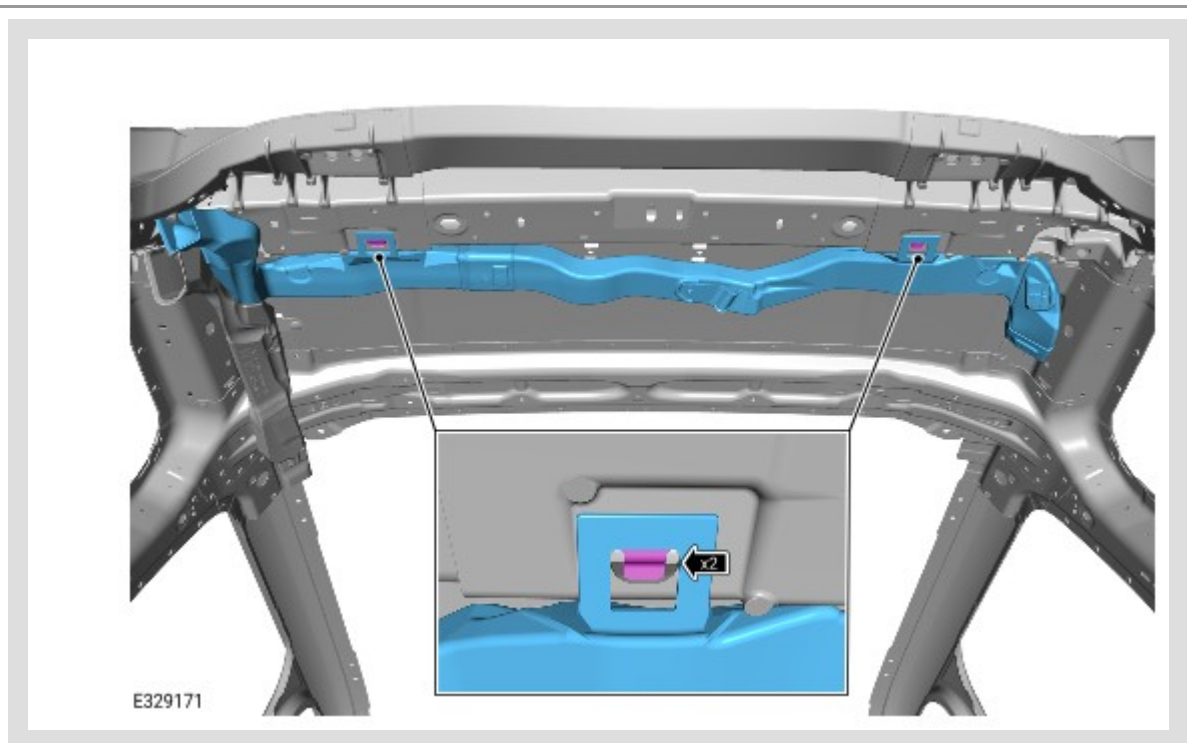
15.

Install the air duct.

- Secure the 2 tabs.

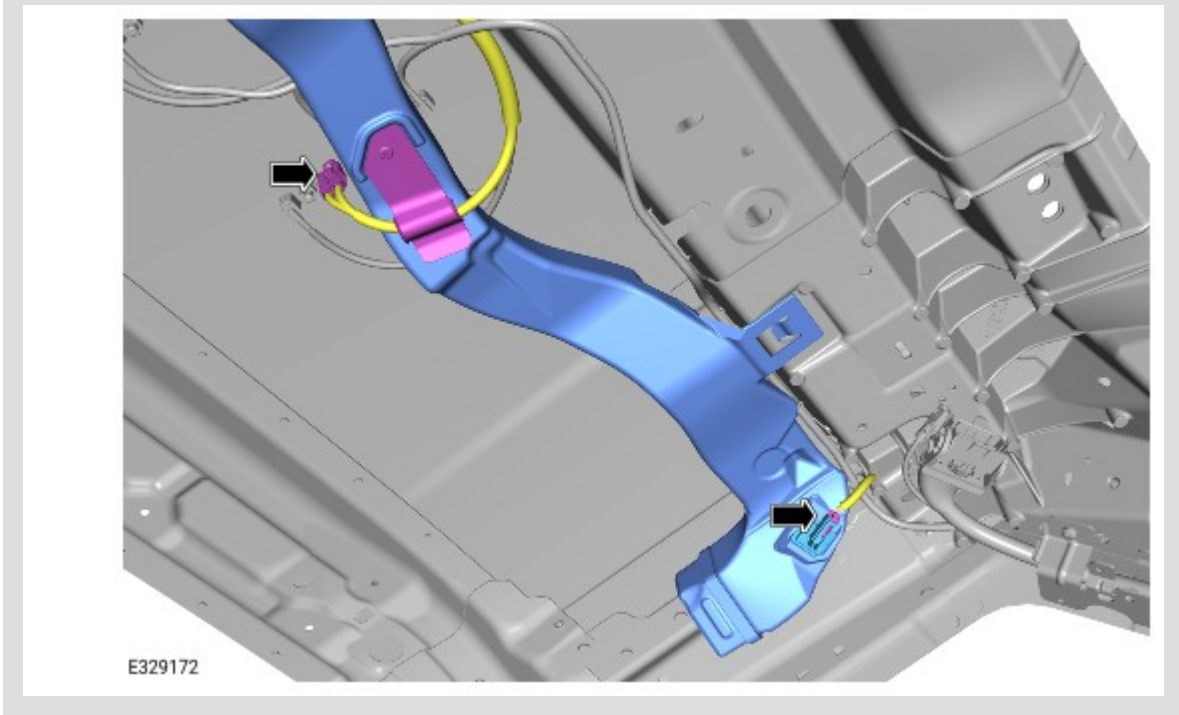
16.

Position the left roof pod wiring harness as shown in the illustration and connect the electrical connector.

- Connect the air temperature sensor electrical connector.

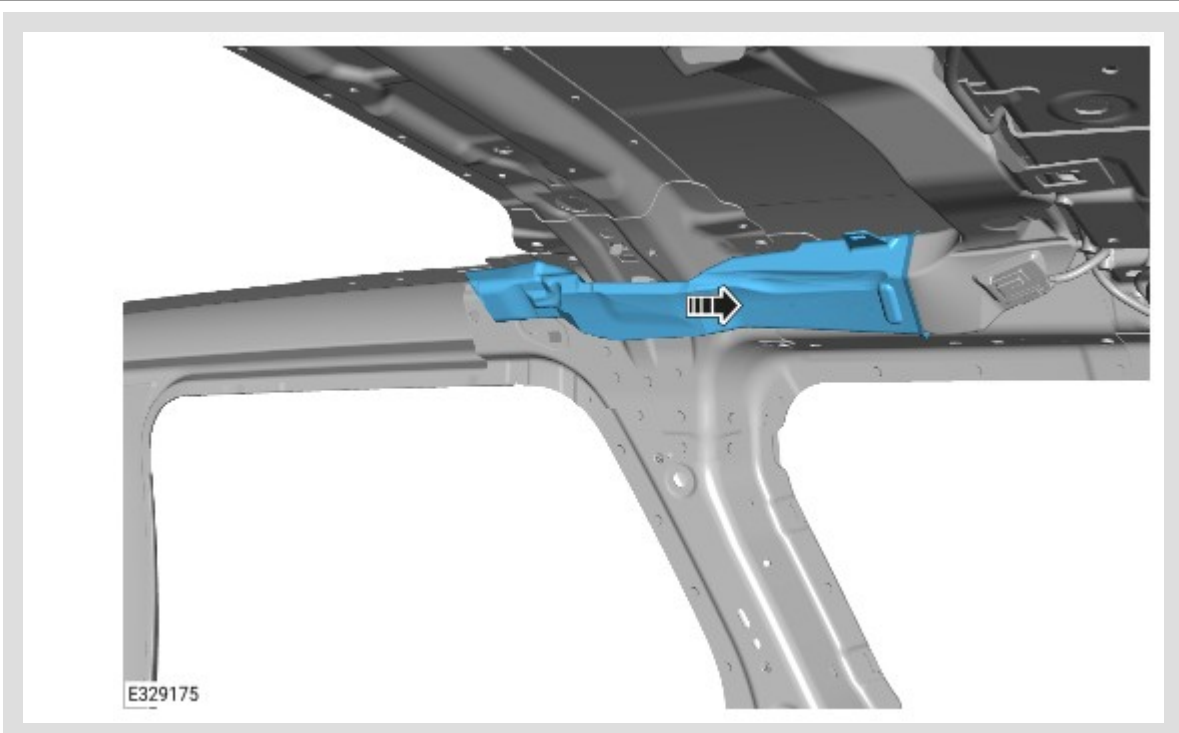
17.

Install the duct.

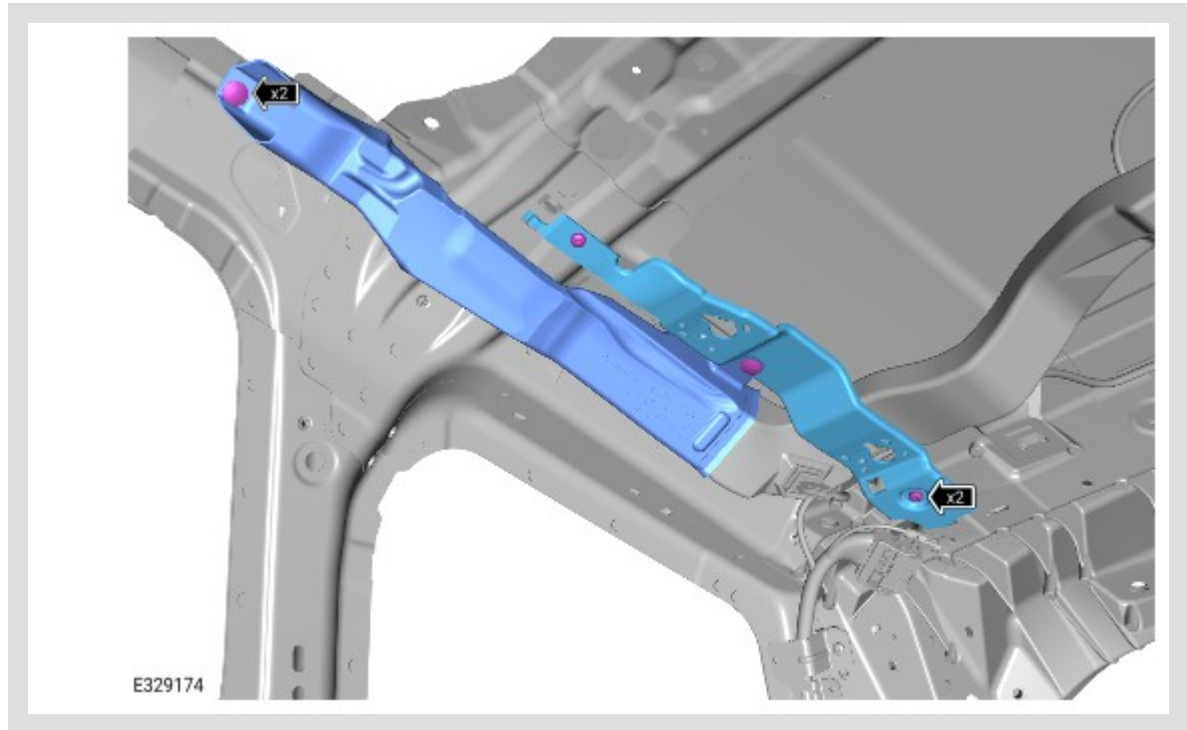
18.

Make sure the air duct retaining tab is located under the right cargo net bracket, as shown in the illustration.

Install the right cargo net bracket.

- Install the 2 bolts.
 - Torque: **6 Nm**
- Install the 2 trim clips.

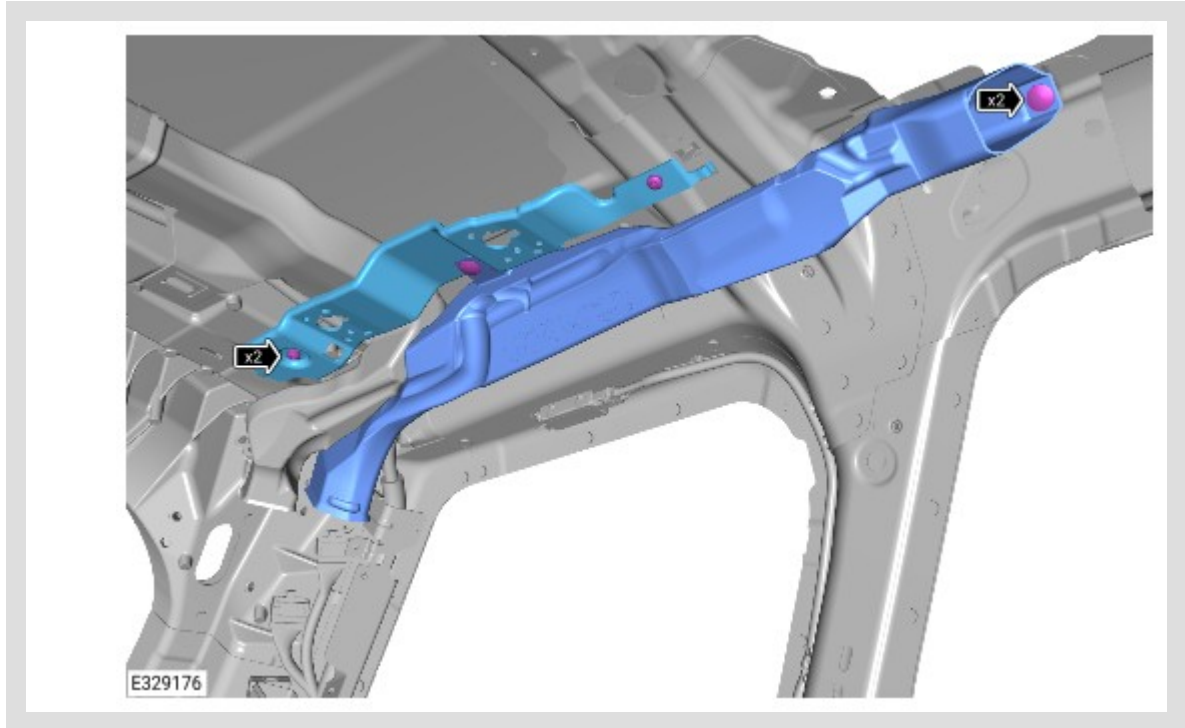
Make sure the air duct retaining tab is located under the left cargo net bracket, as shown in the illustration.

Install the left cargo net bracket.

- Install the 2 bolts.
 - Torque: **6 Nm**
- Install the 2 trim clips.

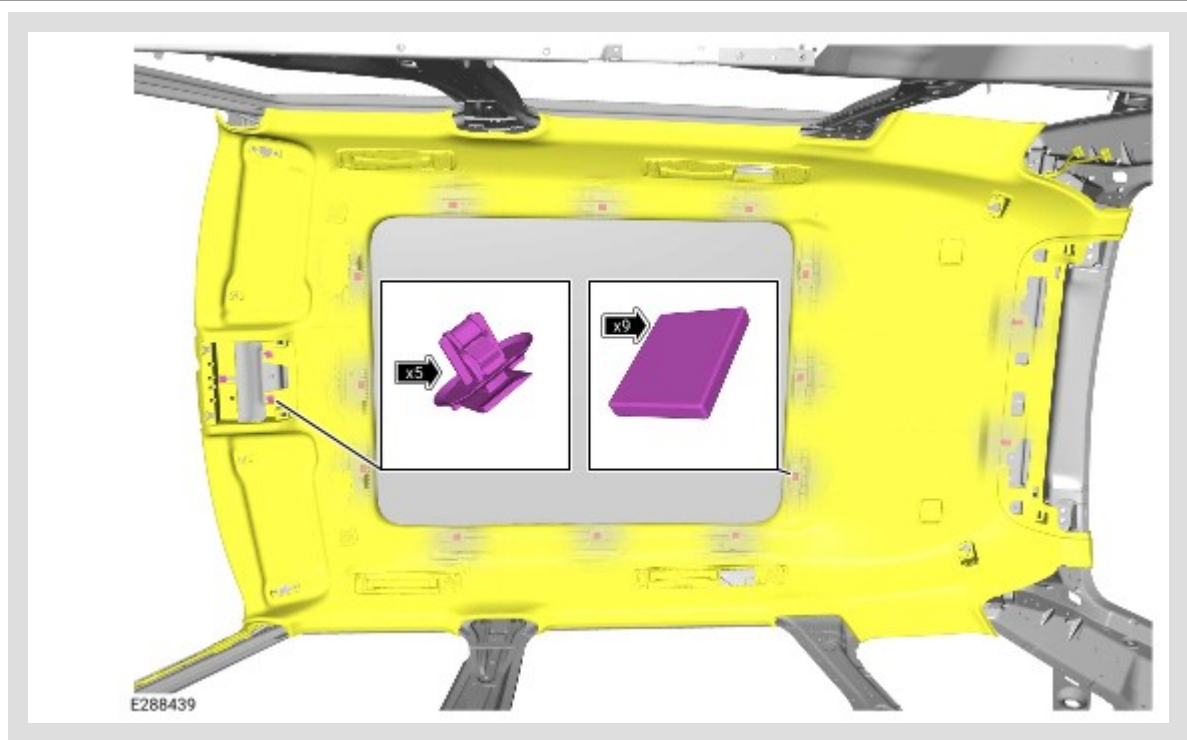
20.

Raise the headliner.

- Secure the 5 clips.
- Secure the 9 magnets.

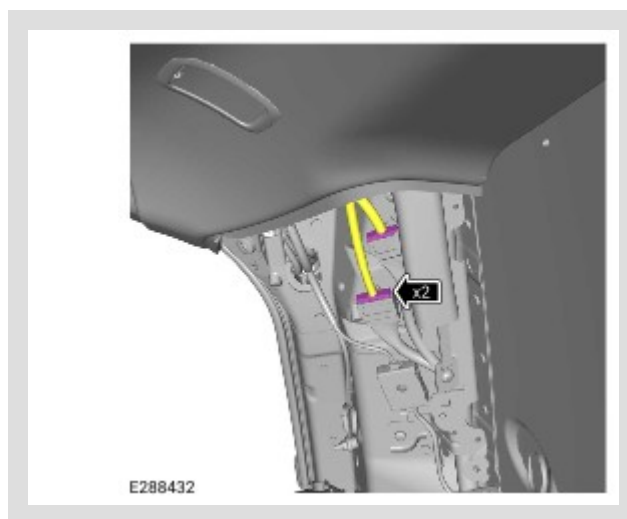
21.

Connect the 2 headliner harness electrical connectors.

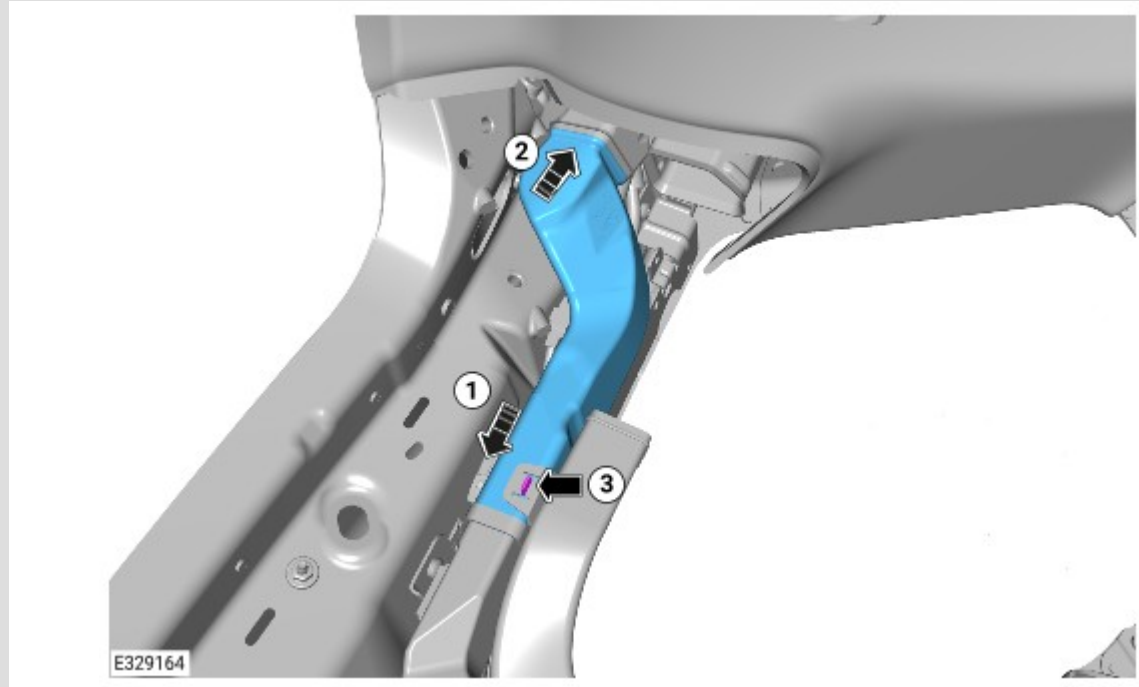
22.

Install the duct in the order shown in the illustration.

- Install the tab.

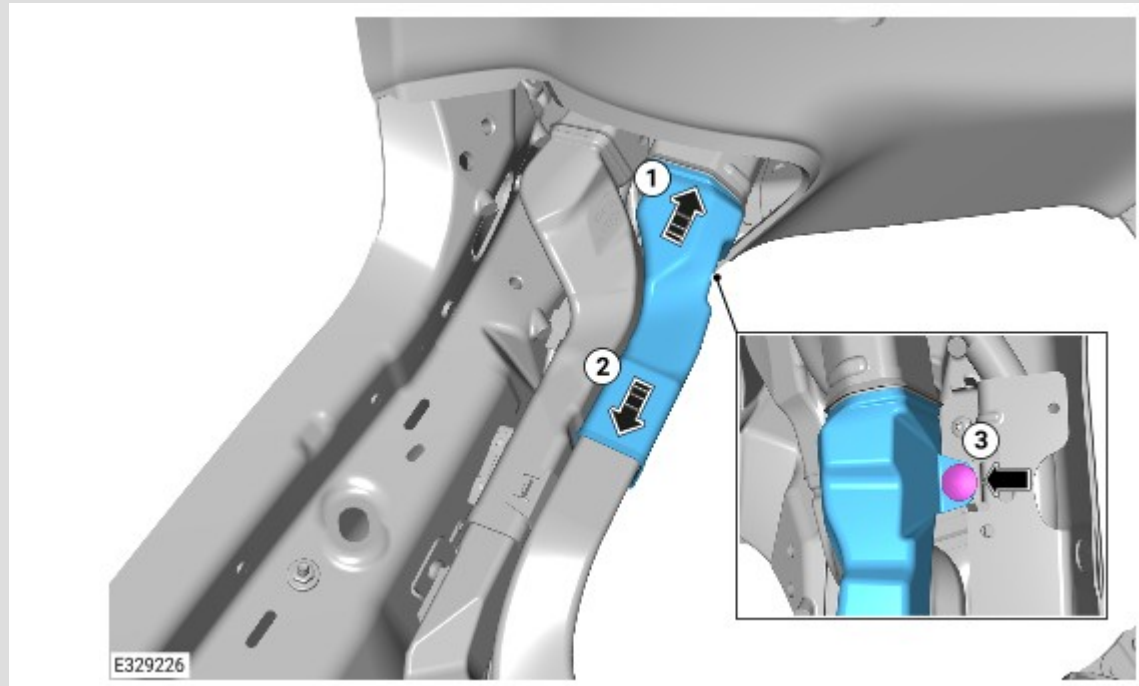
23.

Install the duct in the order shown in the illustration.

- Install the trim clip.

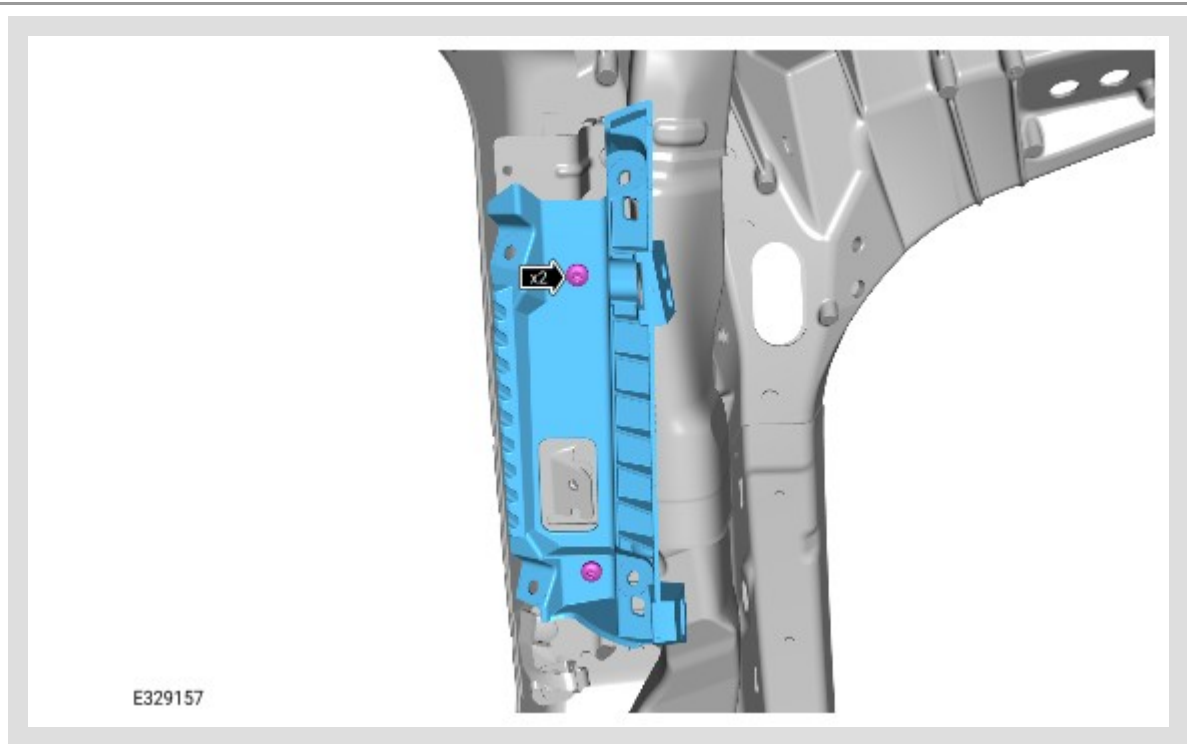
Install the D-pillar trim panel mounting bracket.

- Install the 2 bolts.
 - Torque: **4.8 Nm**

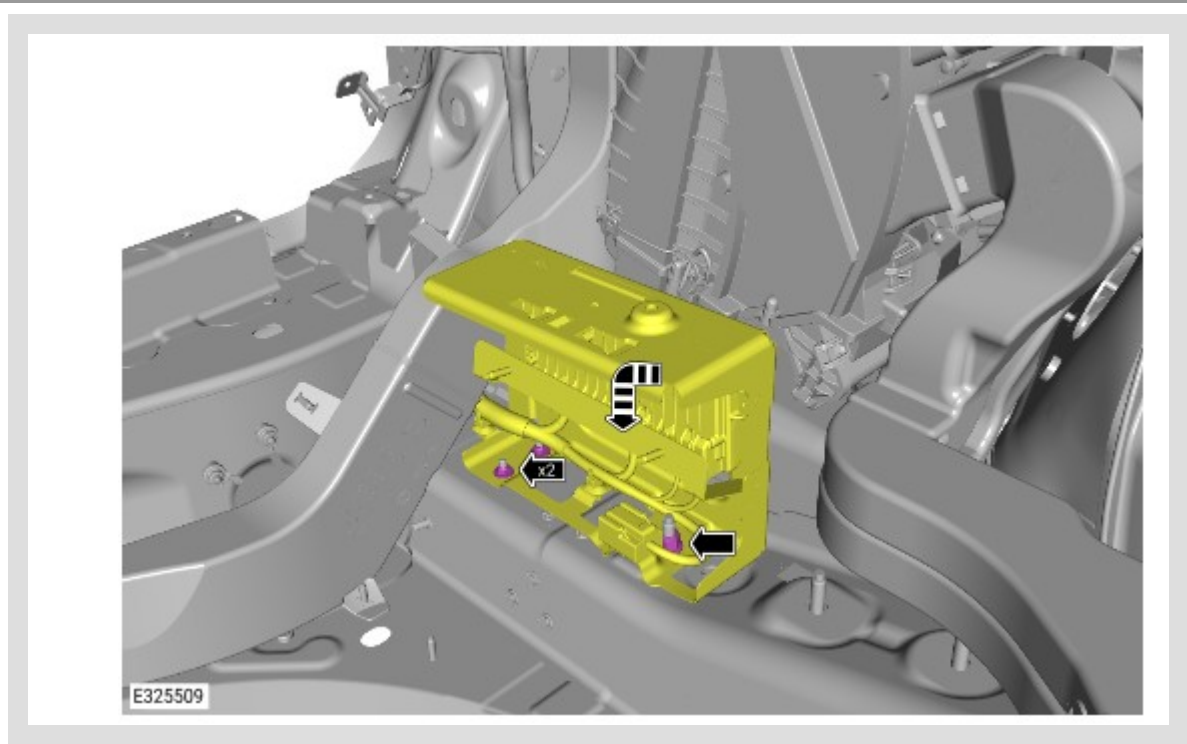
Install the module housing bracket.

- Install the 2 nuts.
 - Torque: **5.4 Nm**
- Install the nut.
 - Torque: **48 Nm**

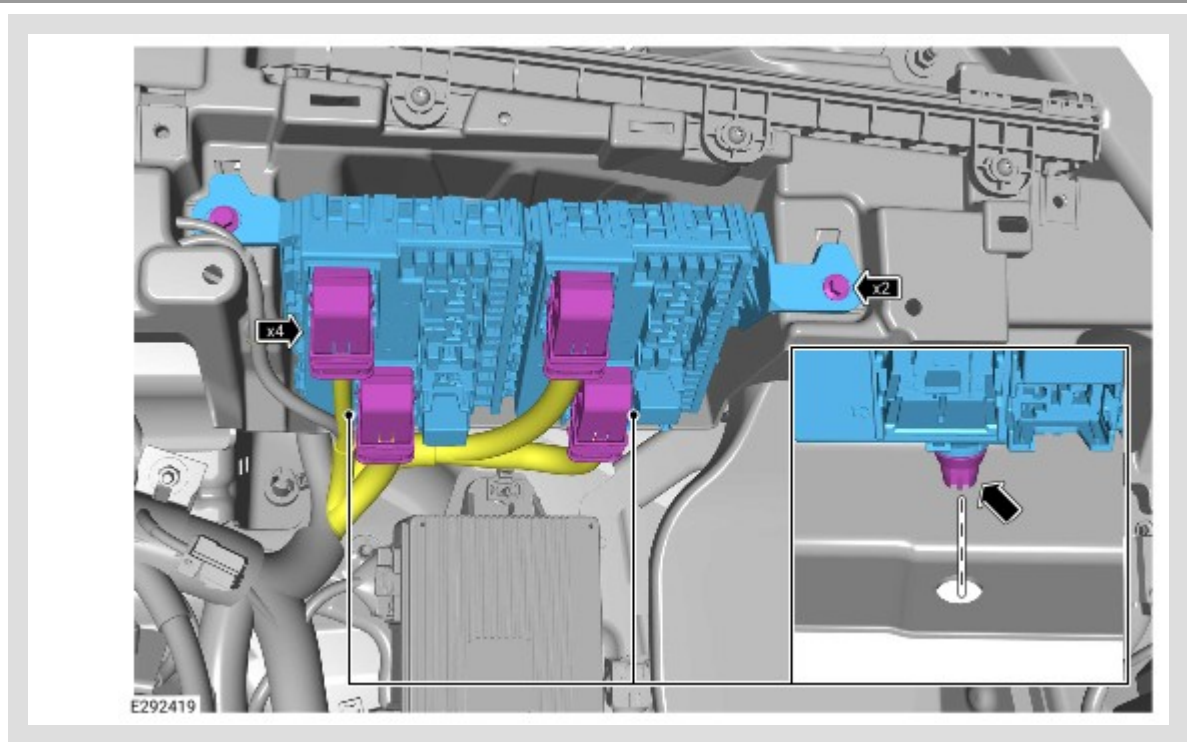
Install the rear right junction box assembly.

- Connect the 4 electrical connectors.
- Install the 2 bolts.
 - Torque: **6 Nm**

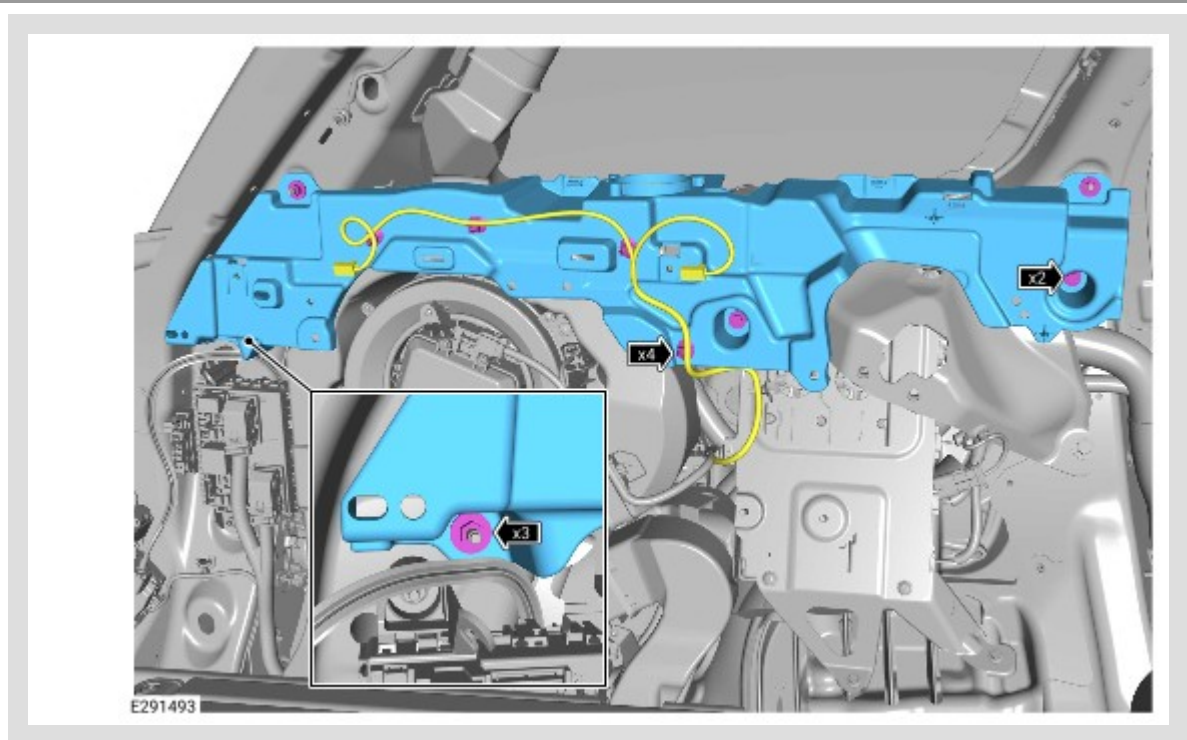
27.

Install the left upper loadspace side bracket.

- Install the 4 wiring harness clips.
- Install the 2 bolts.
 - Torque: **5 Nm**
- Install the 3 nuts.
 - Torque: **5 Nm**

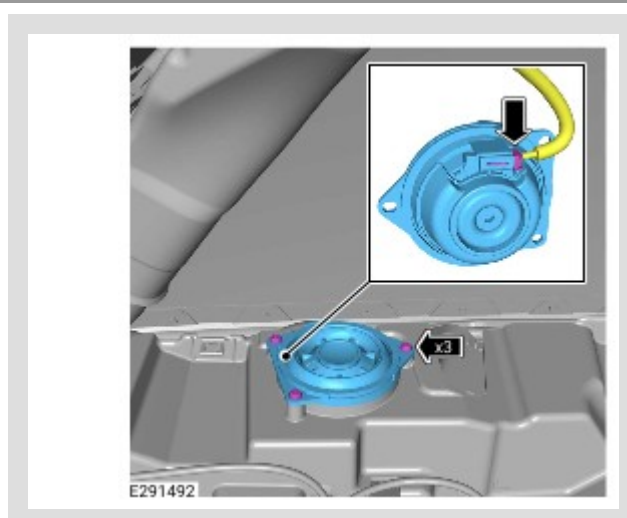
28.

Install the left loadspace speaker.

- Connect the electrical connector.
- Install the loadspace speaker.
- Install the 3 screws.
 - Torque: **1.9 Nm**

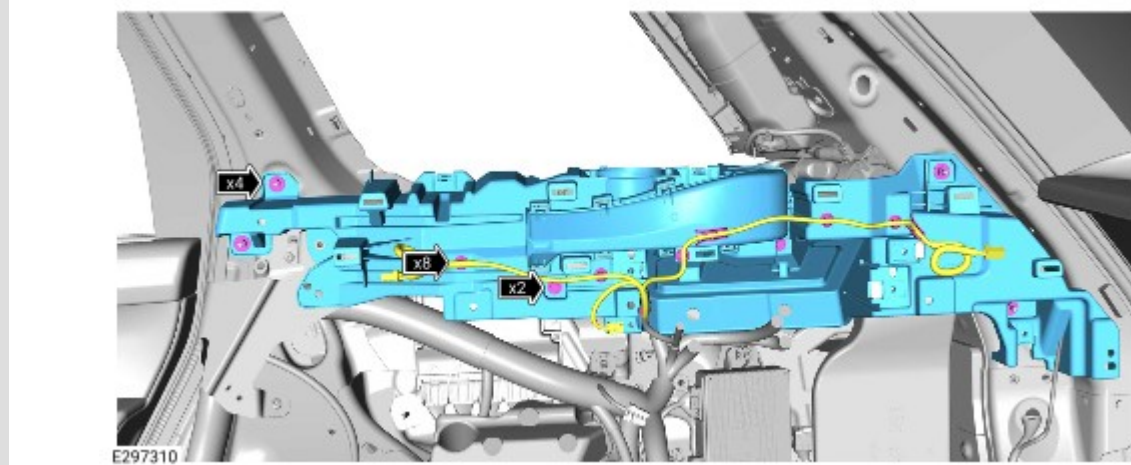
31.

Install the right upper loadspace side bracket.

- Install the 8 wiring harness clips.
- Install the 2 bolts.
 - Torque: **5 Nm**
- Install the 4 nuts.
 - Torque: **5 Nm**

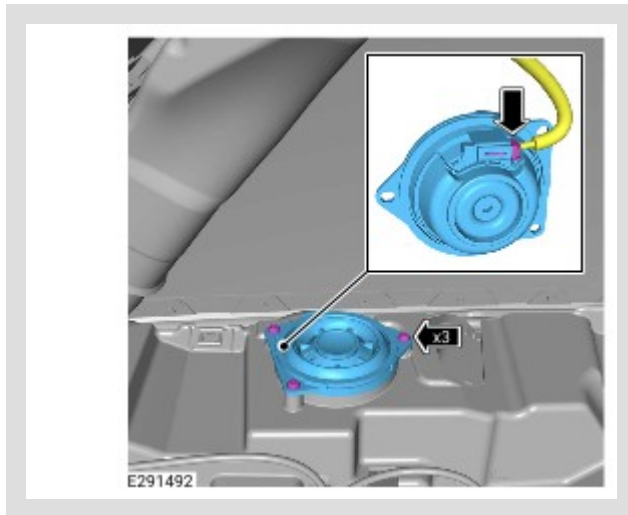
32.

Left side is shown, right side is similar.

Install the right loadspace speaker.

- Connect the electrical connector.
- Install the loadspace speaker.
- Install the 3 screws.
 - Torque: **1.9 Nm**
