STAR ONLINE PUBLICATION

Case Number: S2408000090

Symptom/Vehicle Issue: Passenger Mirror Inoperative

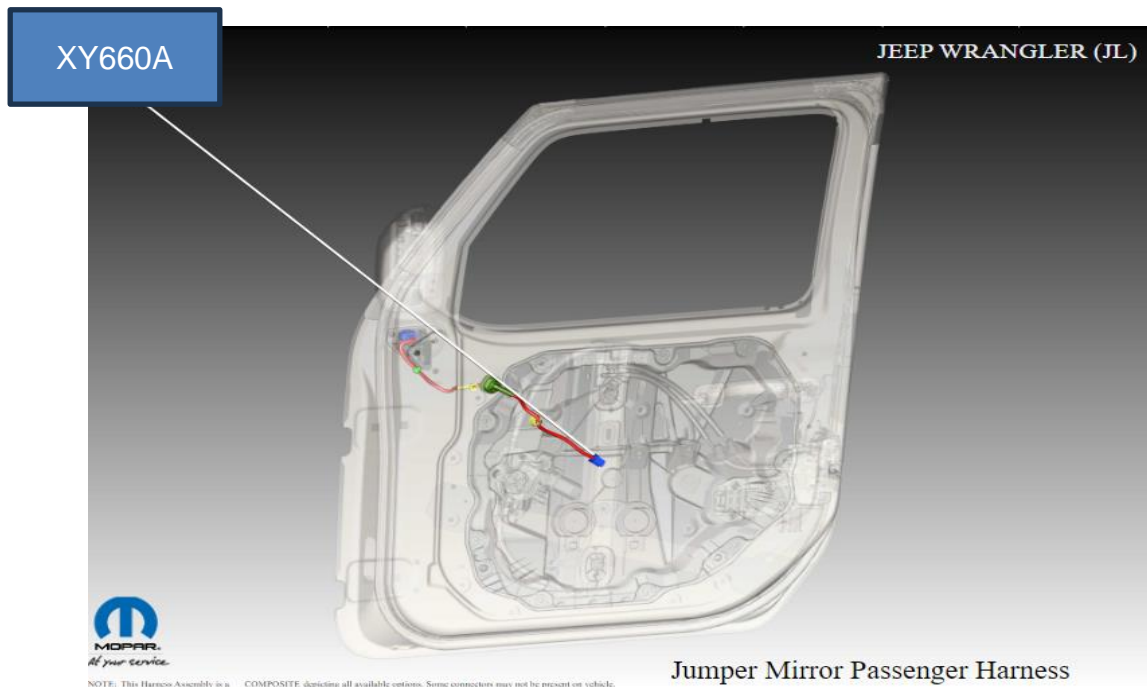
Discussion: Inspect the passenger door connector XY660A grey 10-way connector for a loose or pushed out terminal. Secure the connector using the push-pull-push method, no parts required.
