STAR ONLINE PUBLICATION

Case Number: S2423000036

Symptom/Vehicle Issue: Third Row Upper Seat Back Handle Inoperative And Or Cables Disconnected.

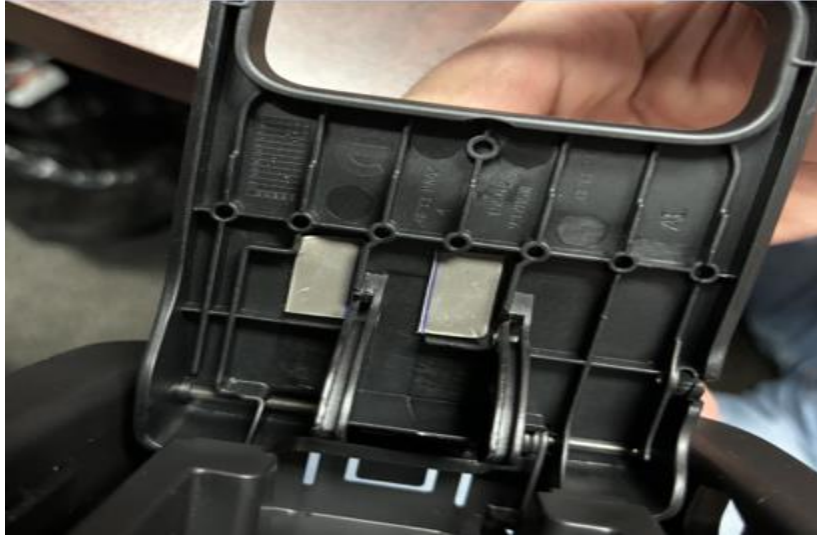
<<<Note>>> The foam is to be applied on the cable barrel insertion side of the handle as shown below.

3rd Row Seat Back Release Handle

Discussion: Obtain MOPAR 05019058AA foam tape. Cut 2 pieces 120mm x 110mm. Install the cables in the handle in their proper location. Apply the cut foam pieces as shown in Fig 1.

Verify proper seat release function prior to returning the vehicle to the owner.
