STAR ONLINE PUBLICATION

Case Number: S2423000038

Symptom/Vehicle Issue: B1053-64 RFHM (KIN COMMUNICATION) - SIGNAL PLAUSIBILITY FAILURE. Vehicle May Not Start.

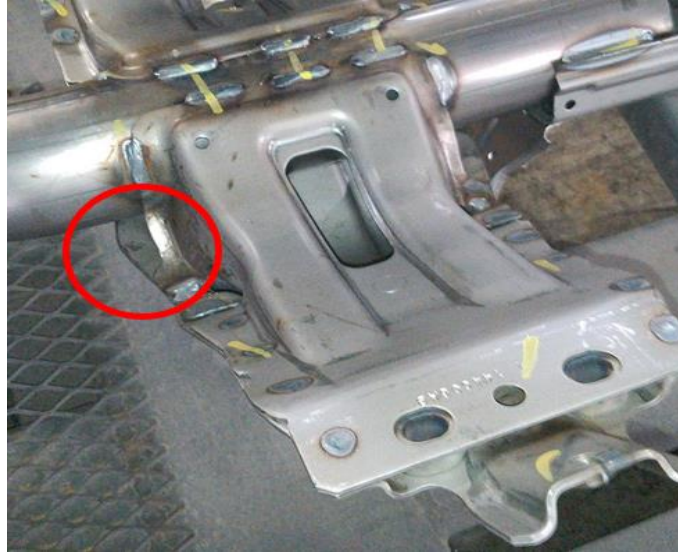
Discussion: In addition to following published diagnostics for the B1053-64 DTC, inspect the instrument panel (IP) harness in the location shown below for wiring damage. The area to be inspected is the steering column support bracket inboard side where the KIN D2664A connected is located. See images below.

Fig 2.
Area to inspect for wire chaffing. Note harness is not present.

If the KIN harness is found to have damage at the IP cross car beam, the sharp edge on the beam will need to be filed down and a wiring repair will be necessary. Mopar connector kit 05183472AA is available if the wire(s) cannot be easily repaired with solder splice and heat shrink repair method. Refer to Service Library 29 - Non-DTC Diagnostics / Circuit Testing Procedures / Standard Procedure WIRE SPLICING for the approved wire repair procedure. Refer to the connector repair kits link in Star Parts for connector repair kits, wiring repair parts, tools, band splices, heat shrink, convolute tubing and connectors.

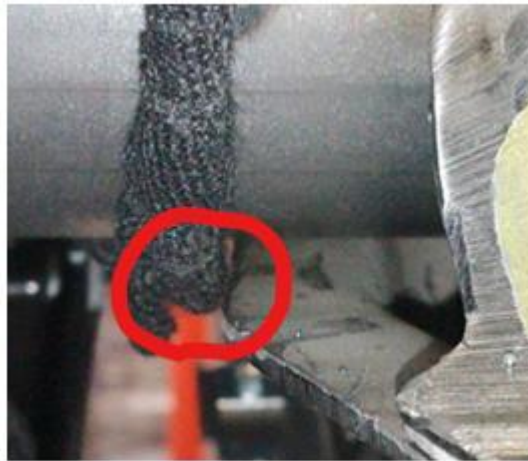
Fig 3.
Chaffing of KIN harness
