| GROUP | MODEL |
|---|--|
| Voluntary Service<br>Campaign | 2014-2017MY<br>Forte & Forte Koup (YD) |
| SC238 <u>A</u> | August 2024 |

# BRAKE TUBE/LINE REINSPECTION/REPLACEMENT & ANTI-CORROSION MATERIAL REAPPLICATION (SC238A)

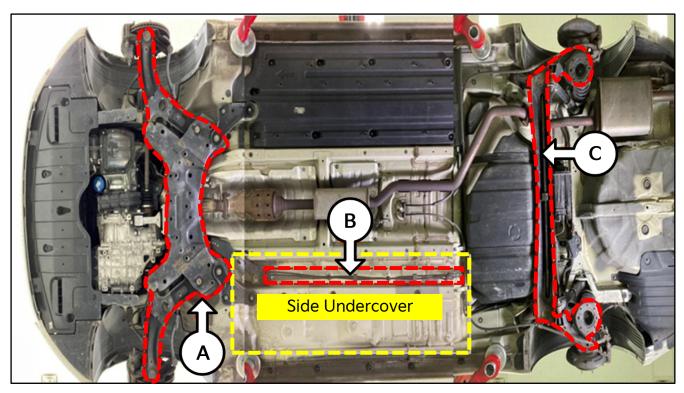
### Affected Areas for Application of Anti-Corrosion Material

A: Sub Frame / Front Lower Arms

B: Fuel / Brake Tube

C: Torsion Axle Complete

Other: Two-way Brake Tube Connector / Flexible Brake Hose / Fuel Tank Band / Parking Cable Bracket

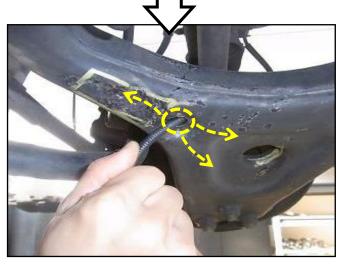
7. Rotate the camera in order to check all angles for proper wax application inside the inspected components, and to obtain your images that will be used for warranty claim submission.
