# VOLVO

## Technical Journal

| Technical Journal Title<br>Incorrect fuel level or tank capacity | | Ref. No.<br>TJ 36647.4.0 | |
| Function Description<br>Fuel tank | | Page<br>Page 1 of 3 | |

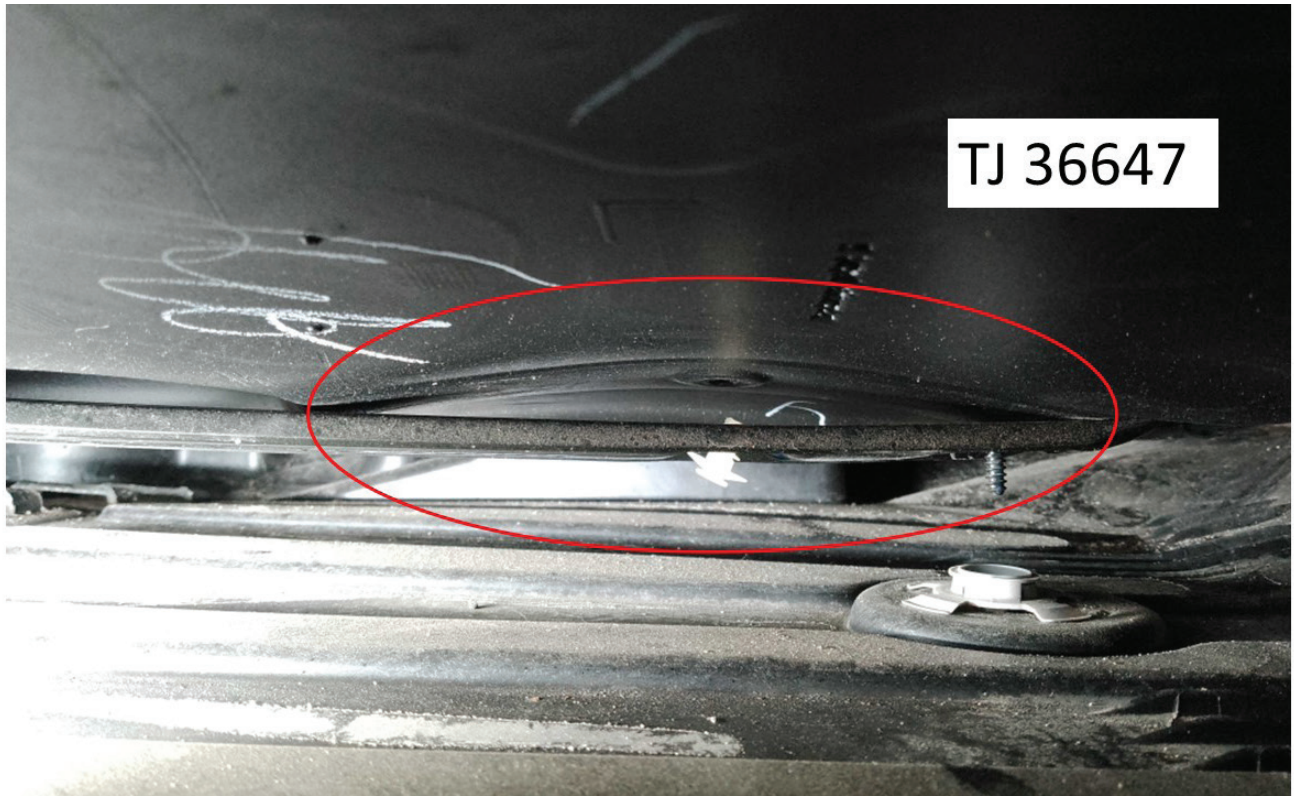
| File Name | File Size |
|---|---|
| TJ_36647_1.jpg | 0.1883 MB |

\*See attached document TJ\_36647\_1.jpg to confirm if the tank has been deformed as shown. If deformed, replace fuel tank and FTI (Fuel Tank Isolation) valve according to VIDA.
