| Technical Journal Title High Temperature Message in DIM after Coolant Pump Replacement | | Ref. No. TJ 36858.1.1 | |
| Function Description Cooling system | | Page Page 1 of 3 | |

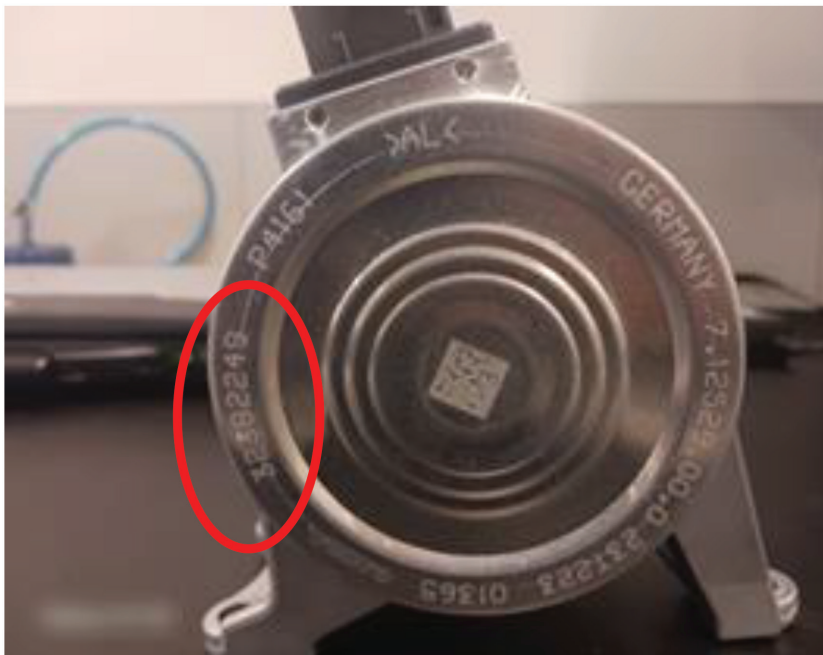
TJ 36858

If customer with a recently replaced coolant pump P/N 32382249 (P/N can be found according to attachment TJ_36858_1.pdf) complains about "high temperature" message in DIM with DTCs ECM-U040100 and ECM-P021700, follow advice under "Service".

* Replace the cooling pump per VIDA instructions.

Coolant pump PN 32441265 has modified internal programming that will prevent the overheating condition. Orders for the previous part number will supersede to this part automatically.
