| Technical Journal Title<br>Long Range PHEV ERAD Knocking Noise Repair Kit | | Ref. No.<br>TJ 36894.3.0 | |

If a customer notices a knocking noise from the ERAD during acceleration or deceleration at low speeds, please follow the advice under "Service."

TJ Instruction VCC-528981-1

| <b>Title</b> | ERAD bearing | <b>Page</b> | 1 ( 7 ) |

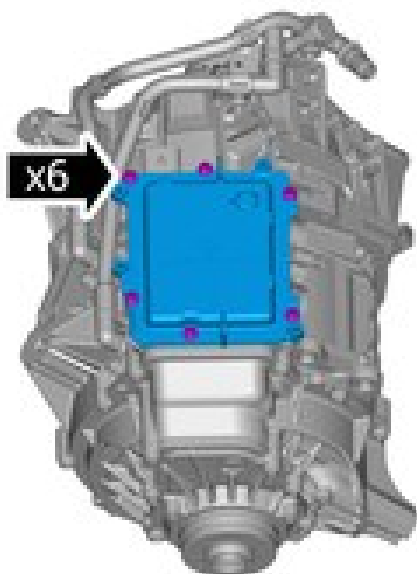
Remove the screws.

Remove the marked part.

High voltage wiring harness lid, ERAD ,  
9 Nm

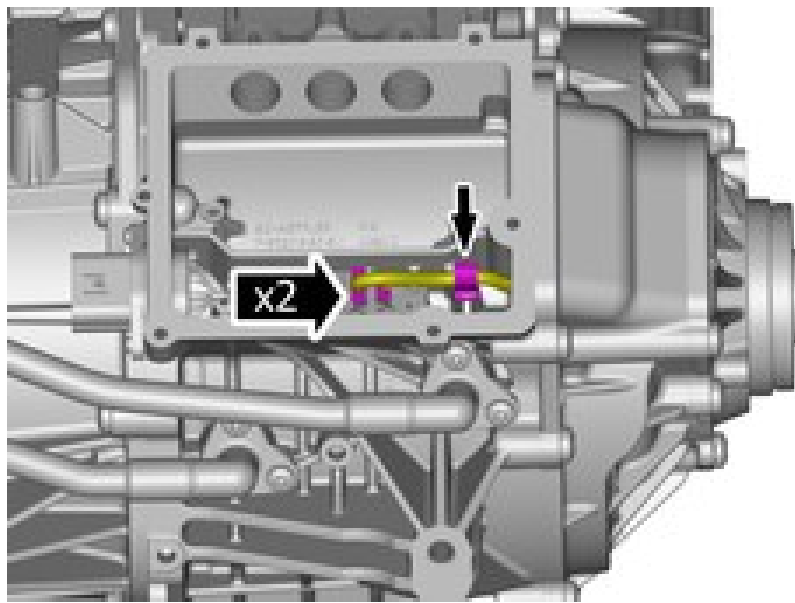
Disconnect the connectors.  
Loosen the fastener.

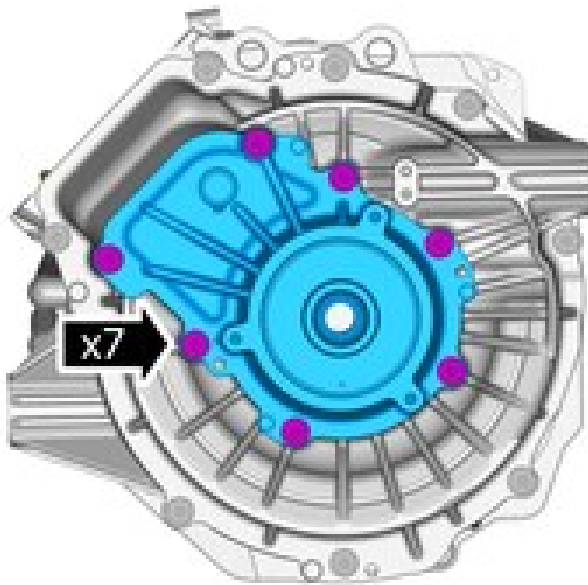
**Caution! Take extra care when handling the components.**

Remove the screws.  
Remove the marked parts.

Inner shaft lid screw, ERAD , 23 Nm

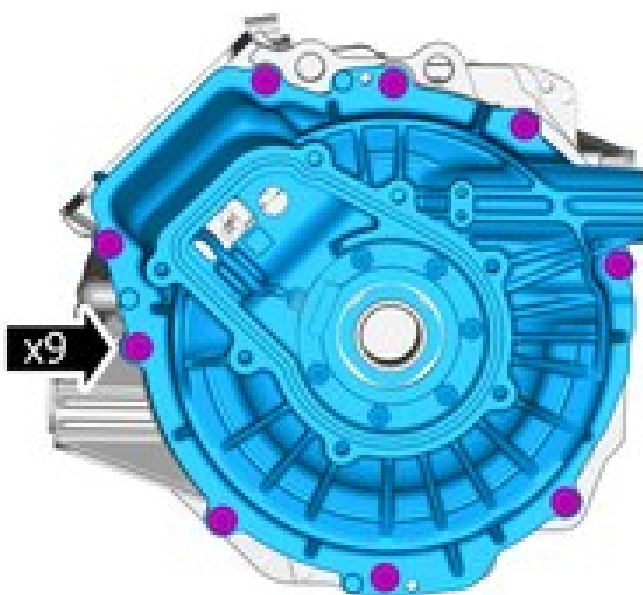
**Caution! Take extra care when handling the component.**

Remove the screws.

Remove the marked part.

Electric motor cover screw, ERAD , 23 Nm

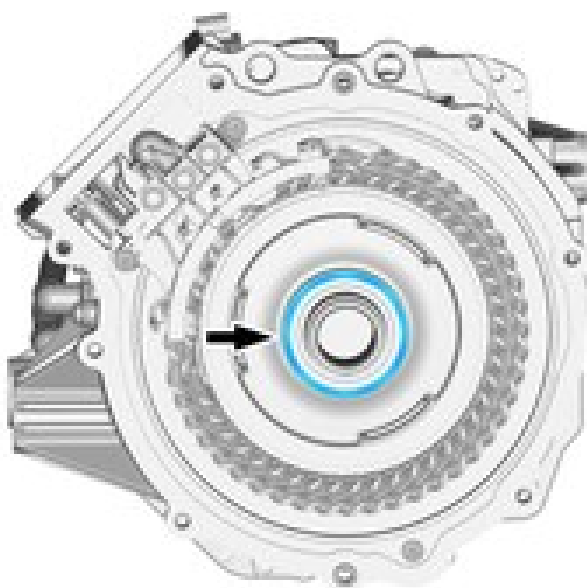
Remove the marked part.

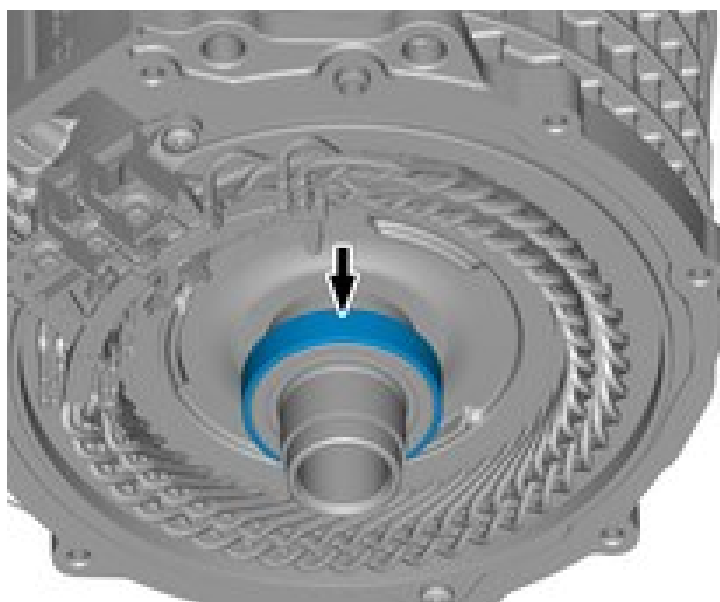
**Caution! Make sure that the surface is clean and free of foreign material.**

Clean the marked area.

**Use:** Abrasive cloth , 9511024

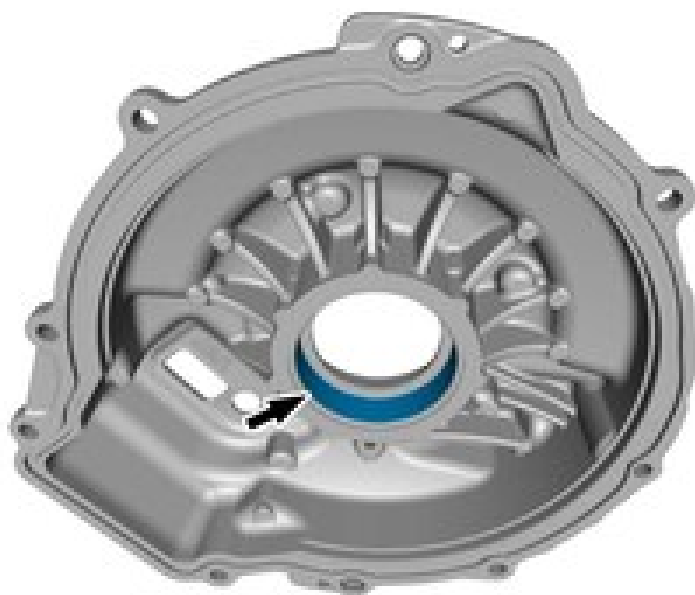
**Caution! Make sure that the surface is clean and free of foreign material.**

Clean the marked area.

**Use:** Abrasive cloth , 9511024

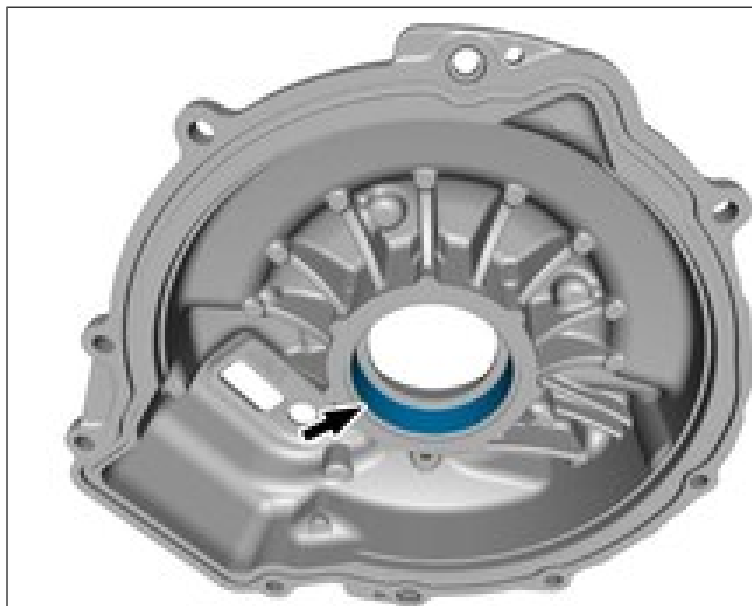
Apply grease on the area indicated.  
Apply a thin and even layer.

**Use:** Splines grease , 1161748

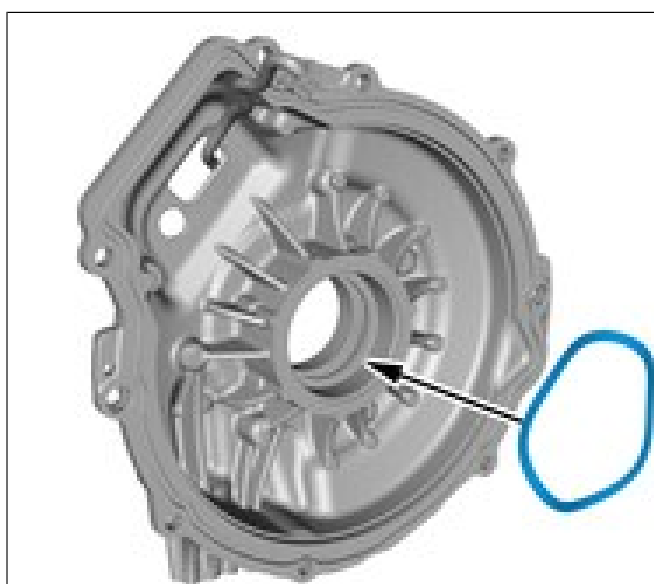
Install the marked component. (wave spring)

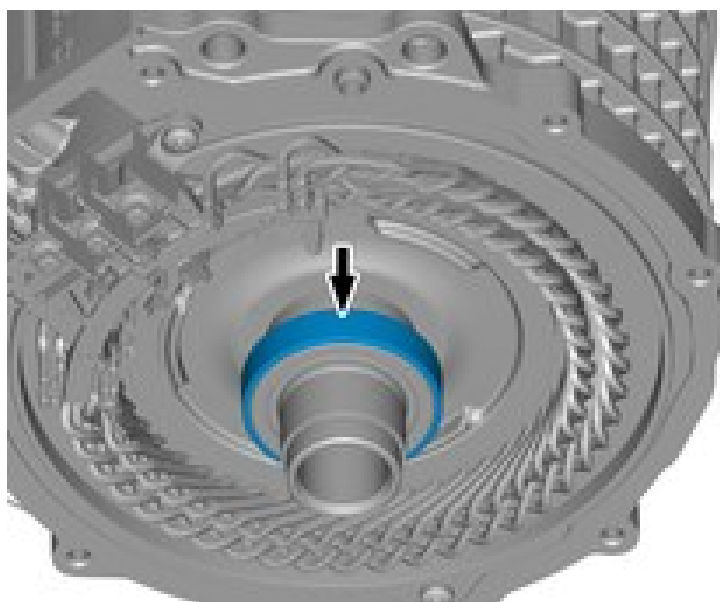
Apply grease on the area indicated.  
Apply a thin and even layer.

**Use:** Splines grease , 1161748
