Service Bulletin

Bulletin No.: 18-NA-306

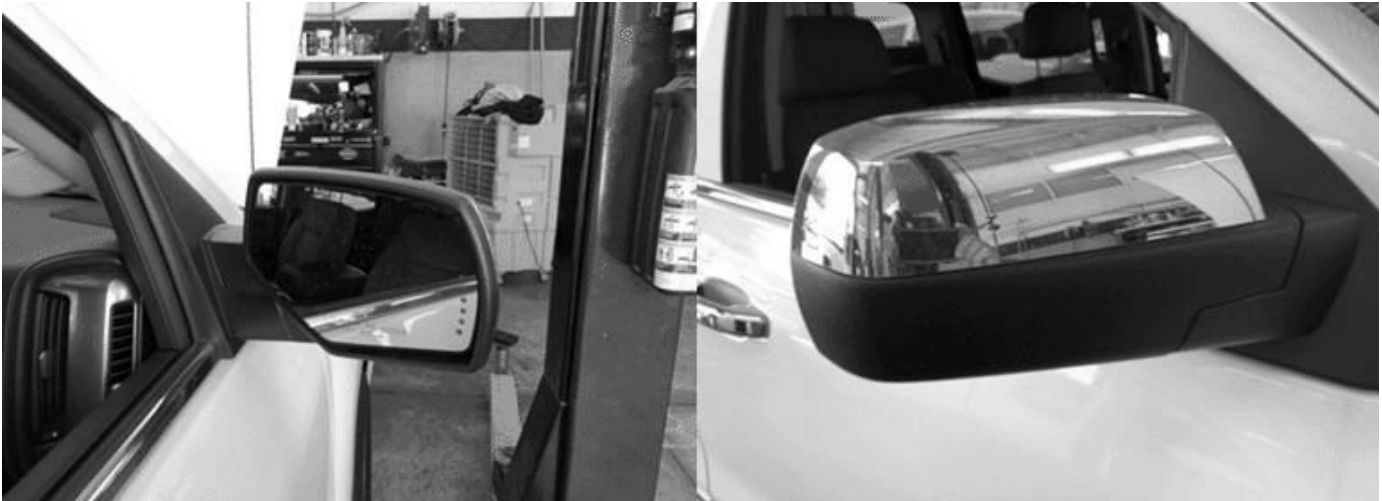
This pointed to where the concern was, which makes it easy to view and see the customer's concern.

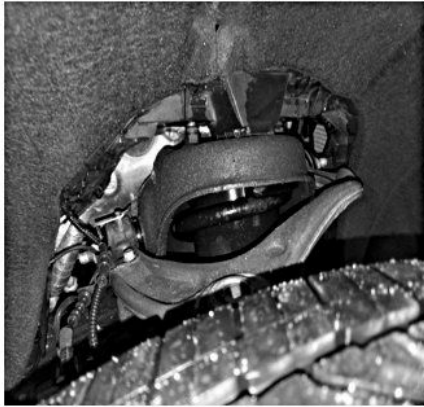
This dealer provided a close-up view of the front and back of the mirror. What is good about these photos is they are close enough for us to be able to determine if there is any type of impact damage on either side. Also, the mirrors are clean and the angle the photos are taken does not give a reflection that obstructs the view of the mirrors.

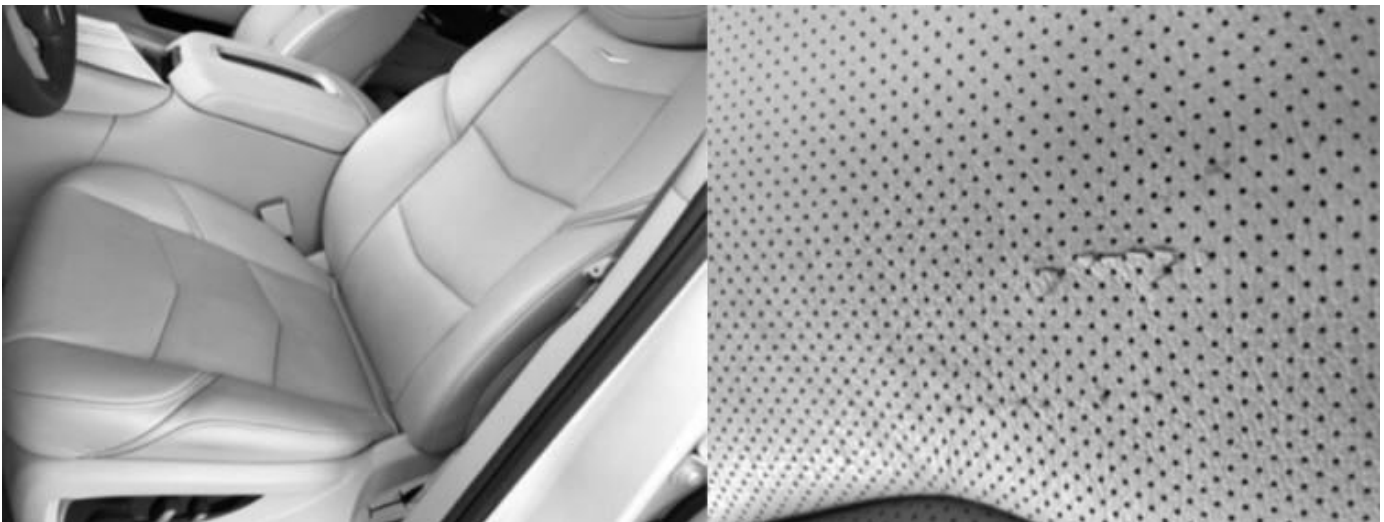
This dealer provided the correct images; however, those images are not labelled as required.

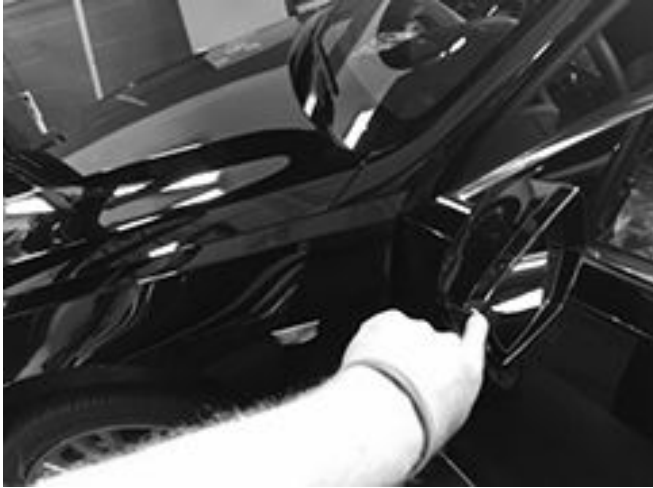
This dealer provided the full view of the seat and a close-up of the defect; however, we don't know where on the seat this concern is.

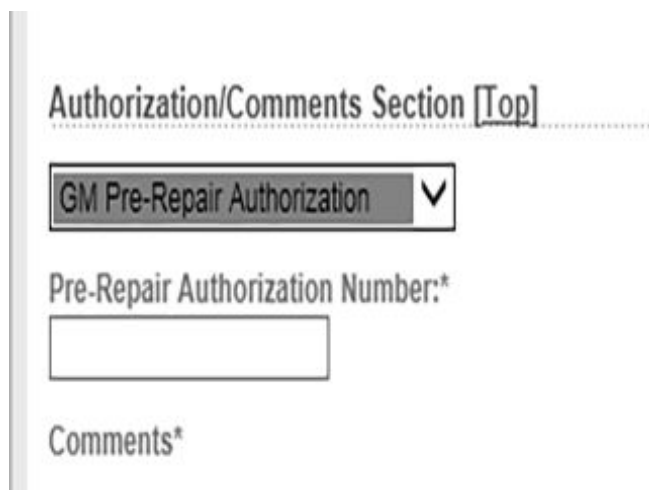
Processing Approved Pre-Authorizations through Global Warranty Management (GWM)
