Service Bulletin

GL1800 #26
Revised August 2024

2009 ~ 2017 GL1800 GOLD WING TIRE PRESSURE MONITORING SYSTEM (TPMS) REPLACEMENT

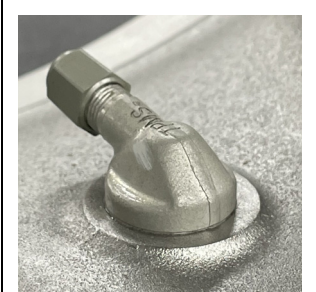
To easily identify if a unit already has the new supplier parts installed, refer to the images below.

Original TPMS
Sensor/Valve
