# Service Bulletin

Bulletin No.: 24-NA-147

**Subject: Information on Seat Belt Lap Anchor Inspection**

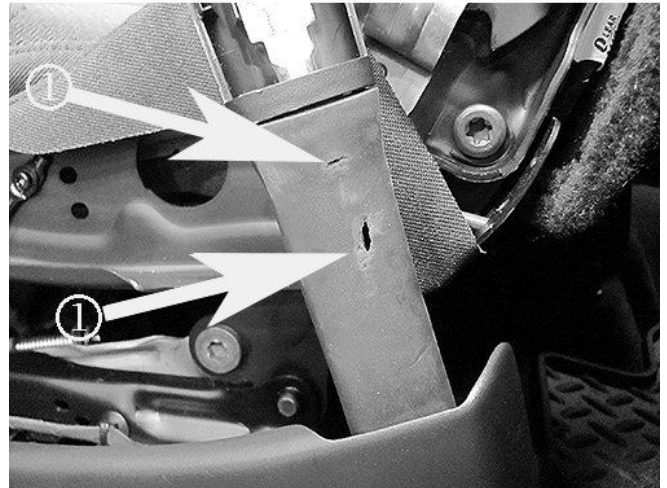
6693387

## Examples of Varying Damage

**Important:** Damage can vary by seatbelt type.

If at any time, wear or damage is found during the Safety System Check, we suggest that the seatbelt component be replaced. Follow the Service Information repair procedure for the year, make and model of the customer car.
