VOLUNTARY RECALL CAMPAIGN

Classification: RS23-003D	Reference: NTB23-080D	Date: July 8, 2024
------------------------------	--------------------------	-----------------------

VOLUNTARY SAFETY RECALL CAMPAIGN 2004-2012 ARMADA, TITAN, AND 2004-2009 QUEST; DRIVER AIR BAG COVER

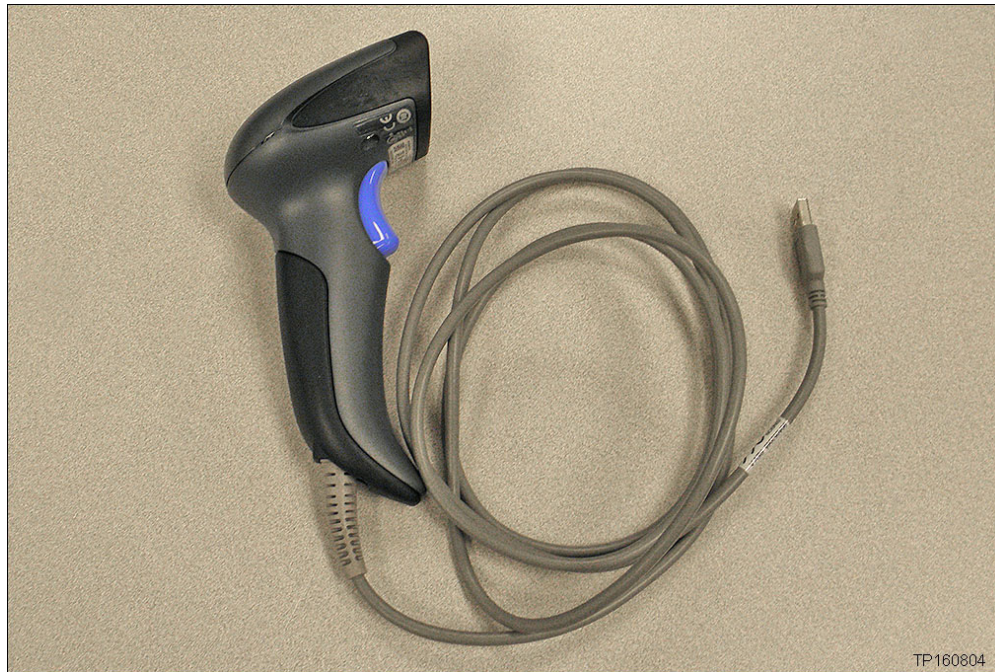
Figure 1

Quick Scan Tool (J-52352)

- Each dealer has been previously shipped one Quick Scan Tool (J-52352).

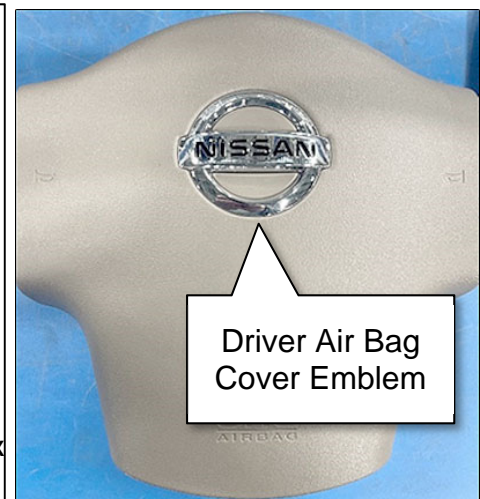
Figure 6

- If the serial number result is **OK**, check for the presence of the Driver Air Bag Cover Emblem (Figure 6).
 - If the Driver Air Bag Cover Emblem is present, the Driver Air Bag Cover does not require replacement; skip to step 38 on page 22 to reinstall the Driver Air Bag Module.

- If the Driver Air Bag Cover Emblem is NOT present, obtain the information below and send to: FQA_inspection_support@nissan-usa.com
 - Take one clear digital photo of the repair order and the missing Driver Air Bag Cover Emblem (both in the same photo)

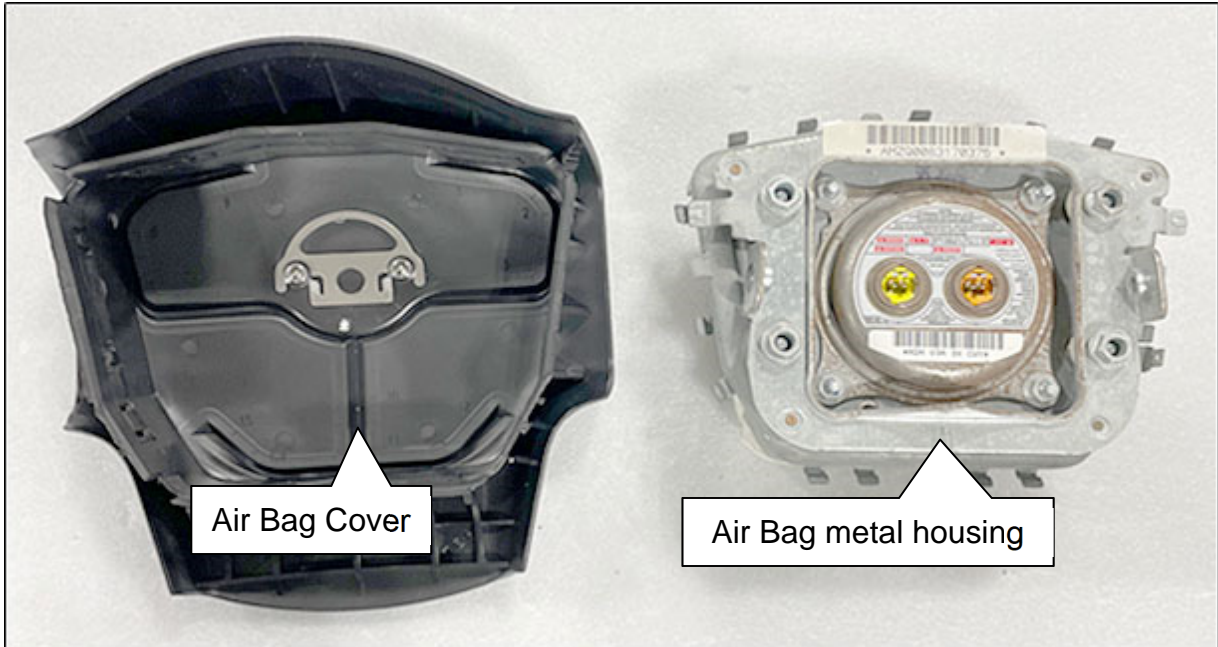
Figure 23

25. On a clean, flat, cloth covered surface, place the new Air Bag Cover face-down (emblem facing down) and the Air Bag metal housing cushion side down (Figure 23).

IMPORTANT: Confirm that loose objects or debris do not enter in the Air Bag Cover.

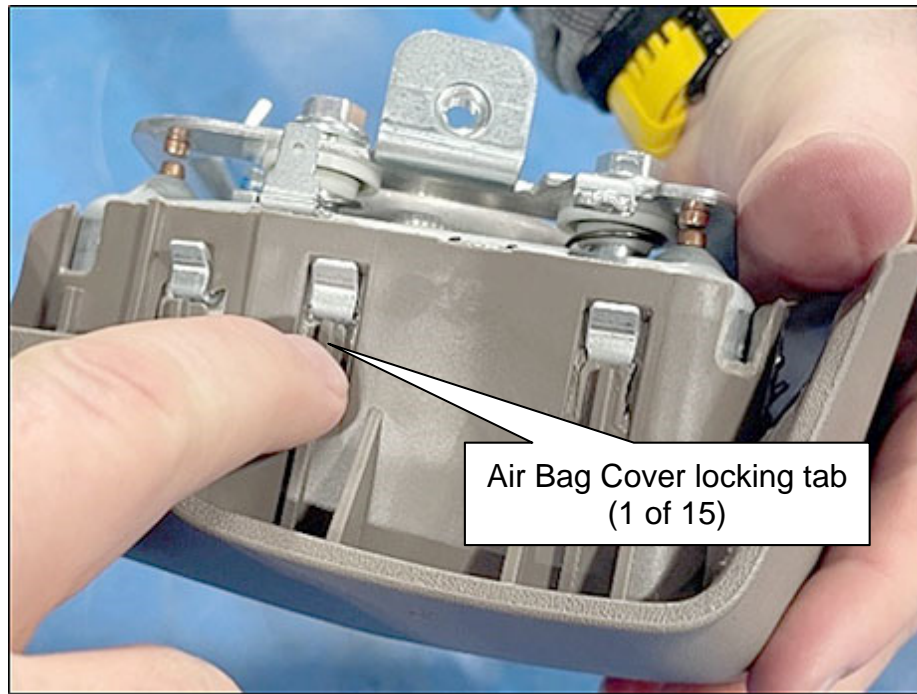
Figure 30

31. If needed, use a finger to push and seat each of the fifteen (15) Air Bag Cover locking tabs under each metal housing hook (Figure 30).

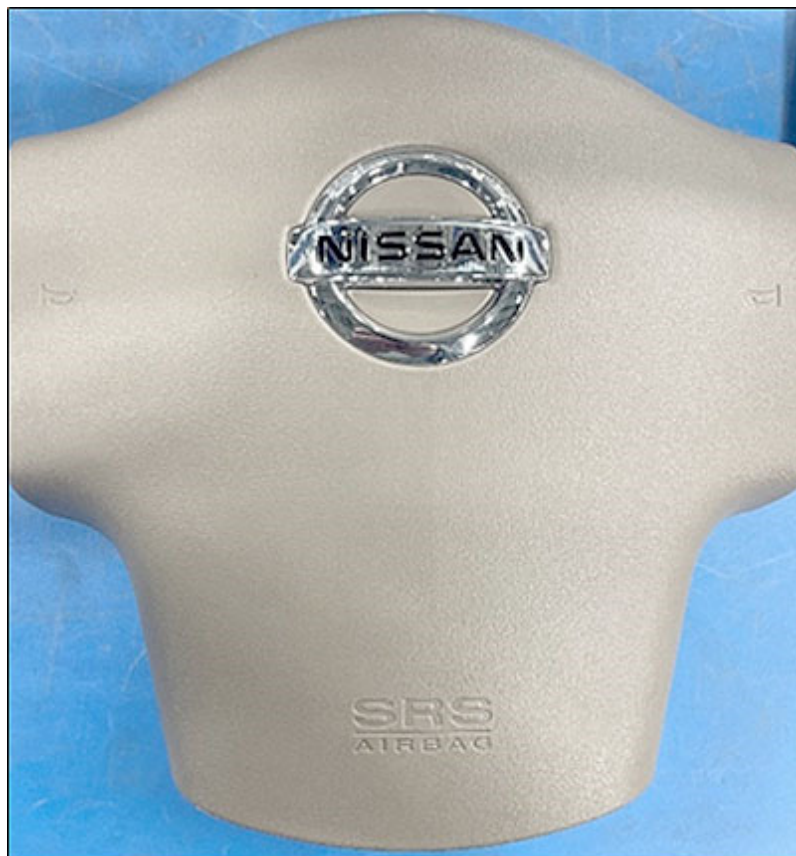
Figure 36

37. Visually inspect emblem and textured cover surface for scratches or damage.
