Service Alert

Subject: MELTED OR WARPED MIRROR COVER OR OUTSIDE TRIM	Service Alert No.: SA-058/24
	Last Issued : 08/15/2024

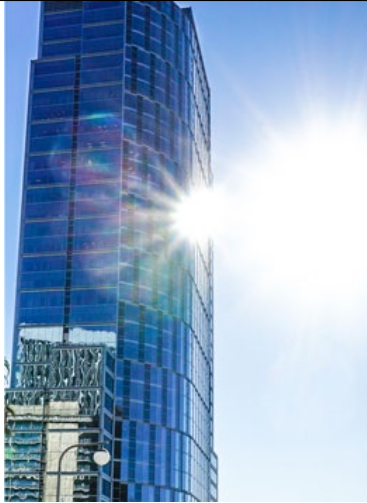
If a structure's windows create enough of a curve, the concave glass can focus the sun's rays onto a small area and acting like magnifying glass direct the sunbeams into a hot pinpoint of light. This magnification of the sun's rays can cause damage to vehicle trim (see examples). Additional information and exemplar images regarding this phenomenon can be found by performing a google search.
