McLaren Artura eMotor Cooling Pump

Topic: E-motor cooling pump LIN fault

Condition: E-motor overheating faults/cooling pump no function

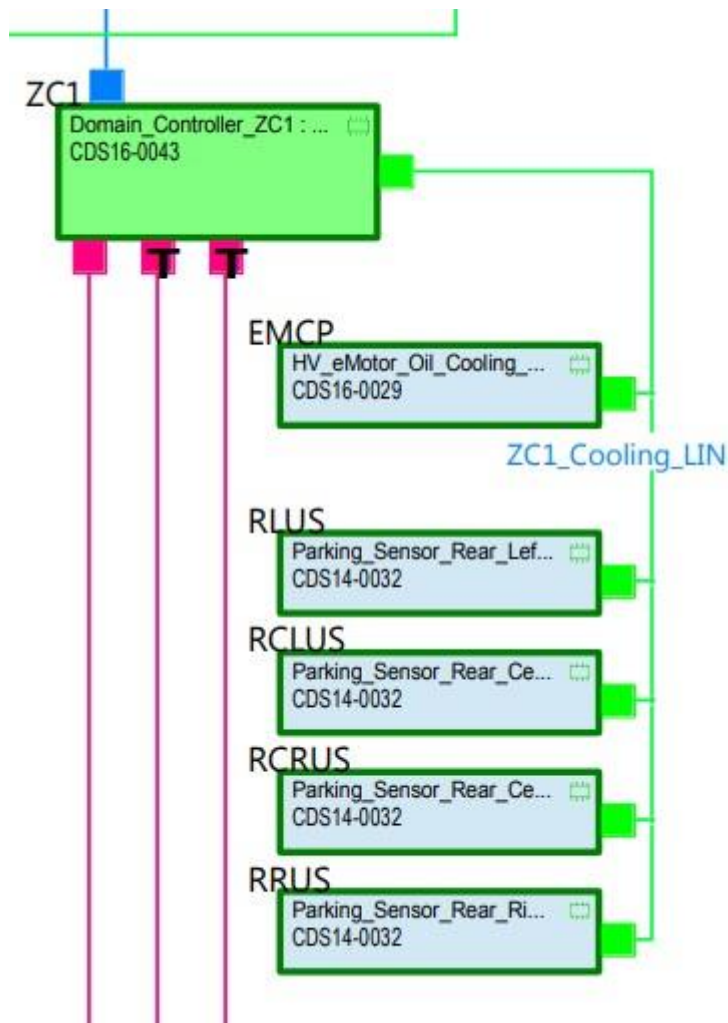
1. Manually confirm cooling pump function by listening/feeling for pump noise/vibration during activation.
2. If no pump function is determined check for any DTC's for the rear parking sensors. If rear sensor faults are present please troubleshoot these first as they can affect cooling pump function as they are on the same LIN bus (see diagram below).
