July 2024
SF704 A

Subject: eCascadia & eM2 Electric Refrigerant Compressor - Lubrication

Models Affected: Specific model years 2024-2025 Freightliner eCascadia and eM2 vehicles, manufactured November 14, 2023, through May 15, 2024.

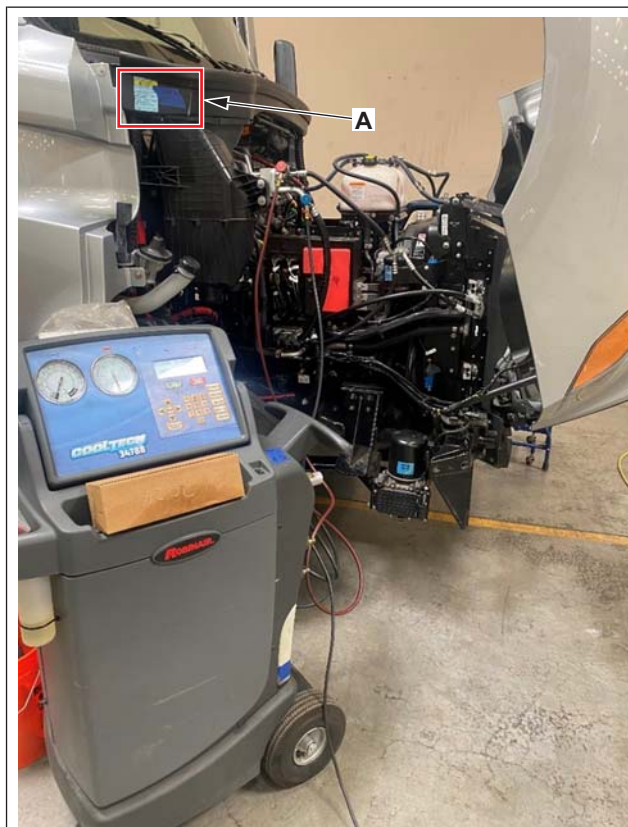
Fig. 1, Evacuating the Refrigerant

4. Evacuate the refrigerant from the air conditioning (A/C) system. For instructions, see **Chapter 17.1.14: Refrigerant Service Operations** in the applicable workshop manual. See **Fig. 1**.

A. Check for a hand-written label at the location shown.

2. Park the vehicle on a level surface, place the vehicle in neutral, shut down the vehicle, and set the parking brake. Chock the tires.
3. Check for a (hand-written) label, near the refrigerant label on the front wall, indicating oil has already been added. If the label clearly states 8 oz of oil has been added, no other action is needed; proceed to step 7 to install a completion sticker. If there is any uncertainty as to what action was already taken, proceed to Step 4.

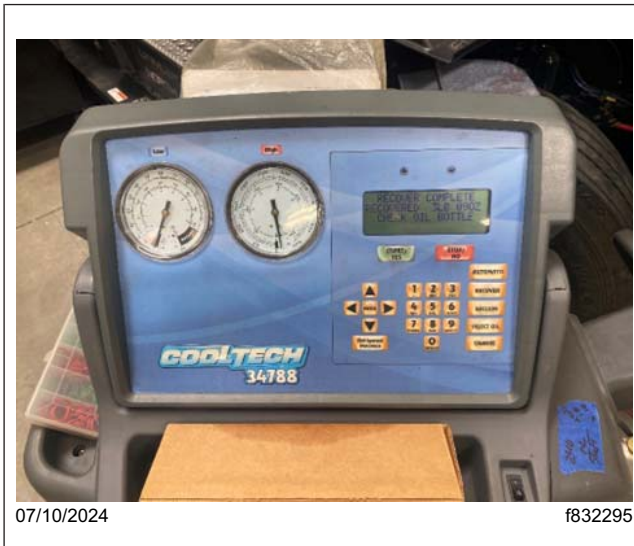
Fig. 2, Refrigerant Recovery, Recycling, and Recharging Machine

5. Carefully note the amount of oil that is recovered with the refrigerant. See [Fig. 2](#) and [Fig. 3](#).

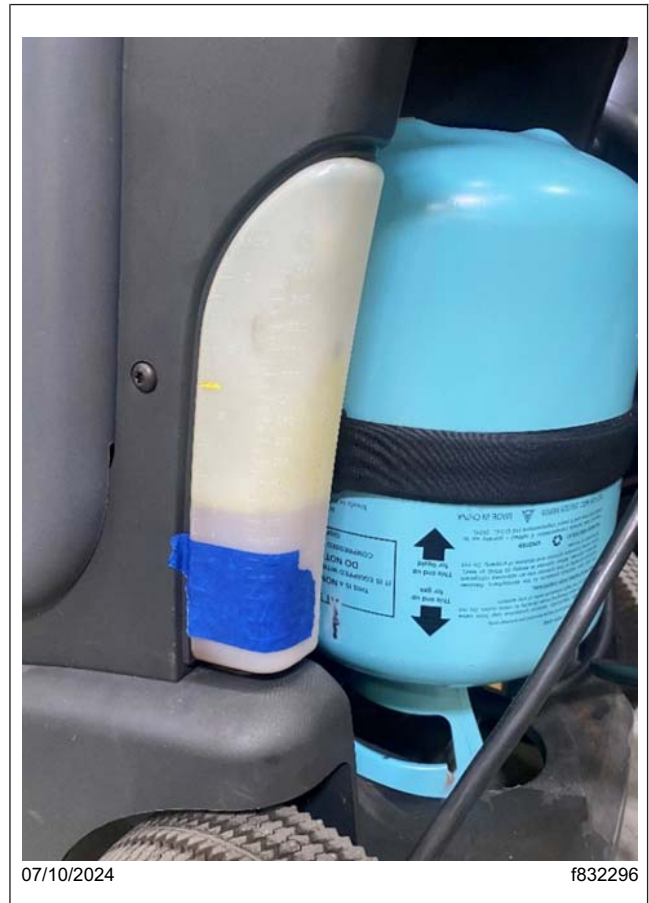
Fig. 3, Oil Recovered with the Refrigerant

Is a measurable amount of oil recovered with the refrigerant?

YES → The system likely has a normal oil charge. Recharge with the refrigerant, and only add the amount of oil that came out.

NO → The system likely has an inadequate oil charge. Add 8 fl oz (237 mL) of oil into the system before recharging with the refrigerant.

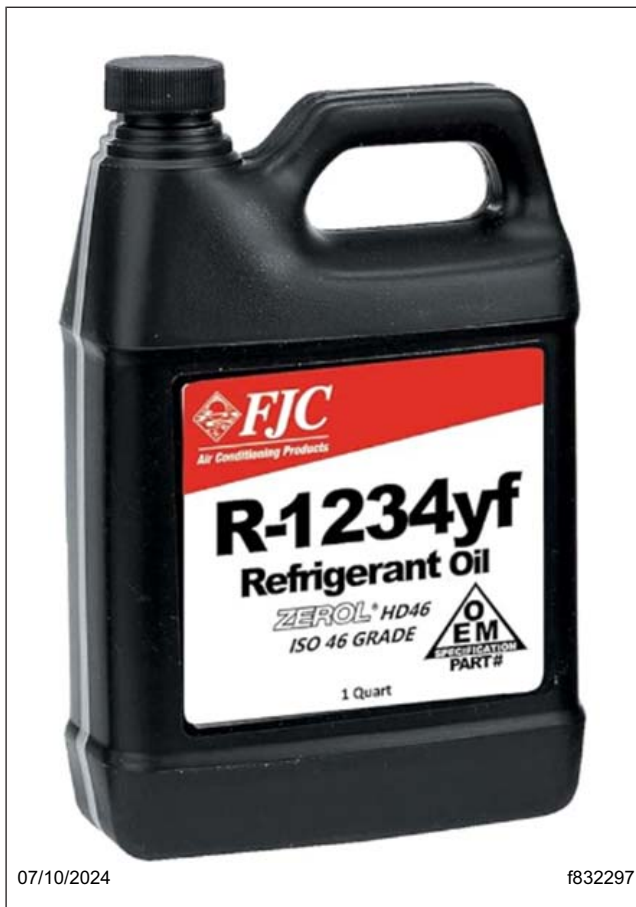
Fig. 4, Refrigerant Oil

6. When adding refrigerant oil, make sure to use ZEROL brand HD46 oil (SHC ZERHD46 8OZCN). See [Fig. 4](#).
 - 6.1 The preferred method of adding oil to the system is to use an HD46-dedicated syringe, and opening refrigerant line connections. If adding a full 8 fl oz (237 mL) to a system, add 2 fl oz (59 mL) to the low-side line going to the compressor, or directly into the compressor suction port, 3 fl oz (89 mL) into the receiver/dryer, and 3 fl oz (89 mL) into the condenser. See [Fig. 5](#).

Mixing standard PAG oil with HD46 can damage an electric refrigerant compressor and cause the A/C to become inoperative.

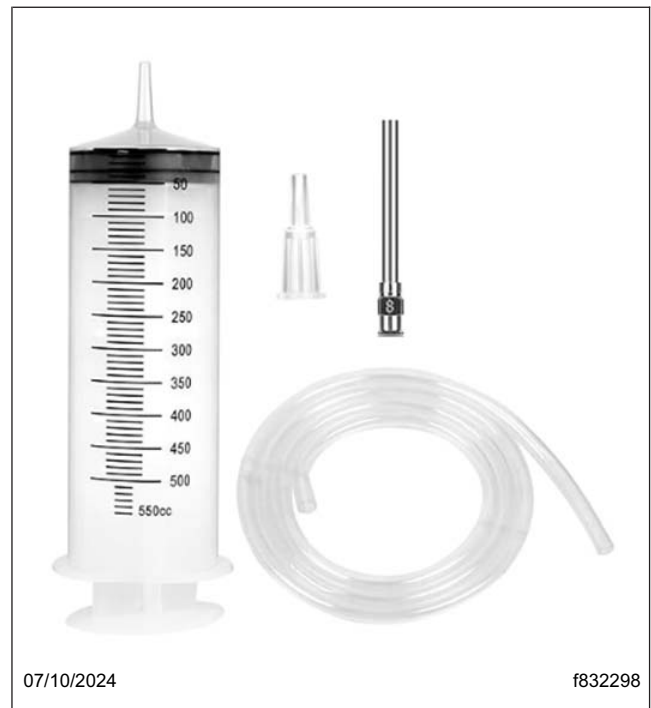
Fig. 5, HD46-Dedicated Syringe and Line Connections

- 6.2 If injecting oil using a refrigerant recovery/charge machine, without opening the system, make sure to use a dedicated machine that has only ever been used to inject this type of oil.
