# 42-080 ABS Wheel Speed Fault Code Correction for MBSP Equipped Vehicles

## TSB-42-080-FTL

► New Cascadia

### Described Condition

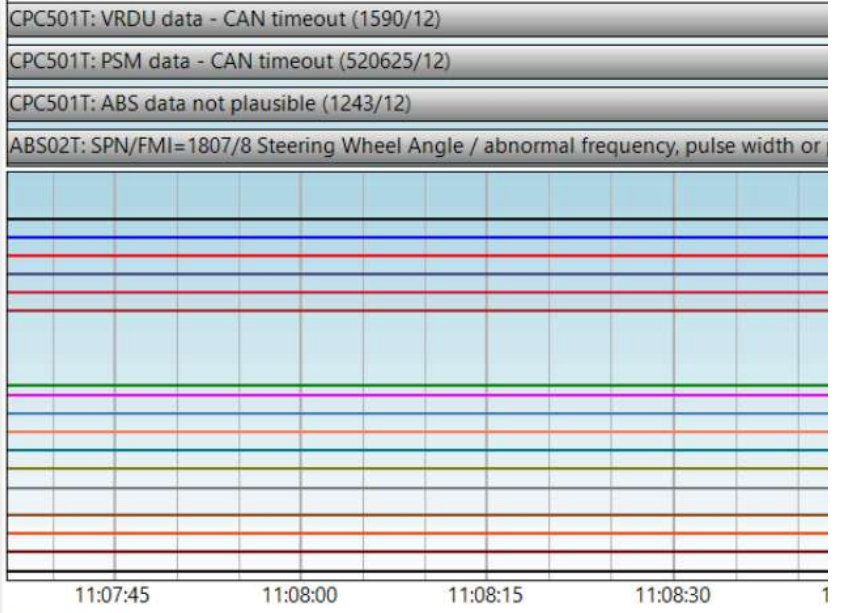
Fig. 1, DiagnosticLink Wheel Speed and Relative Speed Signals

13.  During the test drive, monitor the wheel speeds using DiagnosticLink and ensure that the ABS module and all J1939 connections are active. Do the wheel speeds appear erratic, spike up, or show readings when the vehicle is stationary? It is recommended to refer to the chart instead of the ABS tab/panel. See Table [Wheel Speed Chart Signals 4](#) and Fig. [1](#) for the charting selections in DiagnosticLink.

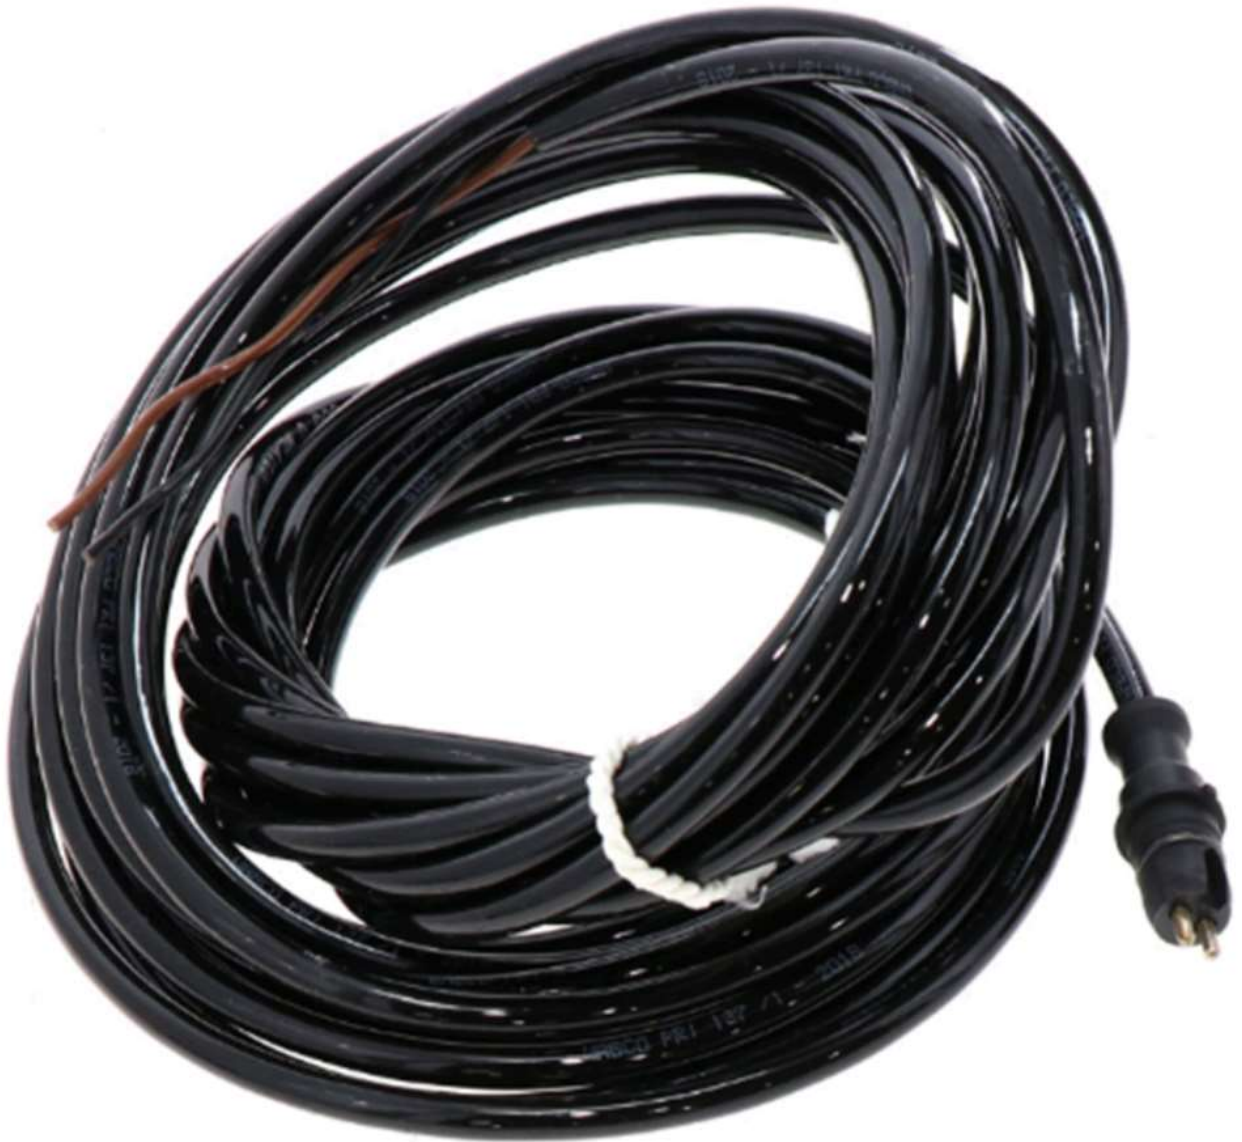
Fig. 3, WABCO ABS Harness

- b.  All harnesses listed above in Table [WABCO Harness Part Numbers 5](#) will require termination at the bulkhead connector BHB. See Fig. [3](#) and Fig. [4](#) for bulkhead connector BHB location.

d.  All the harnesses listed in Table [WABCO Harness Part Numbers 5](#) will require trimming to length and termination at the 76-pin bulkhead connector BHB. See Fig. [3](#) for image of a typical WABCO ABS Harness and Fig. [4](#) for bulkhead connector BHB location.

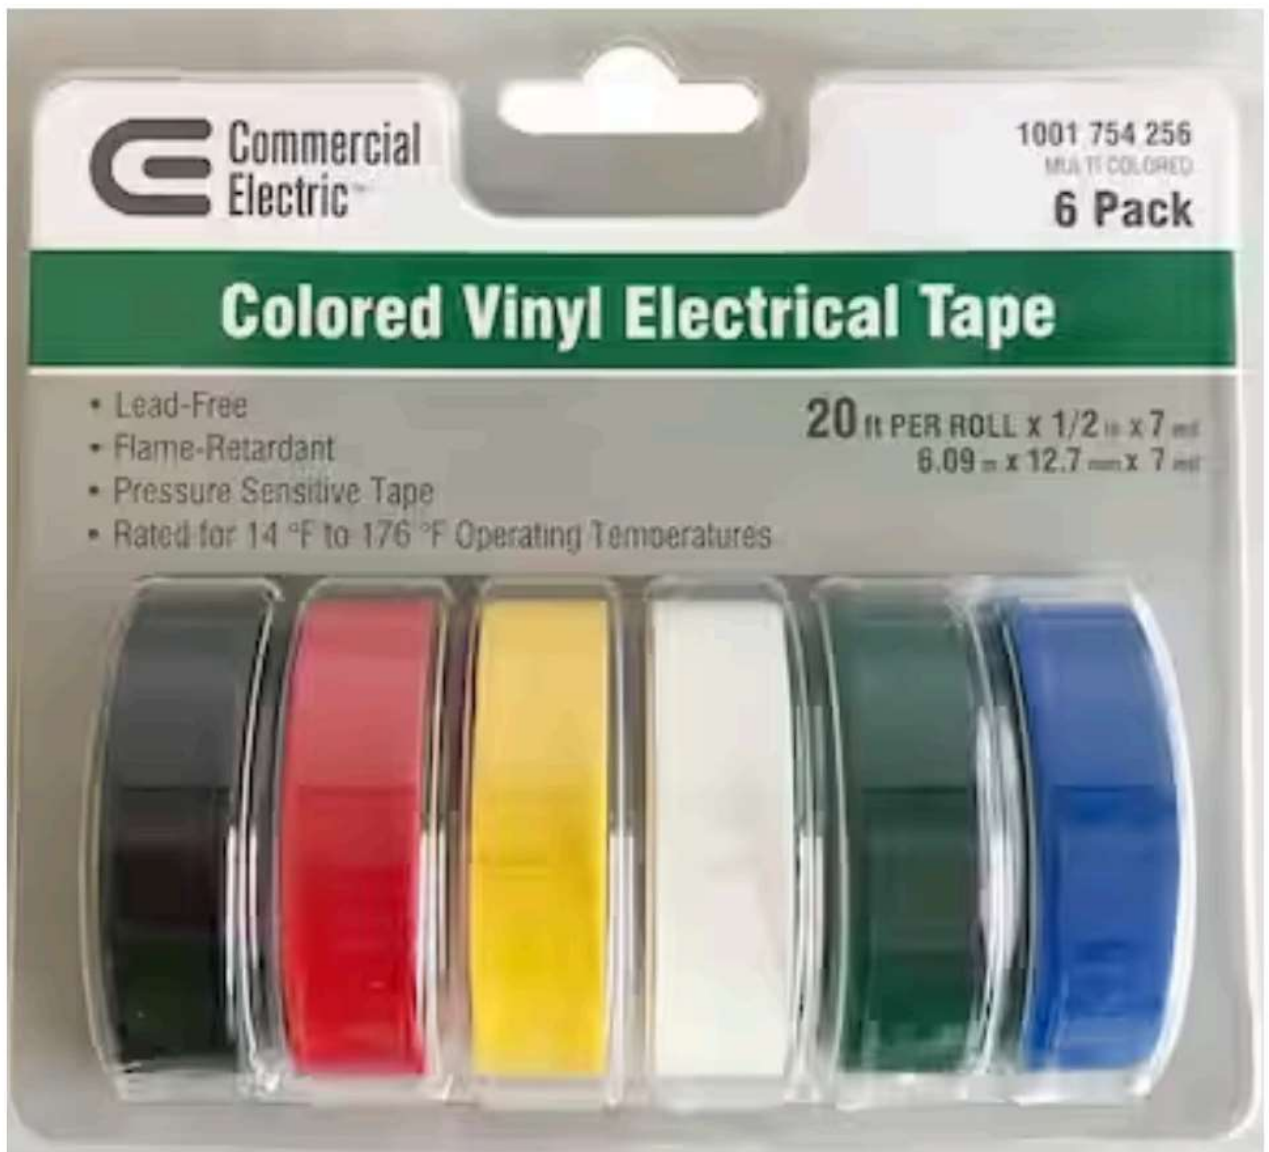
Fig. 5, Multicolored Tape

g.  Carefully mark all eight circuits in the four harnesses to be replaced. Remove and replace only one circuit at a time. Use separate colored tape at each end of the overlay harness in order to correctly identify and avoid mispinning the connector. See Fig. [5](#).

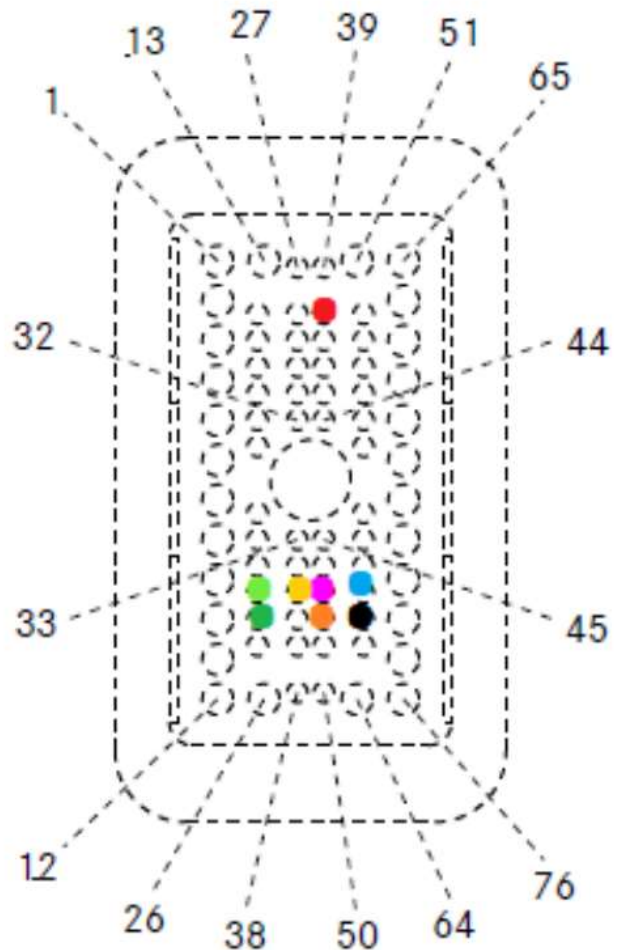
Fig. 6, BulkHead Connector BHB

j.  Verify that the terminals are installed into the correct cavity of the 76-pin bulkhead connector BHB. See Fig. 6.

ID:	CHAS_F_H_DASH_BHB_1B	
PN:	23-13153-016 REF	
	SEALED CONNECTOR	
CAV	CIR#	
—	—	
23	377LA- # 1701 (BK)	●
24	377LR- # 1701 (BK)	●
25	378LRO # 1701 (DKBL)	
34	378LAI # 1701 (BR)	
35	377LA+ # 1701 (BR)	●
37	378LRI # 1701 (BR)	
40	377LR+ # 1701 (BR)	●
41	378LAO # 1701 (DKBL)	
46	378RAI # 1701 (BR)	
47	377RA- # 1701 (BK)	●
48	377RR- # 1701 (BK)	●
49	378RRI # 1701 (BR)	
58	378T- # 1701 (BR)	
59	378T+ # 1701 (DKBL)	
60	378RAO # 1701 (DKBL)	
61	377RA+ # 1701 (BR)	●
62	377RR+ # 1701 (BR)	●
63	378RRO # 1701 (DKBL)
