**Technical Service Bulletin (TSB)**  
**Engine Starter Malfunction**

<b>REFERENCE:</b>	<b>TSB:</b> 08-194-24 <b>GROUP:</b> 08 - Electrical	<b>Date:</b>	September 4, 2024	<b>REVISION:</b>	–
<b>VEHICLES AFFECTED:</b>	<b>2024 - 2025 (B1) Jeep Renegade</b> This bulletin applies to vehicles built on or after January 29, 2024 (MDH 0129XX) and on or before July 07, 2024 (MDH 0722XX).			<b>MARKET APPLICABILITY:</b>	
				<input type="checkbox"/> NA	<input type="checkbox"/> MEA
				<input checked="" type="checkbox"/> SA	<input type="checkbox"/> IAP
				<input type="checkbox"/> EE	<input type="checkbox"/> CH
<b>CUSTOMER SYMPTOM:</b>	<b>Customers may comment on the following:</b> <ul style="list-style-type: none"> <li>Vehicle no start.</li> </ul>				
<b>CAUSE:</b>	Starter issue

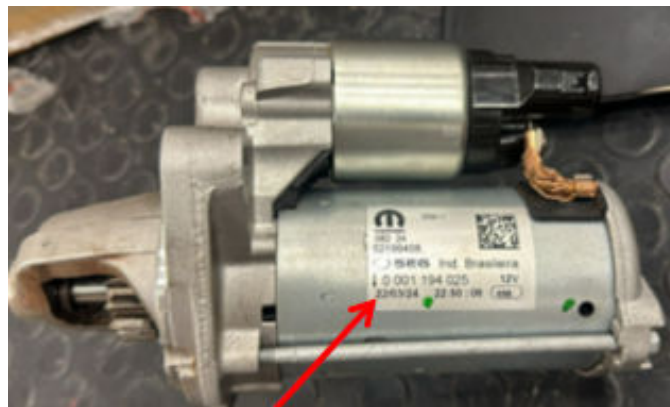
**Fig. 1**  
Starter Build Date

1. Raise the vehicle on the hoist. Refer to the detailed service procedures available in DealerCONNECT/Service Library under: 04 - Vehicle Quick Reference / Hoisting / Standard Procedure.
2. Inspect the build date on the starter [Fig. 1](#).

3. Does it show a build date from January 01, 2024 (01/01/24) to February 06, 2024 (06/03/24)?
  - YES>>> Proceed to [Step 4](#).
  - NO>>> This RSU does not apply. Perform further diagnosis. Use Inspect LOP (08-75-01-94) to close this active RSU.
4. Replace the starter. Refer to the detailed service procedures available in DealerCONNECT/Service Library under: 08 - Electrical / 8F - Engine Systems / Starting / Starter / Removal / Installation.
5. Lower vehicle from hoist.
