## SERVICE BULLETIN

**APPLICABILITY:** 2019-23 Ascent

**NUMBER:** 12-254-24

**SUBJECT:** Rear Quarter Panel Rust / Rear Gate Glass Design Change

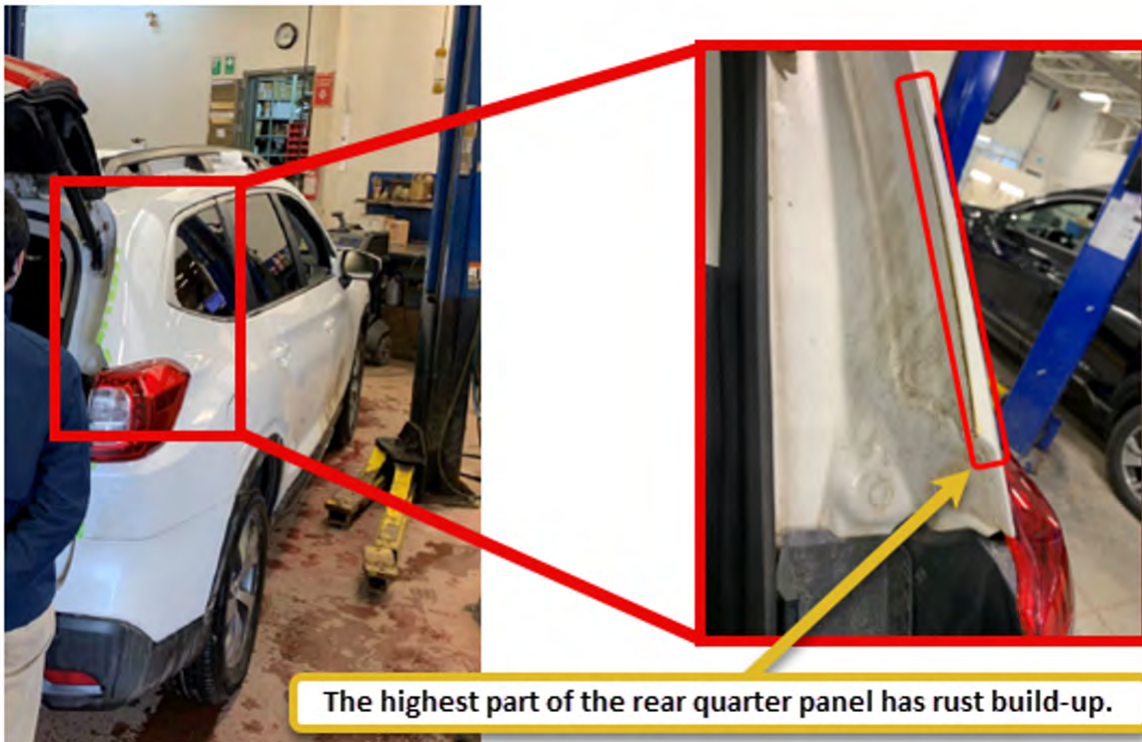
This bulletin announces the design change made to the rear gate glass. This change was developed to address cases of rust build up along the edge of the rear gate opening of the rear quarter panel. Debris can pass through the rear gate opening and become agitated by the rear glass seal causing the paint to wear. The new rear glass seal positioning has been changed preventing any debris build-up. If rust formation is found along the rear quarter panel gate opening. Replace the rear gate glass with the new part.

The highest part of the rear quarter panel has rust build-up.

**RUST REMOVAL/PAINT REPAIR:** It is important to remove any rust from the painted surfaces using the following method:

1. Remove any oil, grease, or wax from the affected area.
2. Apply the applicable Subaru touch-up paint to any area where paint has been removed. It is vital to remove any rust staining prior to paint application.
3. Allow sufficient time to dry before operating the rear gate.
