## L460/L461 CONNECTOR CM32B3/4

### Range Rover

- 22-25MY Range Rover
- 23-25MY RR Sport

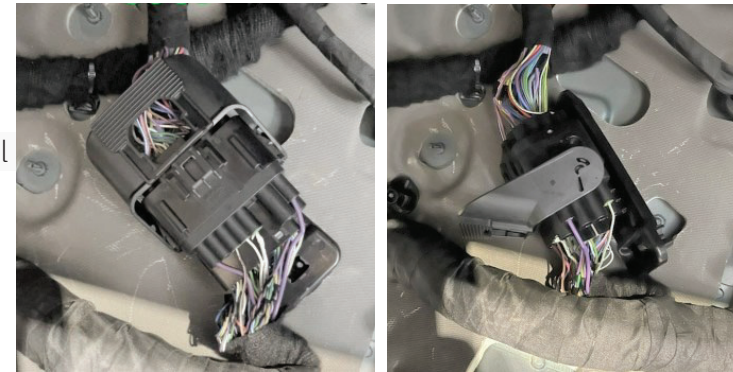
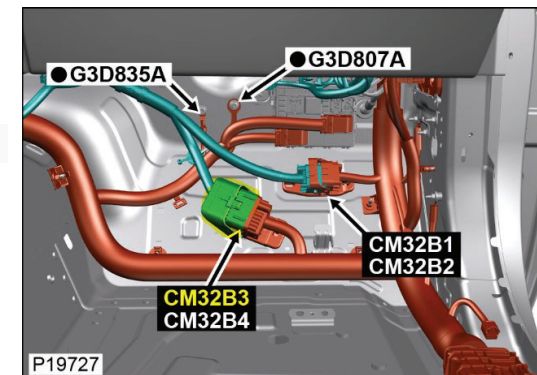
Electrical connector CM32B3/4 which connects the Main Body Harness and Instrument Panel Harness may not be fully latched and secure, and may present the following DTC's within modules on these networks:

Access connector CM32B3/4 (Reference TOPIx Electrical Reference Library CM32B3 / 4) and inspect to confirm if fully latched and secure.

- If CM32B3/4 is found improperly latched and unsecure, inspect pin connections and if no concern found relatch connector and function test vehicle.
- If CM32B3/4 is found to appear properly latched and secure, it is still recommended to disconnect and inspect pin connections for damage and if no concern found, latch connector and function test vehicle.
