“Chassis error” Fault Message

Models	Model Year	Model Type	VIN Range	Vehicle-Specific Equipment
Taycan	As of 2025	Y1A, Y1B, Y1C	N/A	1P8 (Porsche Active Ride)

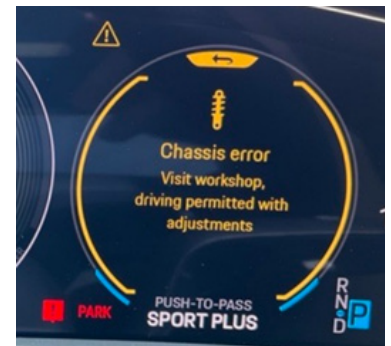
Figure 1 - Instrument Cluster Fault Message

Customer complains of a “Chassis Error” fault message in the instrument cluster.

There is a conflict of the diagnostic parameters of the chassis control unit that causes a fault message to appear when making a turn in the vehicle.

- **C13B6FF - PSM/ESC forced activation by damper control**
- **B19F3F0 - Indicator light for chassis control, yellow warning message**
- **C13F0F0 - Active damper control, function restriction**
- **C13C453 - Level control, deactivated**

1. Create a Pre-VAL.
2. Verify the vehicle has **Active Ride** and the concern is isolated to the conditions described above.
3. Verify the chassis control unit software version is **<0980**.
4. Perform automatic programming of the chassis control unit and verify the software version is **0980 (or higher)**.
5. Create a Post-VAL
6. Test drive vehicle and ensure fault does not return.
