SIM 01 01 24

F5X F60 B36 B46 EVAP PURGE (VENT) VALVE EXT LTD WTY (ELW)
15 YEARS/150,000 MILES

Component-Specific Extended Limited Warranty (ELW)

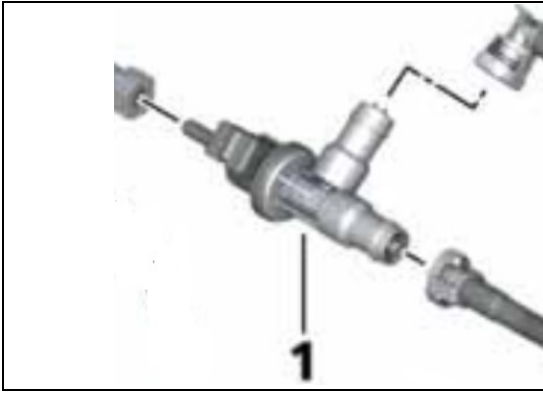
For the eligible vehicles, MINI USA, a division of BMW of North America, LLC (MINI USA) is extending the limited warranty for the vehicle's **fuel tank purge (breather) valve** to:

Over time, the EVAP system's vent (purge) valve may develop material and operational issues, this can cause hard starting, and the engine to run rough, especially while idling.

If a vehicle listed above arrives at your dealer with the issue described in this Service Information Bulletin, perform the corresponding diagnosis and when applicable, replace the EVAP system's vent (purge) valve as instructed or as determined by the diagnosis.
